## TRANSPORTATION AND SAFETY STUDY

### LUDLOW

#### EAST STREET/WINSOR STREET/HAMPDEN STREET INTERSECTION

SEPTEMBER 2010

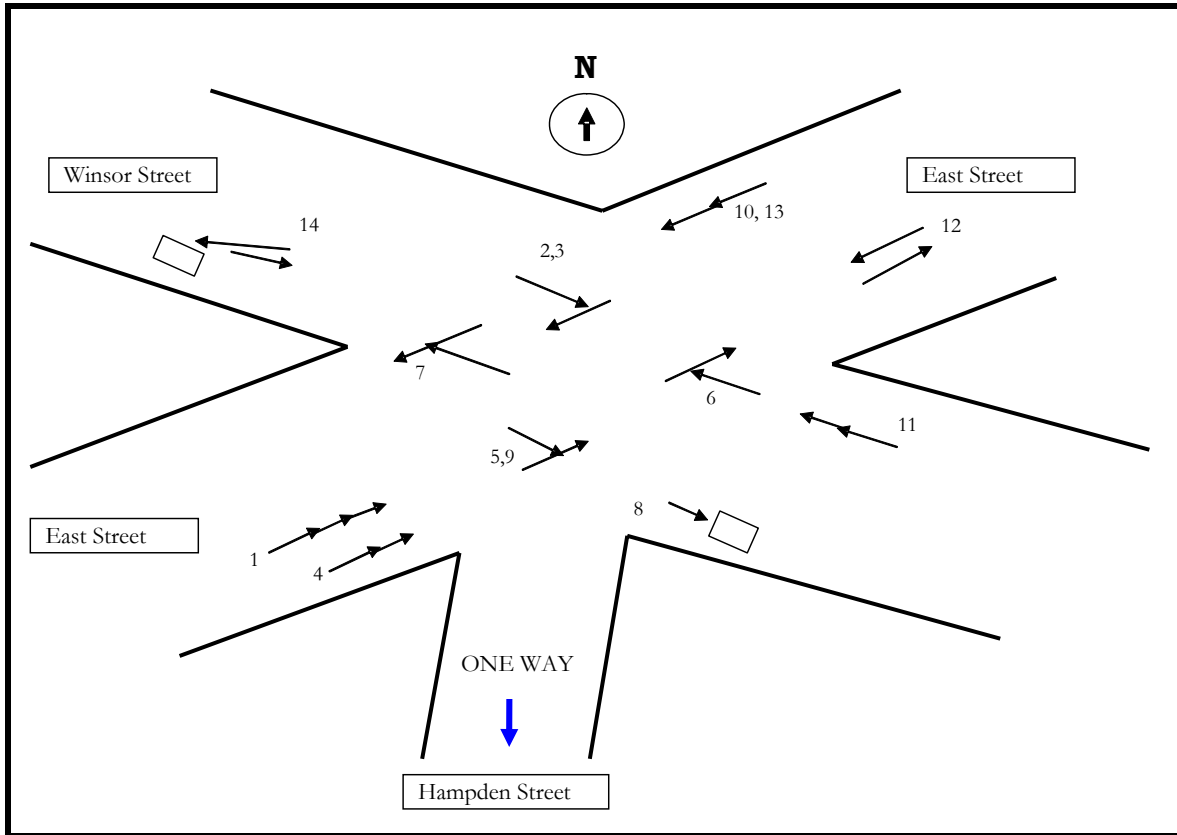
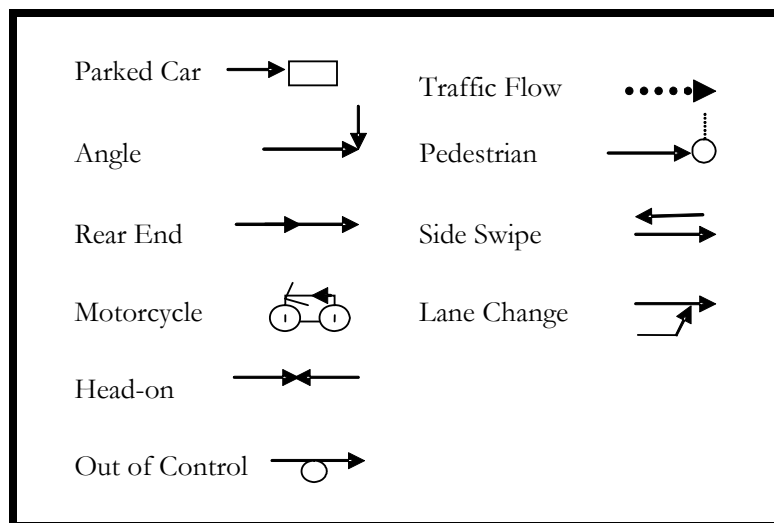
Figure 4: Collision Diagram

Based upon the data in the crash reports, each crash has been depicted graphically in the collision diagram and crash patterns have been identified. Figure 4 shows the collision diagram for the intersection. The details of the crashes shown in the figure are summarized in Table 2.

A total of 14 crash reports were obtained for the calendar years of 2007 to 2009. These crashes have been graphically presented in Figure 4.

Crash numbers 1, 4, 10, 11, and 13 were rear end collisions. One of these rear end collisions occurred when the driver attempted to back up from the intersection. Crash numbers 2, 3, 5, 7, and 9 were angled collisions, some of which were result of drivers not being able to observe the vehicles approaching on East Street due to sight distance restrictions. The vehicles involved in these angle type collisions were also reported to have stopped before proceeding into the intersection. Two crashes were the result of vehicles colliding with other vehicles parked on Winsor Street. Collision number 12 was a side swipe crash between two vehicles moving in opposite direction on East Street. Collision 14 was a side swipe crash between two vehicles which also collided with the third vehicle parked on the street.
