TRANSPORTATION AND SAFETY STUDY

NORTH MAIN STREET (US ROUTE 20 AND MA ROUTE 181), WILBRAHAM STREET (US ROUTE 20) AND SHEARER STREET INTERSECTION

PALMER

FEBRUARY 2010

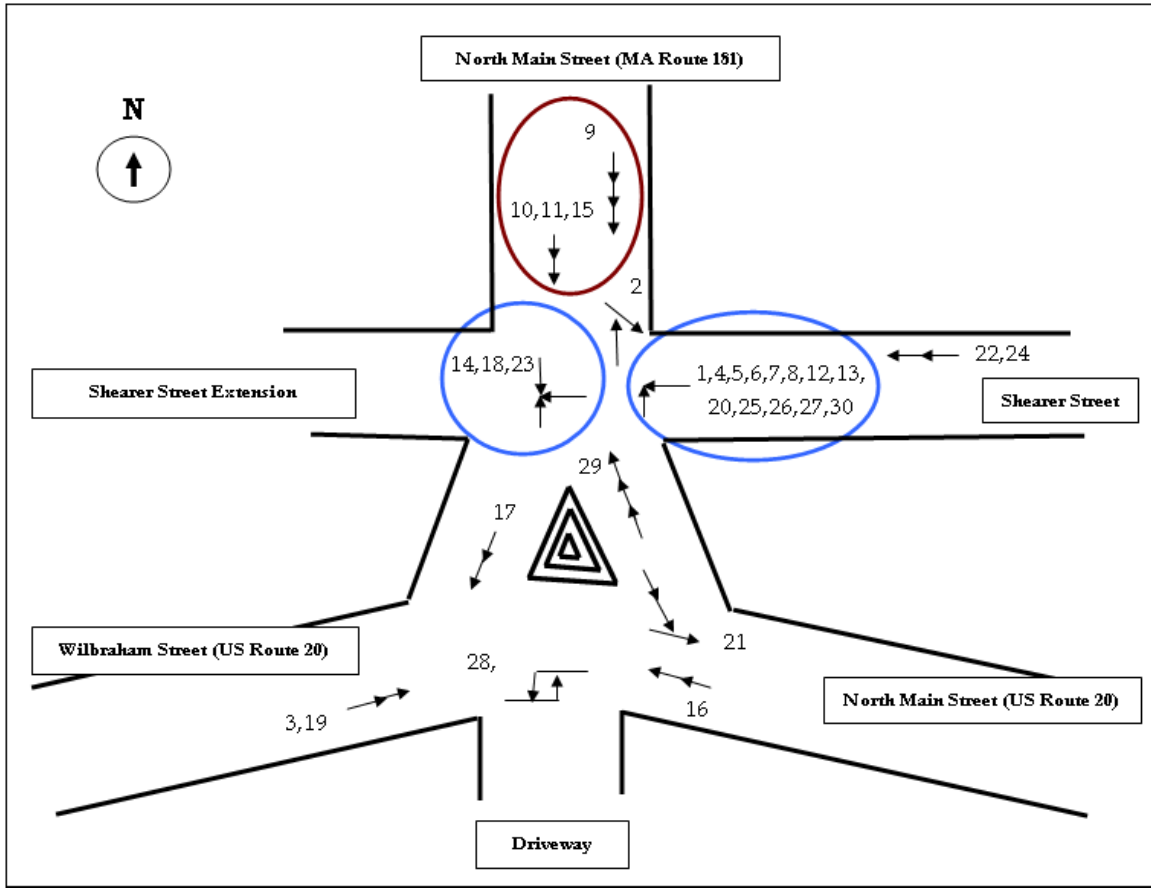
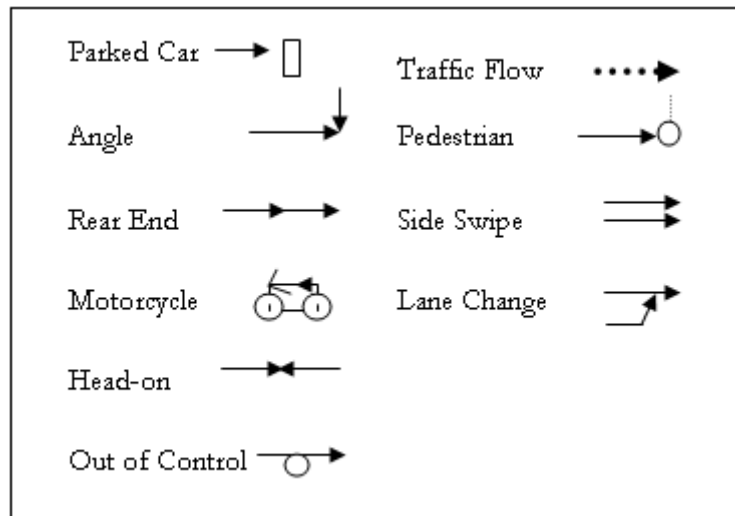
Figure 5: Collision Diagram

Based upon the data in the crash reports, each crash has been depicted graphically in the collision diagram and patterns of crashes have been grouped. Figure 5 shows the collision diagram for the intersection. The details of the crashes shown in the figure are summarized in Table 2.

The collision diagram shows that most of the crashes (24 out of 30) occurred at *Intersection 1*. Also, most of the crashes occurred between northbound through traffic on North Main Street and westbound traffic on Shearer Street. A total of 6 crashes involved three vehicles colliding with each other and 3 out of these six involved through traffic on Shearer Street and North Main Street. A number of rear end type collisions were observed on the southbound approach of North Main Street (MA Route 181). These rear end collisions on the southbound approach of North Main Street could be because of the vehicles making sudden stops before the intersection to avoid blocking the intersection and the Palmer Ambulance Entrance. It is possible that vehicles attempting to turn left out of Shearer Street have difficulty in reviewing left turning traffic from Wilbraham Street onto North Main Street.
