Top High Risk At-Grade Railroad Crossings in the Pioneer Valley

**Prepared under the direction of the Pioneer
Valley MPO by the:
PIONEER VALLEY PLANNING COMMISSION**

APRIL 2019

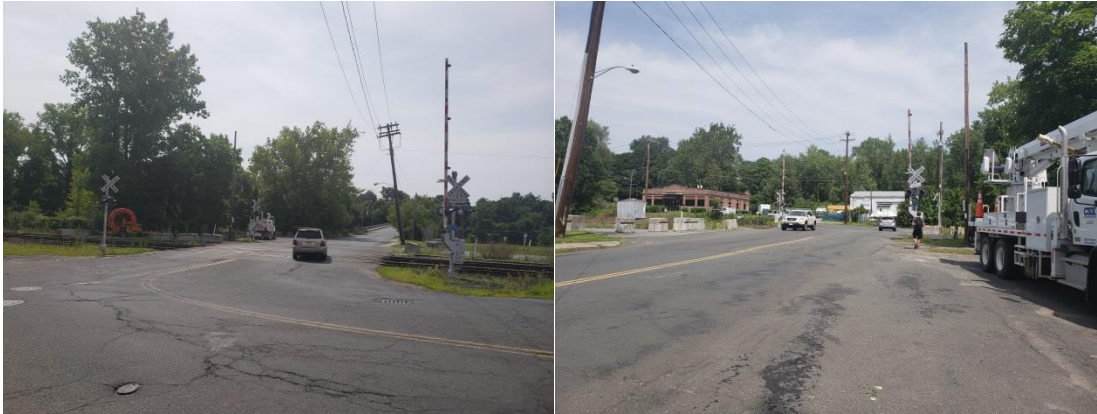
Figure 3: Cross Bucks and Gates along West Springfield side approach (left) and Agawam Side Approach

There are activated gates accompanied by flashing lights and cross bucks along both north and south bound directions of the Front Street in advance of the railway track crossing. The gates are approximately 15 feet wide and extend along the approach however the receiving lanes along both sides remain open. Because of this it is possible for some vehicles to ignore the gates and make an illegal movement across the tracks in case of longer gate closing intervals. Auxiliary flashing lights accompanied by cross bucks have been installed along the south bound approach of Front Street to alert the vehicles along the bend.

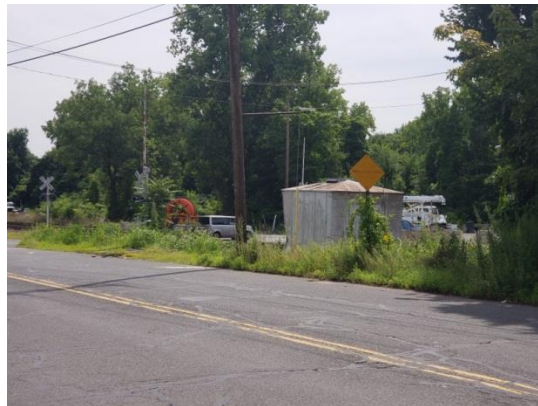
Figure 4: Faded Advance Warning Sign along Front Street

Warning Sign along Front Street southbound approach was mostly faded and needed replacement. At the time of the field survey advance warning sign along north bound approach of Front Street was found missing.

Advance warning sign along the West Springfield approach needs to be replaced. Vegetation along the Bridge Street approach towards the east needs to be maintained and trimmed for proper visibility of cross bucks and flashing lights.

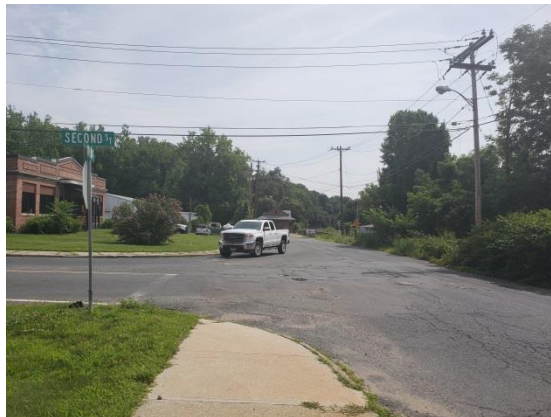
Figure 5: Pavement Condition and Curbing

At the time of the survey, pavement in the vicinity of the crossing was found to be in poor to fair condition because of multiple pot holes and cracks. The pavement markings were faded at numerous locations and concrete curbing along the sidewalk in the north of Front Street was damaged intermittently.

It is recommended that the local department of public works for both the communities work in cooperation to improve the conditions within their jurisdictions along this location. As a short term measure the pavement markings need to be repainted and long term the pavement needs repaving to improve the condition and eliminate rutting and pot holes. It is recommended that the curbing along the pavement also gets repaired and replaced as per need.

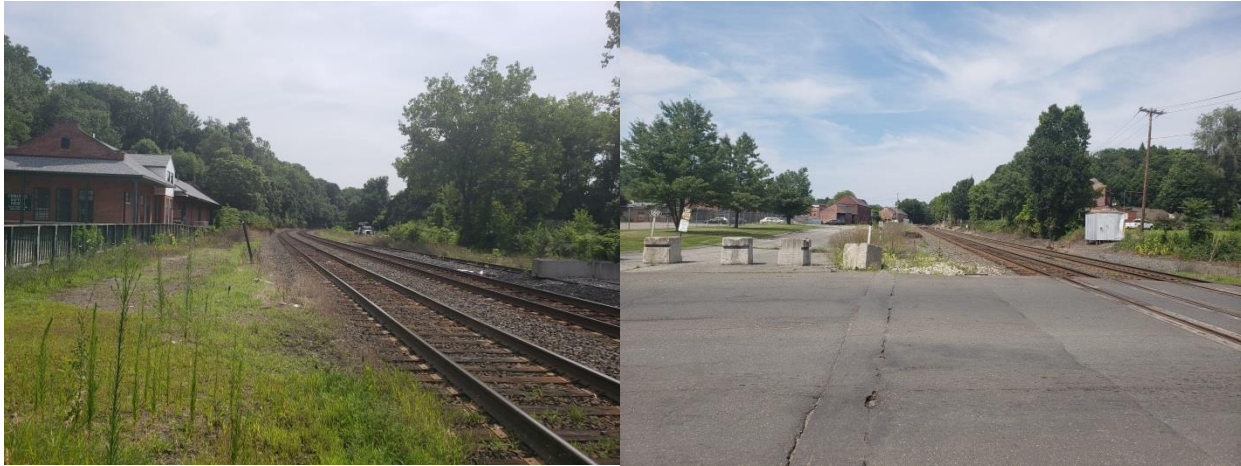
Figure 6: Geometry of the Railroad Tracks

The sight distance for the vehicles along the tracks in both directions was limited because of the curvature in the tracks along both east and west directions of Front Street. Longer gate closing times sometimes lead to driver frustration, the limited sight distance also adds on to the problem as the drivers waiting at the gates cannot see approaching trains from either side of the gates.

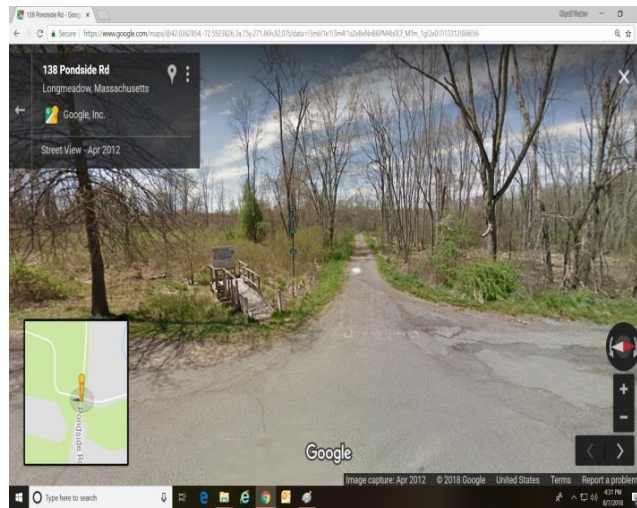
Figure 11: Google Street View Image from 2012

Bark Haul Road is partly paved and partly gravel. Google Images dating back to 1990 depict that it was open to traffic back then. This is also evident by distinct rutting along the road. Google Street view from April 2012 also indicates that the road was open to traffic as recently as the year 2012.

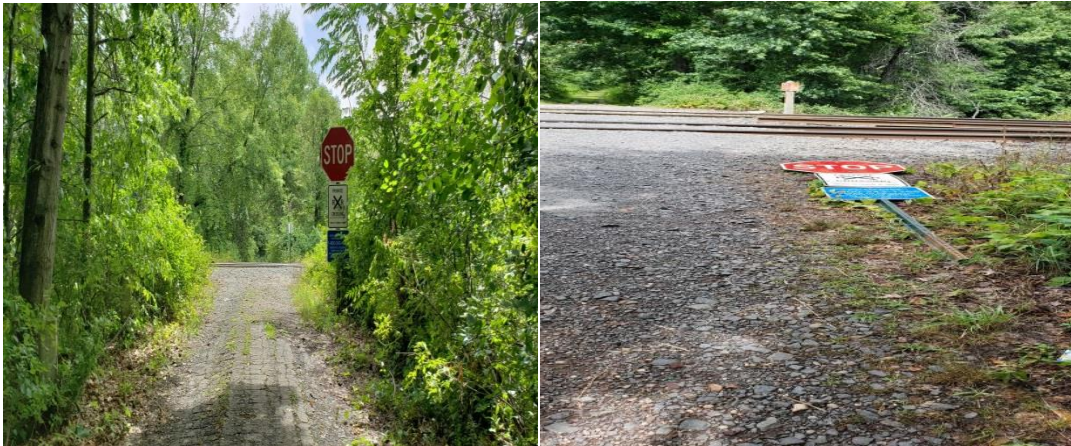
Figure 12: Warning Signs along Bark Haul Road

The WBAPS report states there are cross bucks present at the location however at the time of field visit only Stop signs were observed along both approaches of Bark Haul Road supplemented by a private railroad crossing sign and an information sign for reporting incidents and emergencies. The sign post for westbound approach of Bark Haul Road was damaged and the signs were laying along the road. Overgrown vegetation was covering the signs along both directions.

In the meantime short term improvement measures like repairing the damaged signs and proper maintenance of the gate restricting the access of motor vehicles should be considered to ensure the safety of the users of this road.

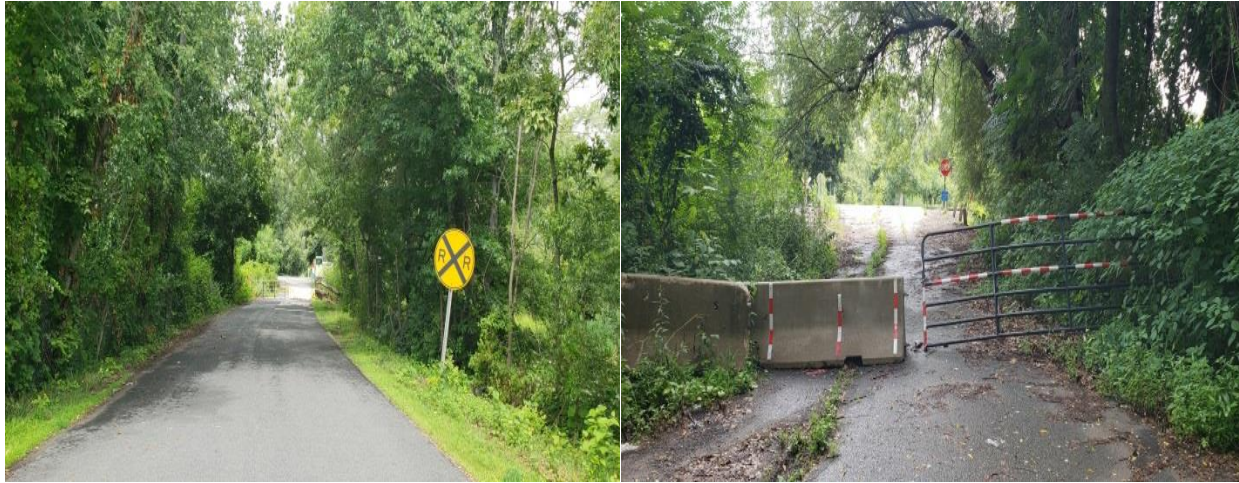
Figure 13: Birnie Road Northbound Approach; Advance Warning Sign and Barriers

Birnie Road has been closed to traffic since March 2017 after the crash that resulted in fatality occurred along this location between a motor vehicle and a train. Currently the Town DPW is awaiting the upgrade of the existing warning devices before reopening the road to public.

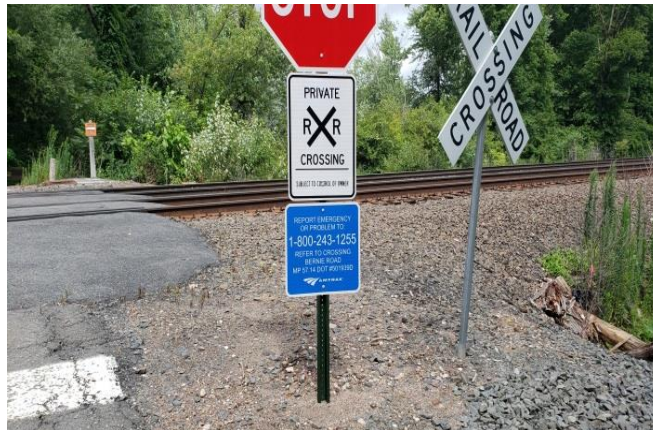
Figure 14: Cross Bucks and Stop Sign

The warning devices information for the two locations in Longmeadow seems to be switched in the FRA database. Birnie Road crossing has Stop Sign and crossbucks to alert the drivers about the approaching tracks. These devices were installed before 2017 as can be seen in Google street view from October 2015. Currently the Town is awaiting the upgrade of the warning devices to flashing lights along with cross bucks at this location. The PVPC was not able to officially confirm whether or not gates will be installed.

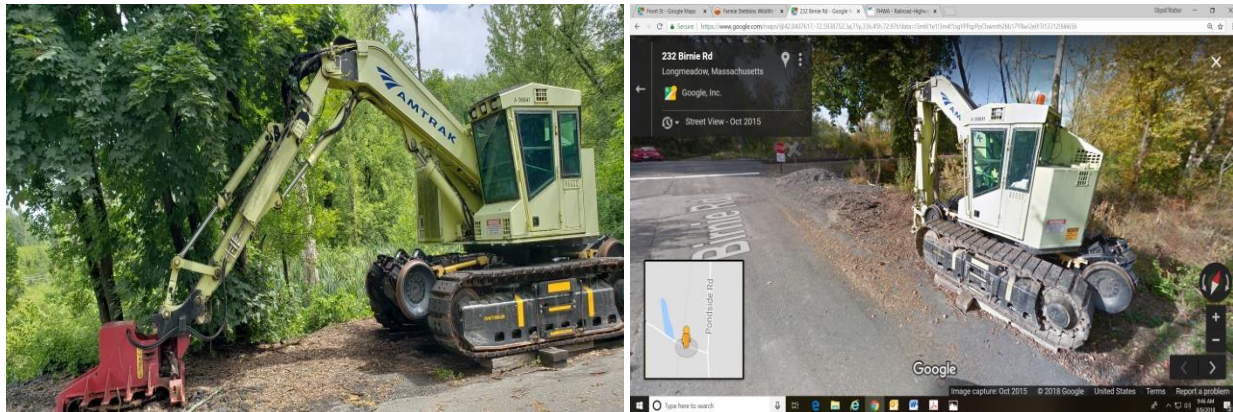
Figure 15: Amtrak Service Vehicle

An Amtrak service vehicle is parked along the side of Birnie Road westbound approach. This vehicle can also be observed in street view images dating back to 2015.

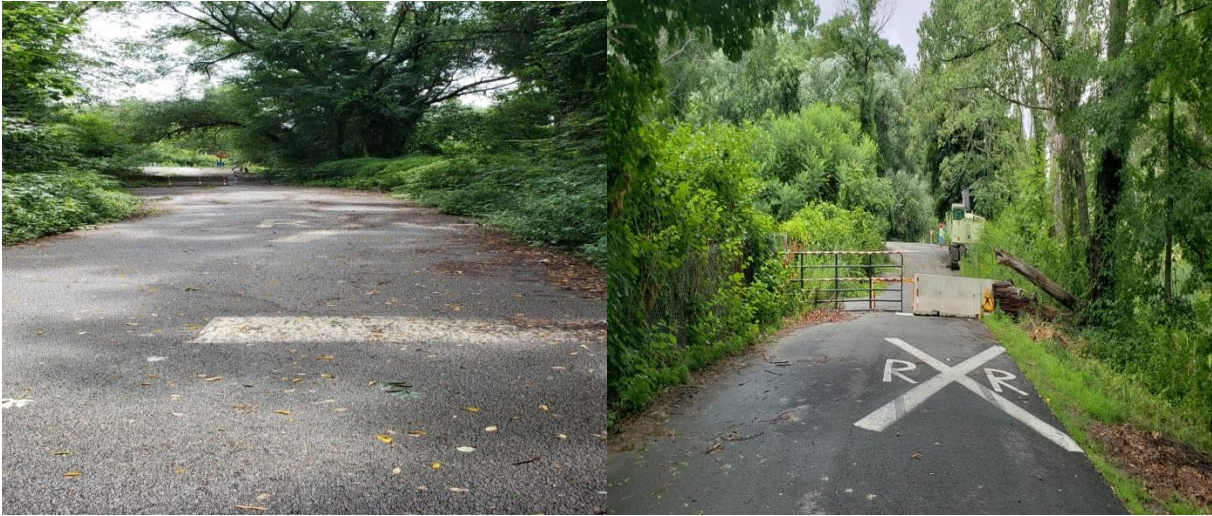
Figure 16: Pavement Markings

Pavement markings exist along both approaches of Birnie Road to inform the drivers about the approaching railroad tracks crossing the highway. These markings have considerable faded along the eastbound approach.

There are plans for several improvements along this location which include updating the warning devices and improving pavement condition and vegetation maintenance. The details of the planned improvements could not be verified at the time of this report; however it is expected to surely improve the safety conditions along this location.
