## TRANSPORTATION AND SAFETY STUDY

SOUTH HADLEY

NEWTON STREET (ROUTE 116) / LYMAN STREET (ROUTE 33) INTERSECTION

APRIL 2010

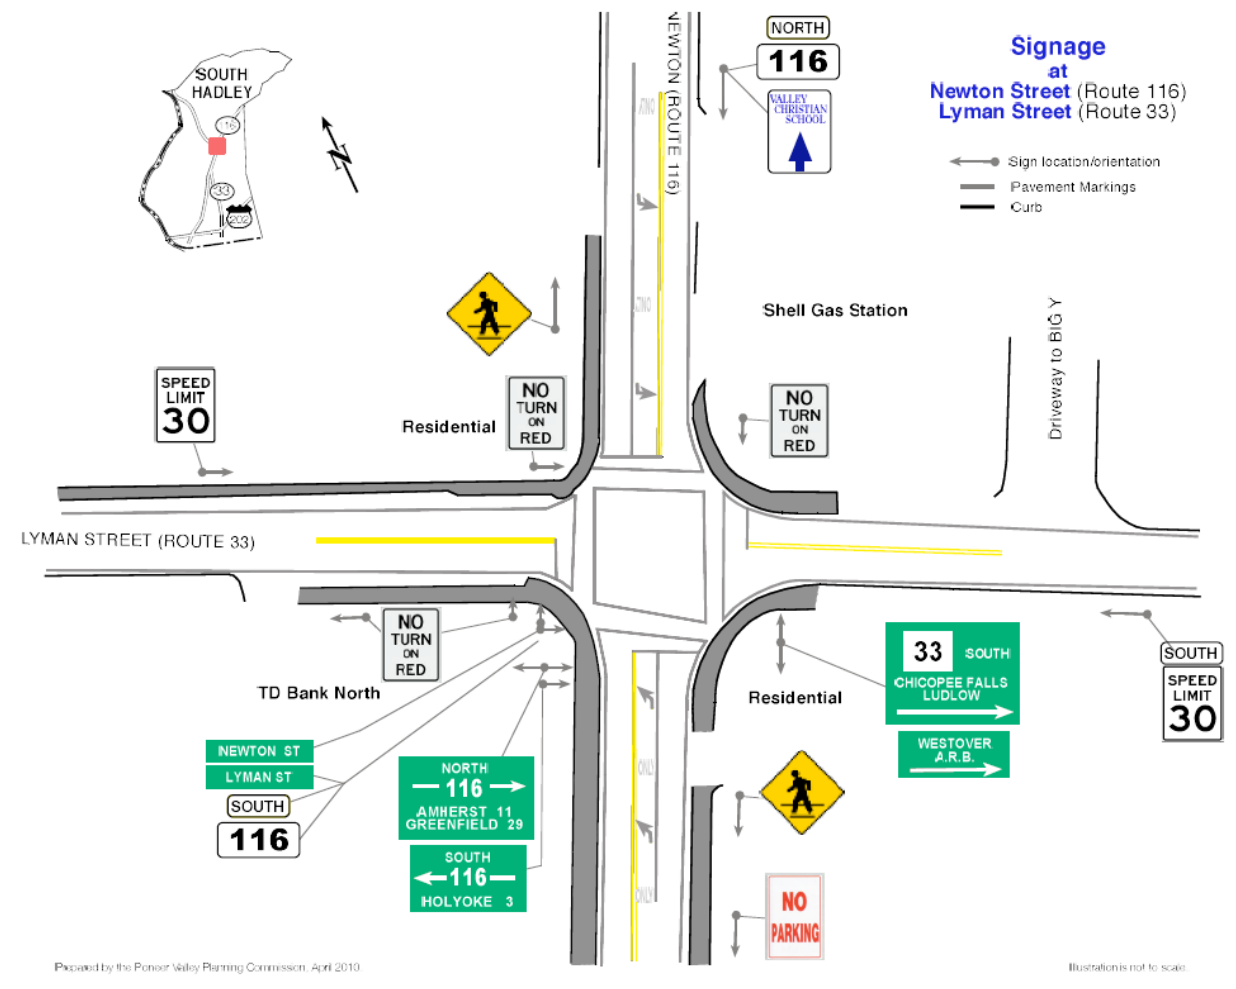
**Figure 2: Pavement Markings and Signs at the Intersection**

At the time of the field inventory, the pavement condition of the streets in the vicinity of the intersection was poor. Granite curbing, sidewalks and crosswalks with pedestrian push buttons are provided on all four approaches to the intersection. Pavement markings were observed to be in fair to poor condition and both Newton Street and Lyman Street are illuminated by street lights.

The pavement markings are somewhat faded. The crosswalk markings at the intersection and the pavement edge lines have also faded. It is recommended that the Town of South Hadley and MassDOT consider repainting pavement markings in the vicinity of the intersection.

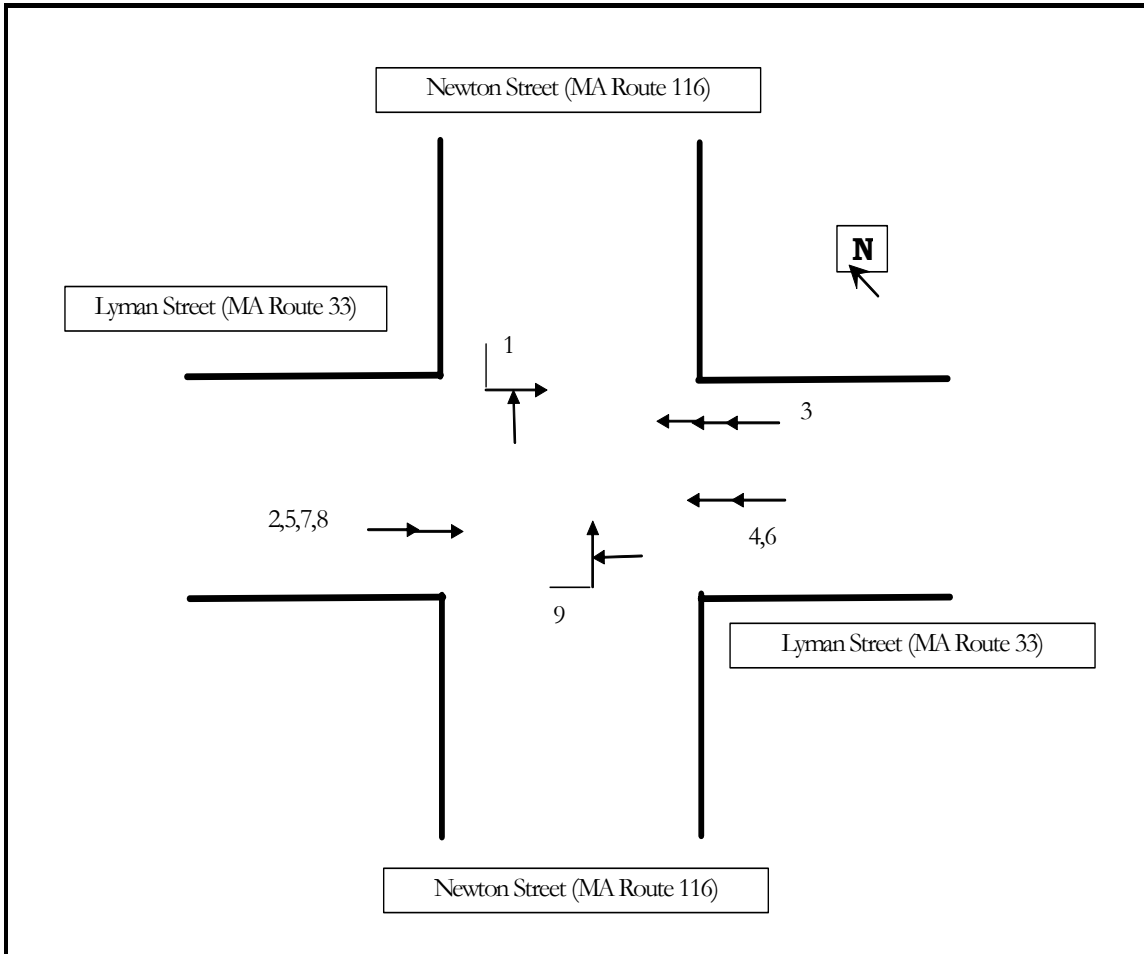
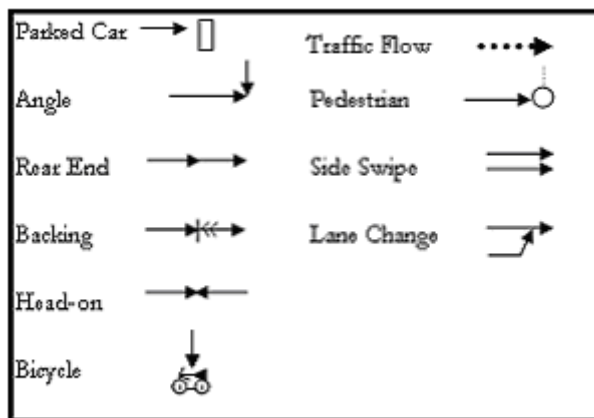
**Figure 5: Collision Diagram**

PVPC obtained the crash reports from the South Hadley Police Department for the calendar years of 2007 to 2009. The objective was to analyze the collision patterns and determine factors that may contribute to crashes at this intersection. Figure 5 shows the collision diagram for the intersection. The details of the crashes shown in the figure are summarized in Table 2.

As can be seen from the collision diagram 7 out of 9 crashes were rear end type collisions occurring on both approaches of Lyman Street. One crash occurred between vehicle turning left onto Newton Street from Lyman Street southeast bound approach and through moving vehicle from Lyman Street northwest bound approach. Only one crash occurred between vehicles on Newton Street approaches. Therefore it can be observed that there might be some safety issues at Lyman Street approaches.

The pedestrian signal for the crosswalk across the Lyman Street eastbound approach does not have a visor. It is recommended that MassDOT consider installing a signal visor for this signal head. A high percentage of rear end crashes at both Lyman Street approaches suggest the need to make signals more prominent to increase safety at the intersection. Installing back plates on all the signal heads will assist in making the signal heads more visible. It is recommended that MassDOT consider checking the effects of wind loading on the spanwire assembly to examine the feasibility of adding back plates to the signal assembly to improve visibility and to reduce the probability of red-light running and rear end crashes. It is also recommended that MassDOT consider adding near side signal heads on strain poles at both Lyman Street approaches in addition to back plates to further improve signal visibility.
