Traffic and Transportation Study
at the Intersection of
Page Boulevard (Route 20) and Bircham Street
in the City of Springfield, MA

June 2022

Safety Study and Signal Warrant Analysis at the Intersection of Page Boulevard (Route 20) and Bircham Street in the City of Springfield, MA

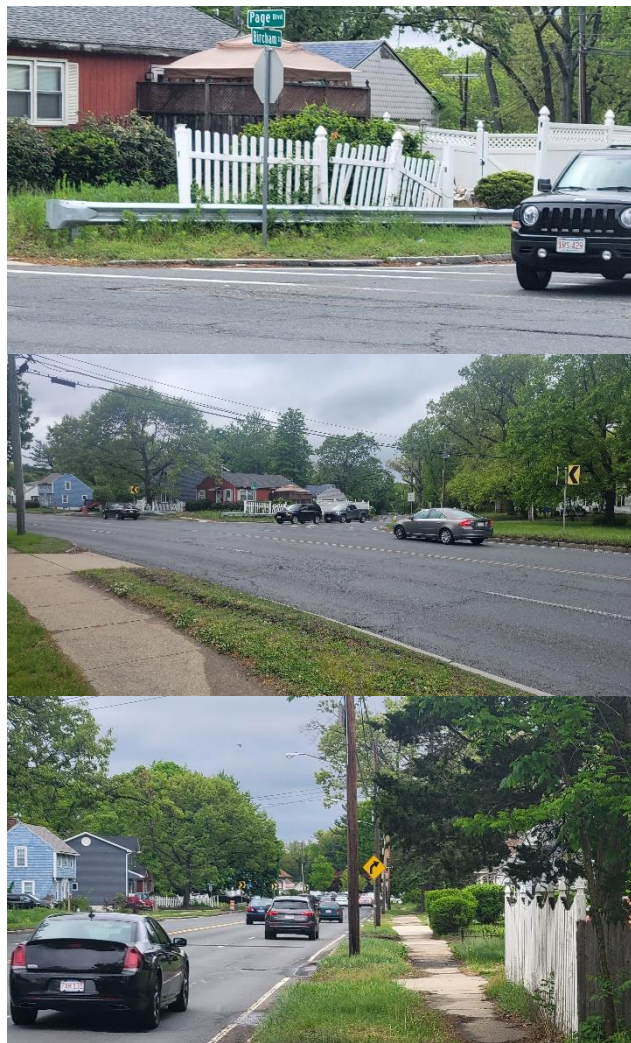
Top: Guardrail along northwest corner of the intersection, to the west of Bircham Street

Middle: Bircham Street approach from Page Boulevard westbound

Bottom: Chevrons and Curve Ahead signs along Page Boulevard eastbound approach

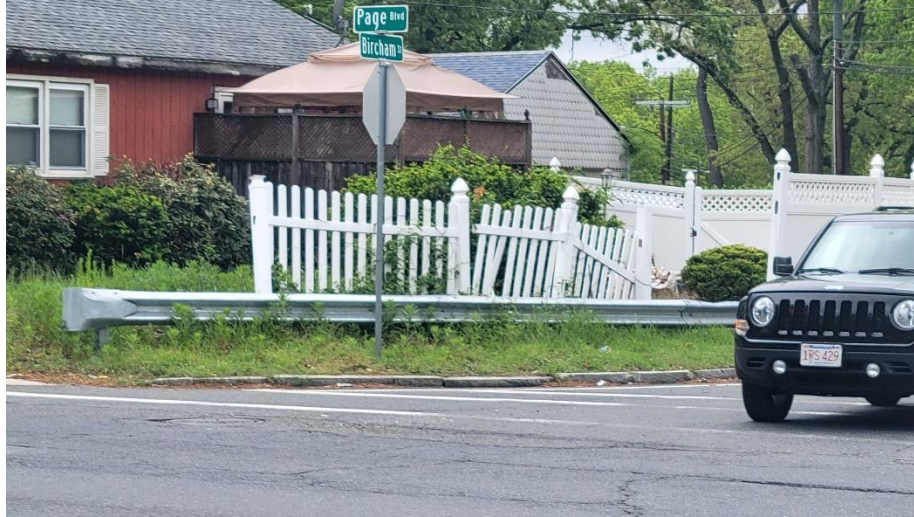
Figure 2: Guard Rail and Damaged Fence along Northwest corner of the Intersection

are installed along both sides of Page Boulevard in the vicinity of the intersection. Sidewalks are provided on both sides of Page Boulevard and granite curbing is provided in the vicinity of the intersection. A double line crosswalk is located across the Bircham Street approach to the intersection. A guard rail is provided along the northwest corner of the intersection which extends down the west side of Bircham Street. A white wooden fence behind this guard rail was damaged at the time of the field inventory.

The granite curbing along the intersection was mostly intact and sidewalks are raised and separated from the pavement by a grass strip along Page Boulevard. The sidewalks have overgrown vegetation and dirt accumulation at several locations. The guard rail along the northwest corner is in good condition but the fence for the private residence immediately behind the guardrail is broken, which indicates it could have been hit by a vehicle or vehicles in past.

7. The guardrail along the northwest corner of the intersection does not have reflective chevrons. It is recommended that reflective high visibility chevrons get installed along the guardrail to improve visibility and reduce possibility of vehicles crashing into it. Removal of the overgrown vegetation in the vicinity of the guardrail will also assist in improving the visibility of this guardrail.

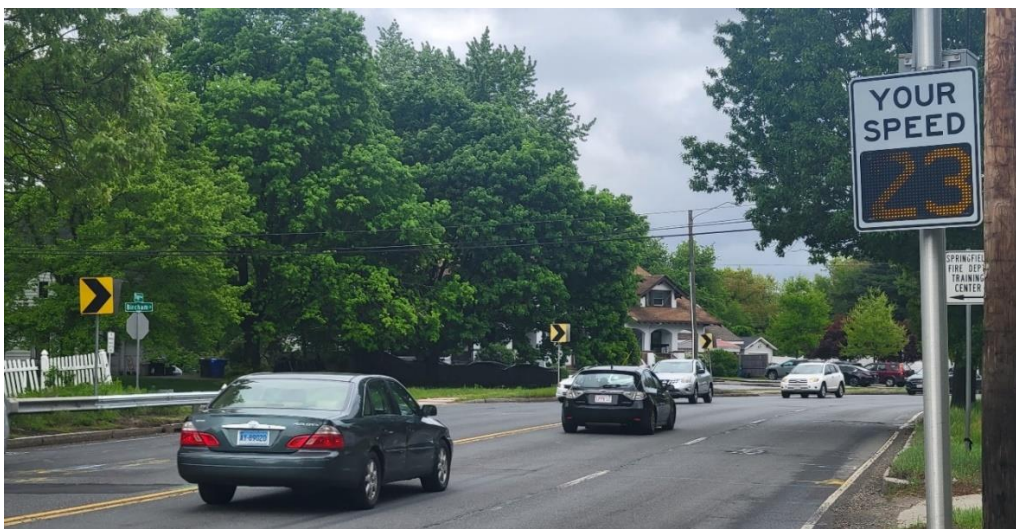
Figure 3: Chevron Signs along Northern Side of Page Boulevard

Post mounted Chevron signs along northern side of the curve on Page Boulevard are not visible to the vehicles travelling in the far-right lane along eastbound approach if there are larger vehicles in the adjacent inside/left lane travelling in the same direction. It was also noted that the chevrons are beginning to fade and may not have a high level of reflectivity at night. The speed limit sign for the eastbound approach is in good condition. No advance warning signs about the approaching intersection were observed along either side of Page Boulevard.

6. The post mounted chevron signs need to be updated and mounted higher according to the guidelines of the Manual of Uniform Traffic Control Devices. (MUTCD). New signs will improve the visibility and help define the curve along Page Boulevard in the vicinity of the intersection.
