Brightwood Neighborhood Walk Assessment Springfield, MA

November 18, 2015

MAKING MASSACHUSETTS MORE WALKABLE

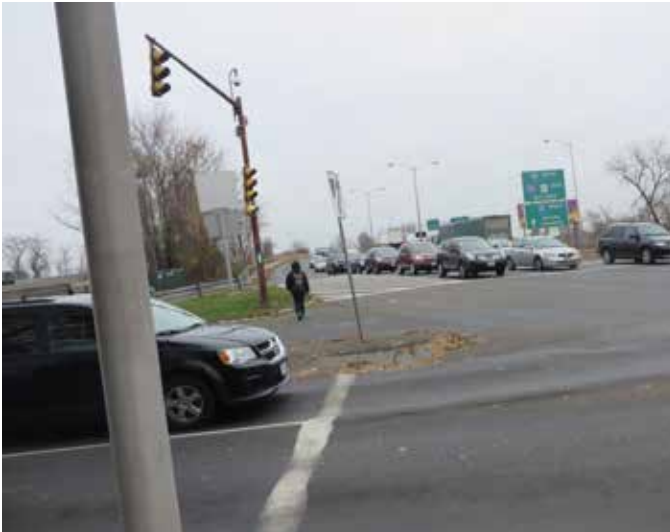
A pedestrian crosses the northern edge of the Route 20 and Plainfield/West/Avocado Street intersection, despite the lack of a protected crossing

There are currently no safe pedestrian crossings across the northern and eastern sides of the intersection at Route 20 and Plainfield/West/Avocado Streets. The walk assessment and Road Safety Assessment teams both noted the need to improve pedestrian accommodations, connectivity and crossings at this intersection specifically and along Route 20 more broadly (US Route 20 Corridor Road Safety Assessment, pgs. 30, 33). To improve pedestrian safety at the Plainfield/Avocado Street intersection, the Springfield casino developer MGM has agreed to implement the following measures, which WalkBoston supports:

- Construct a new sidewalk along the easterly side of Plainfield Street, north of US Route 20, providing connectivity from the existing sidewalk to the intersection (WalkBoston recommends that the sidewalk be wider than the existing sidewalk and separated from the curb with a verge at least 5' wide)
- "Remove existing offset sidewalk between the newly constructed sidewalk connections

- "Install a new crossing on the east side of the intersection including the construction of ADA-compliant wheelchair ramps
- "Install pedestrian countdown indications and MUTCD-compliant pedestrian push buttons with appropriate R10-3 series signage at the new crosswalk
- "Recalculate vehicular and pedestrian clearance intervals at the intersection" (MGM Springfield Final Environmental Impact Report, pg. 3-87)

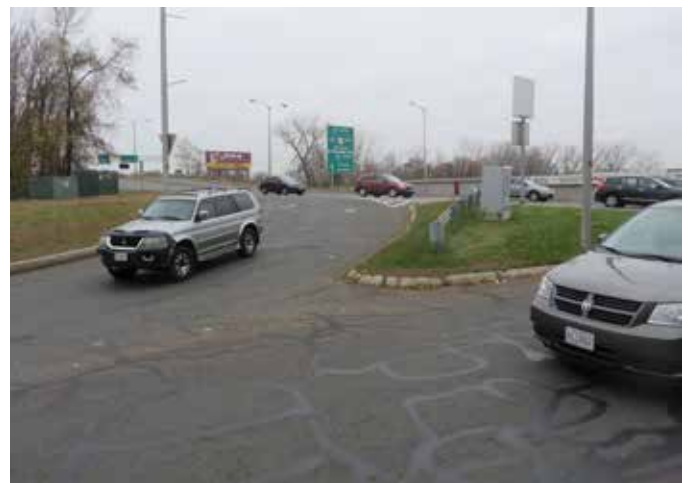
A right-turn slip lane without any crosswalks currently enables westbound traffic on Route 20 to turn north onto Plainfield Street at high speeds without slowing down, creating a risk of vehicular and pedestrian accidents.

- Create a complete crossing with curb ramps and sidewalk extensions across Plainfield Street along the north side of the intersection
- Consider eliminating the right-turn slip lane onto Plainfield Street to slow traffic speed by re-routing all westbound traffic through the signalized intersection

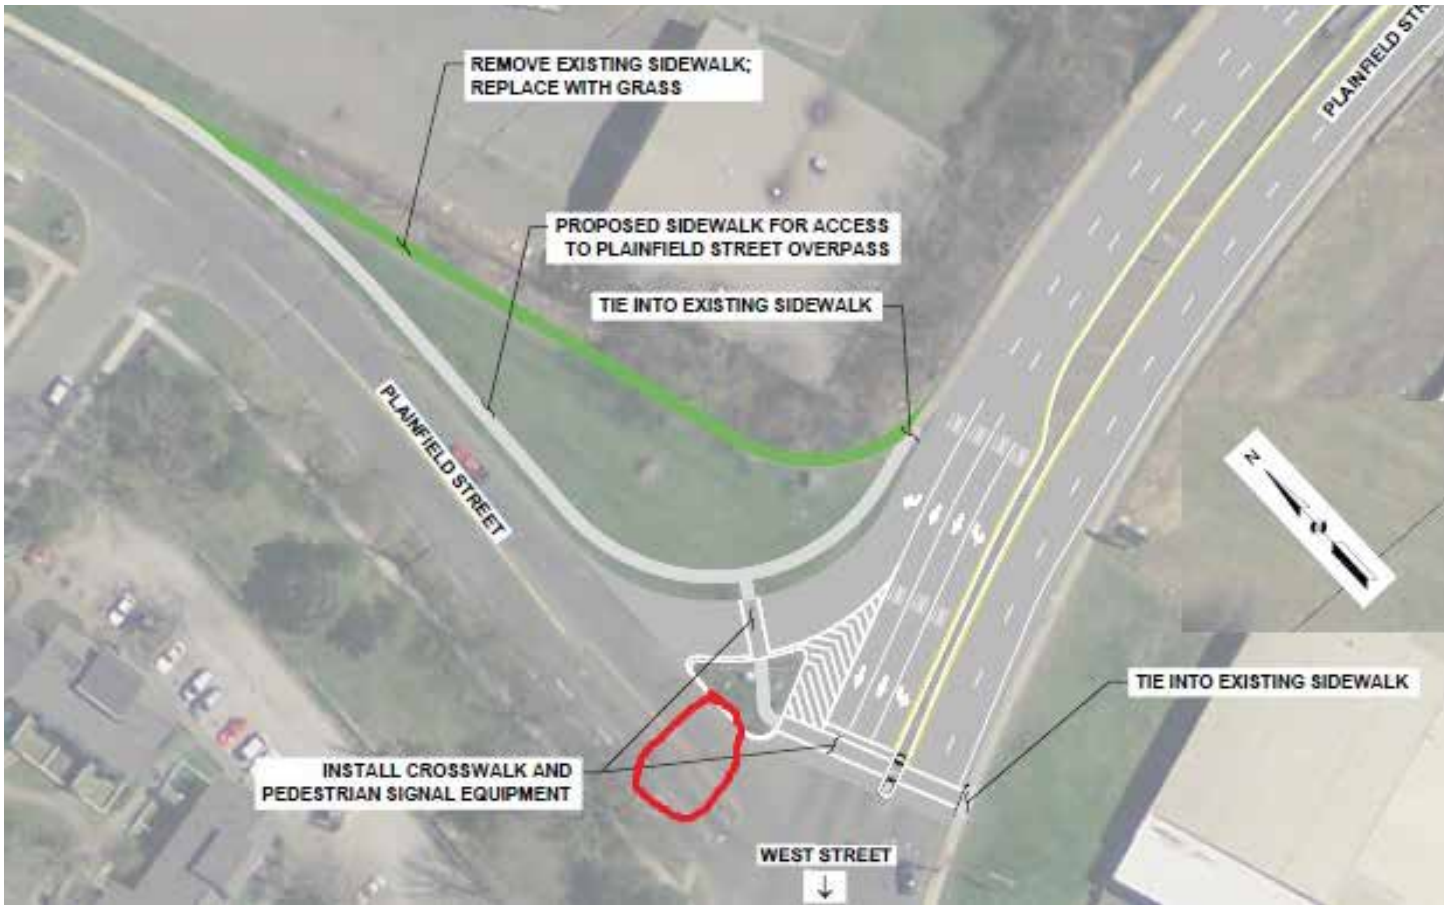
While the measures MGM has agreed to implement at the intersection of Route 20 and Plainfield/West/Avocado Streets will greatly enhance pedestrian safety, in WalkBoston's view additional measures are still needed. MGM's plans do not include a complete pedestrian crossing across Plainfield Street along the northern edge of the intersection. They also maintain the existing right-turn slip lane from Route 20 onto Plainfield Street, which channels traffic at relatively high speeds into the Brightwood neighborhood. WalkBoston therefore recommends the following additional measures:

MGM's plans for improvements at Route 20 and Plainfield/West/Avocado Streets create a crossing across the existing right-turn slip land at Plainfield Street, but fail to create complete crossing across Plainfield Street along the northern edge of the intersection. The lack of a complete crossing is highlighted above in red (source: MGM Springfield Final Environmental Impact Report, pg. 3-88).

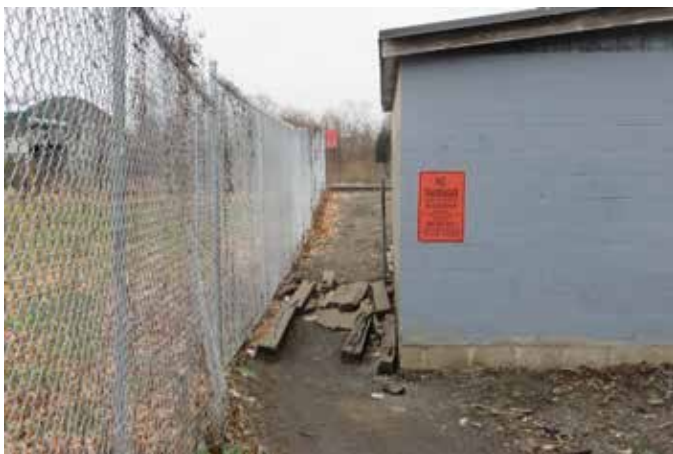
The current pedestrian access path to the railroad crossing from Plainfield Street

A narrow, unmarked dirt path across railroad tracks and through overgrown and trash-strewn lots with a high prevalence of drug activity is one of the only ways for pedestrians to enter and leave the Brightwood neighborhood and access Birnie Avenue and Main Street. Many students and their families currently use this unsafe crossing to get to and from Chestnut Middle School. The City of Springfield currently provides police presence and periodic clearing of overgrowth and trash along the railroad crossing path, but a long-term infrastructure solution is necessary to ensure safe passage for pedestrians. Expecting pedestrians to walk along Plainfield Street all the way to Route 20 to get to Main Street is not a viable solution, given the long distance involved to access desired destinations and the significant pedestrian safety challenges at the convergence of Plainfield Street and Route 20, which are documented elsewhere in this report.

WalkBoston recommends that the City continue to work with MassDOT to advocate for the proposed underground Amtrak railroad crossing. The City should also work to ensure that both ends of the underground passageway have safe, aesthetically pleasing and easily navigable connections to Birnie Avenue, Plainfield Street and the broader Brightwood community. The passageway must also be well lit at all hours.

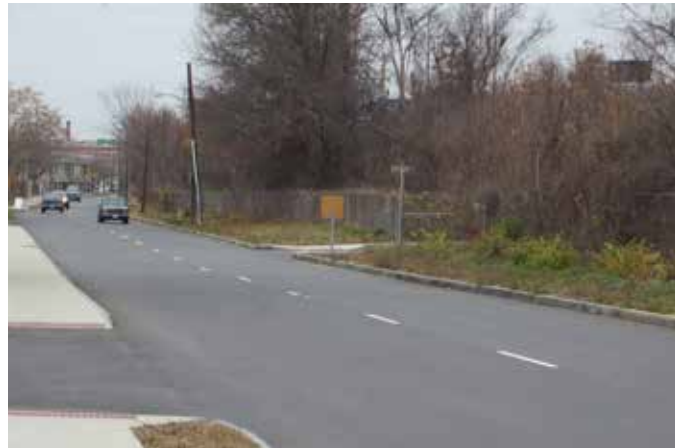
There are currently no crosswalks across Birnie Avenue for pedestrians trying to get from the Brightwood community to goods and services on Main Street and vice versa. To ensure that pedestrians can safely cross Birnie Avenue, WalkBoston recommends installing new crosswalks with ladder design and curb ramps across Birnie Avenue at Huntington and Arch Streets. The City should also consider installing a Rectangular Rapid Flashing Beacon at the crosswalk determined to be the more dangerous and/or frequently used crossing.

The view of Birnie Avenue at Huntington Street. German Gerena Community School is in the background.

Priority Improvement: Paint crosswalks, add accessible curb ramps and consider installation of a Rectangular Rapid Flashing Beacon at Birnie Avenue and Huntington/Arch Streets

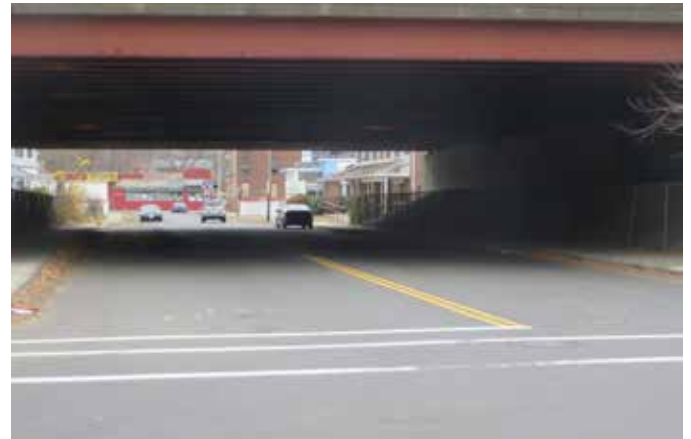
Street connections along Huntington and Arch Streets between Birnie Avenue and Main Street are currently uninviting to pedestrians, with wide travel lanes that encourage high traffic speeds and poor lighting of the I-91 underpasses. In addition, the lack of a buffer between high-speed traffic and the existing sidewalk on the Birnie Avenue ramp approaching Route 20/ Plainfield Street creates additional potential hazards for pedestrians.

The I-91 underpasses along Huntington Avenue and Arch Streets are currently poorly lit and uninviting to pedestrians, even during the day. The wide travel lanes on these streets encourage fast vehicular traffic.

- Install lighting in I-91 underpasses along Huntington and Arch Streets (between Birnie Avenue and Main Streets)
- Put in fog lines on Huntington and Arch Streets to narrow travel lanes and slow traffic speed
- Upgrade all existing crosswalks along Huntington and Arch Streets from standard to ladder design
- Shift and widen sidewalk on western side of Birnie Avenue to create a grassy buffer between pedestrians and high-speed traffic along approach to Route 20/Plainfield Street. Consider installing additional landscaping features along and around grassy buffer (trees, plantings, etc.)

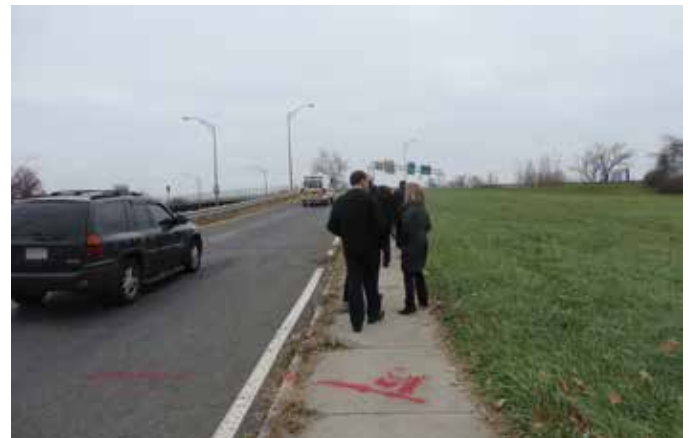
No buffer exists between pedestrians and high-speed traffic along the Birnie Avenue ramp on the approach to Route 20/Plainfield Street.

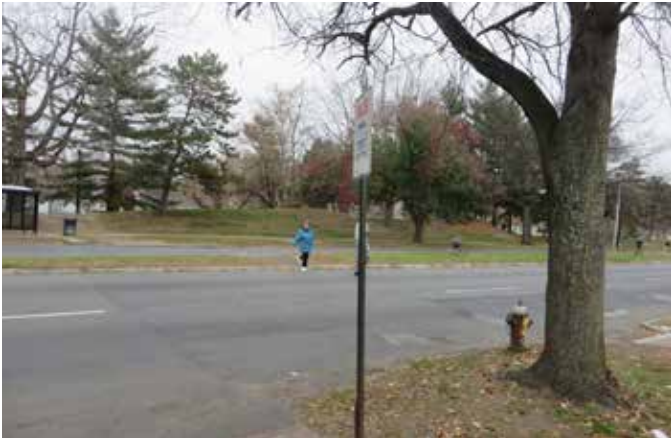
Pedestrians often cross multiple lanes of traffic on West Street in the middle of the block far from existing crosswalks at Riverside Road and Avocado Street.

The Pride Service Station on West Street is one of the only food stores located in close proximity to the Brightwood community. The quickest way for many residents of the Edgewater Apartment Complex and the broader neighborhood to get to Pride is by crossing West Street in the middle of the block, where there is not a safe pedestrian crossing.

WalkBoston recommends creating a new mid-block crosswalk with ladder design and curb ramps extending from the existing sidewalk, as well as a pedestrian refuge island in the existing median strip to ensure safe and easy passage for all, including seniors and persons with disabilities. This crosswalk could be installed opposite the existing PVT A bus stops on either side of West Street, where the sidewalks already extend all the way to the curb. The Road Safety Assessment report for the US Route 20 corridor similarly recommends investigating solutions for mid-block crossing on West Street (pg. 31).

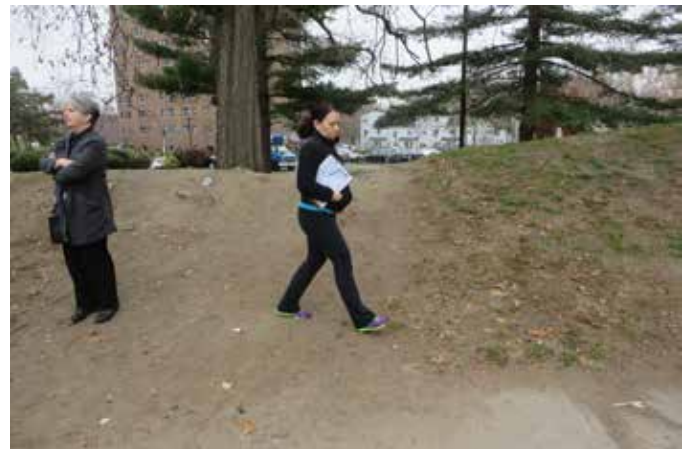
In addition to the mid-block crossing recommended above, additional improvements are needed to ensure safe pedestrian access and crossings along West Street. Of particular note, pedestrians walking on Riverside Road and other areas near the western edge of the Brightwood neighborhood do not have convenient access to a safe crosswalk across West Street. In addition, residents of the Edgewater Apartment Complex and the broader neighborhood lack clear paths to West Street. WalkBoston therefore recommends the following additional measures:

Lacking clear paths from local housing developments to West Street, pedestrians walk over grassy strips and embankments to create their own improvised dirt paths, which are largely inaccessible to seniors and persons with disabilities, and in inclement weather conditions.

- Work with owners of housing developments north of West Street to create paved pathways to West Street (see also US Route 20 Corridor Road Safety Assessment, pg. 31)
- Install pedestrian countdown signals at new and existing crosswalks and update signal timings to ensure sufficient time for pedestrian crossings
- Upgrade all existing crosswalks from standard to ladder design
- Consider installing wayfinding signage at the corner of Riverside Avenue and West Street directing pedestrians to WalkBoston's recommended midblock crossing on West Street

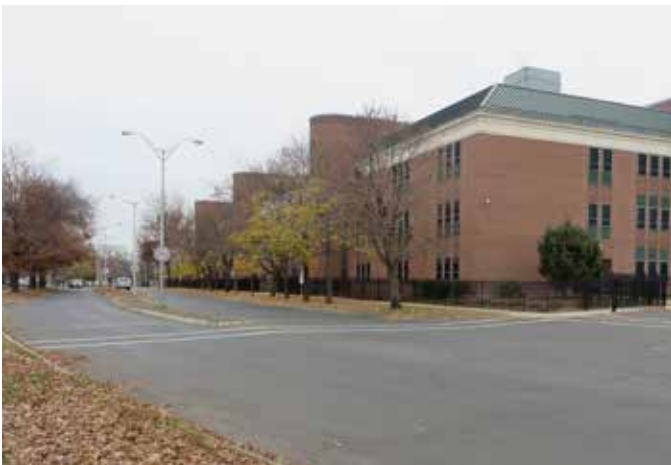
The current crosswalk to access Chestnut Middle School across Plainfield Street leads directly into a driveway and lacks safety features like ladder design, pedestrian refuge islands and sidewalk access. To enhance pedestrian safety and access, WalkBoston recommends improving the crosswalk across Plainfield Street at Chestnut Middle School in the following ways:

The existing crosswalk at Plainfield Street and Chestnut Middle School

- Relocate the crosswalk north so it no longer directly abuts the school driveway
- Create a curb extension at the driveway just south of the newly shifted crosswalk
- Upgrade the newly shifted crosswalk to ladder design and include an in-street pedestrian crossing sign
- Construct new curb ramps and sidewalk extensions leading up to the newly shifted crosswalk on both sides of Plainfield Street
- Create a pedestrian refuge island in the existing median strip

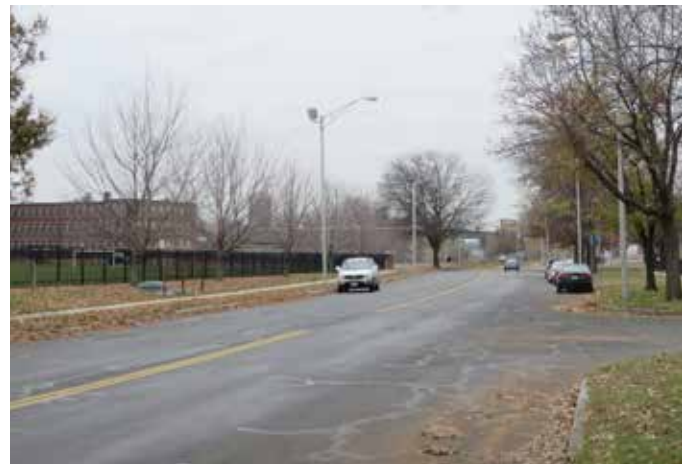
In addition to improving the crosswalk at Chestnut Middle School as described above, there is great scope for a number of additional traffic calming measures and pedestrian connections along Plainfield Street. There are very few crosswalks across Plainfield Street outside the Chestnut Middle School zone and wide travel lanes encourage high traffic speeds. Plainfield Street also lacks bike facilities, even though it is designated as having a “Very High” Level of Bicycle Compatibility in Springfield’s Complete Streets plan (pg. 48).

Wide travel lanes and a lack of crosswalks currently contribute to high traffic speeds and unsafe pedestrian conditions on Plainfield Street.

- Put in fog lines on Plainfield Street to narrow travel lanes and slow traffic speed
- Install new crosswalks with ladder design, curb ramps and sidewalk extensions across Plainfield Street at Clyde, Newland, Orchard, Washburn and Lowell Streets
- Install “School Zone” signs, pavement markings and flashing beacons to enhance the visibility of the Chestnut Middle School and calm traffic in the immediate school vicinity
- Upgrade existing crosswalks along Plainfield Street from standard to ladder design
- Study feasibility of adding bike facilities on Plainfield Street, consistent with “Very High” Level of Bicycle Compatibility designated in Springfield’s Complete Streets plan

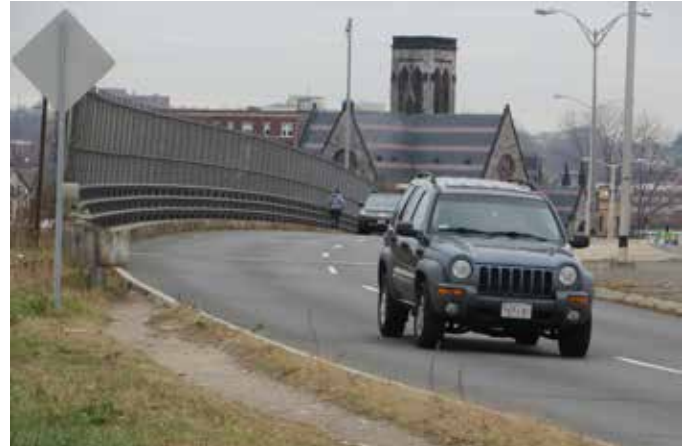
The convergence of the Birnie Avenue ramp with Route 20/Plainfield Street is extremely inhospitable to pedestrians and bicyclists. At this location there are no pedestrian crossings from the sidewalk-less northern side of the Route 20/Plainfield Street bridge to the sidewalk on the southern side of the bridge. As a result pedestrians and bikers often engage in risky and unsafe behavior, either by crossing to the southern side of the bridge to access the sidewalk there despite the lack of a protected crossing, or by walking or biking along the northern side of the bridge against the flow of traffic, with no sidewalk and no physical separation from oncoming high-speed motor vehicles.

A lack of pedestrian facilities at the convergence of the Birnie Avenue ramp with Route 20/Plainfield Street leads to risky and unsafe pedestrian and bicyclist behavior.

WalkBoston recommends that the City of Springfield follow up the Road Safety Assessment process to push for pedestrian accommodations at the convergence of the Birnie Avenue ramp with Route 20 and Plainfield Street, including potential pedestrian crossings across the Birnie Street ramp and across Route 20/Plainfield Street, as well as the potential addition of a sidewalk along the northern side of the Route 20/Plainfield Street bridge. The RSA team made these same recommendations as well (US Route 20 Corridor Road Safety Assessment report, pg. 30). Constructing a sidewalk along the northern side of the bridge in particular will give residents in the Edgewater Apartment Complex and the broader neighborhood around West Street a much safer and more direct route to access goods and services on Main Street.

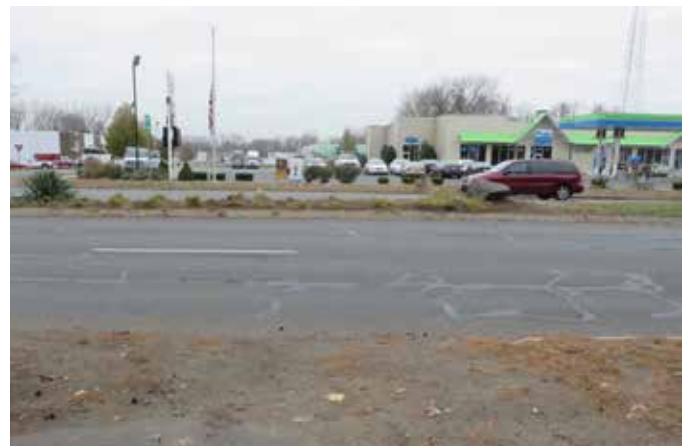
A sidewalk in poor condition along the northern side of West Street opposite the Pride Service Station.

Ensuring that sidewalks are in good condition and that pedestrian areas are well-lit at night throughout the Brightwood neighborhood are critical to ensuring a safe, easily navigable and pleasant walking environment. WalkBoston recommends that the City of Springfield undertake a comprehensive survey of existing sidewalk and lighting conditions in Brightwood to identify key areas for improvements and to prioritize infrastructure upgrades accordingly.
