Route 9 Railroad Overpass Safety Study

FINAL REPORT

Prepared for:
City of Northampton

Prepared by:
Pioneer Valley
Planning Commission

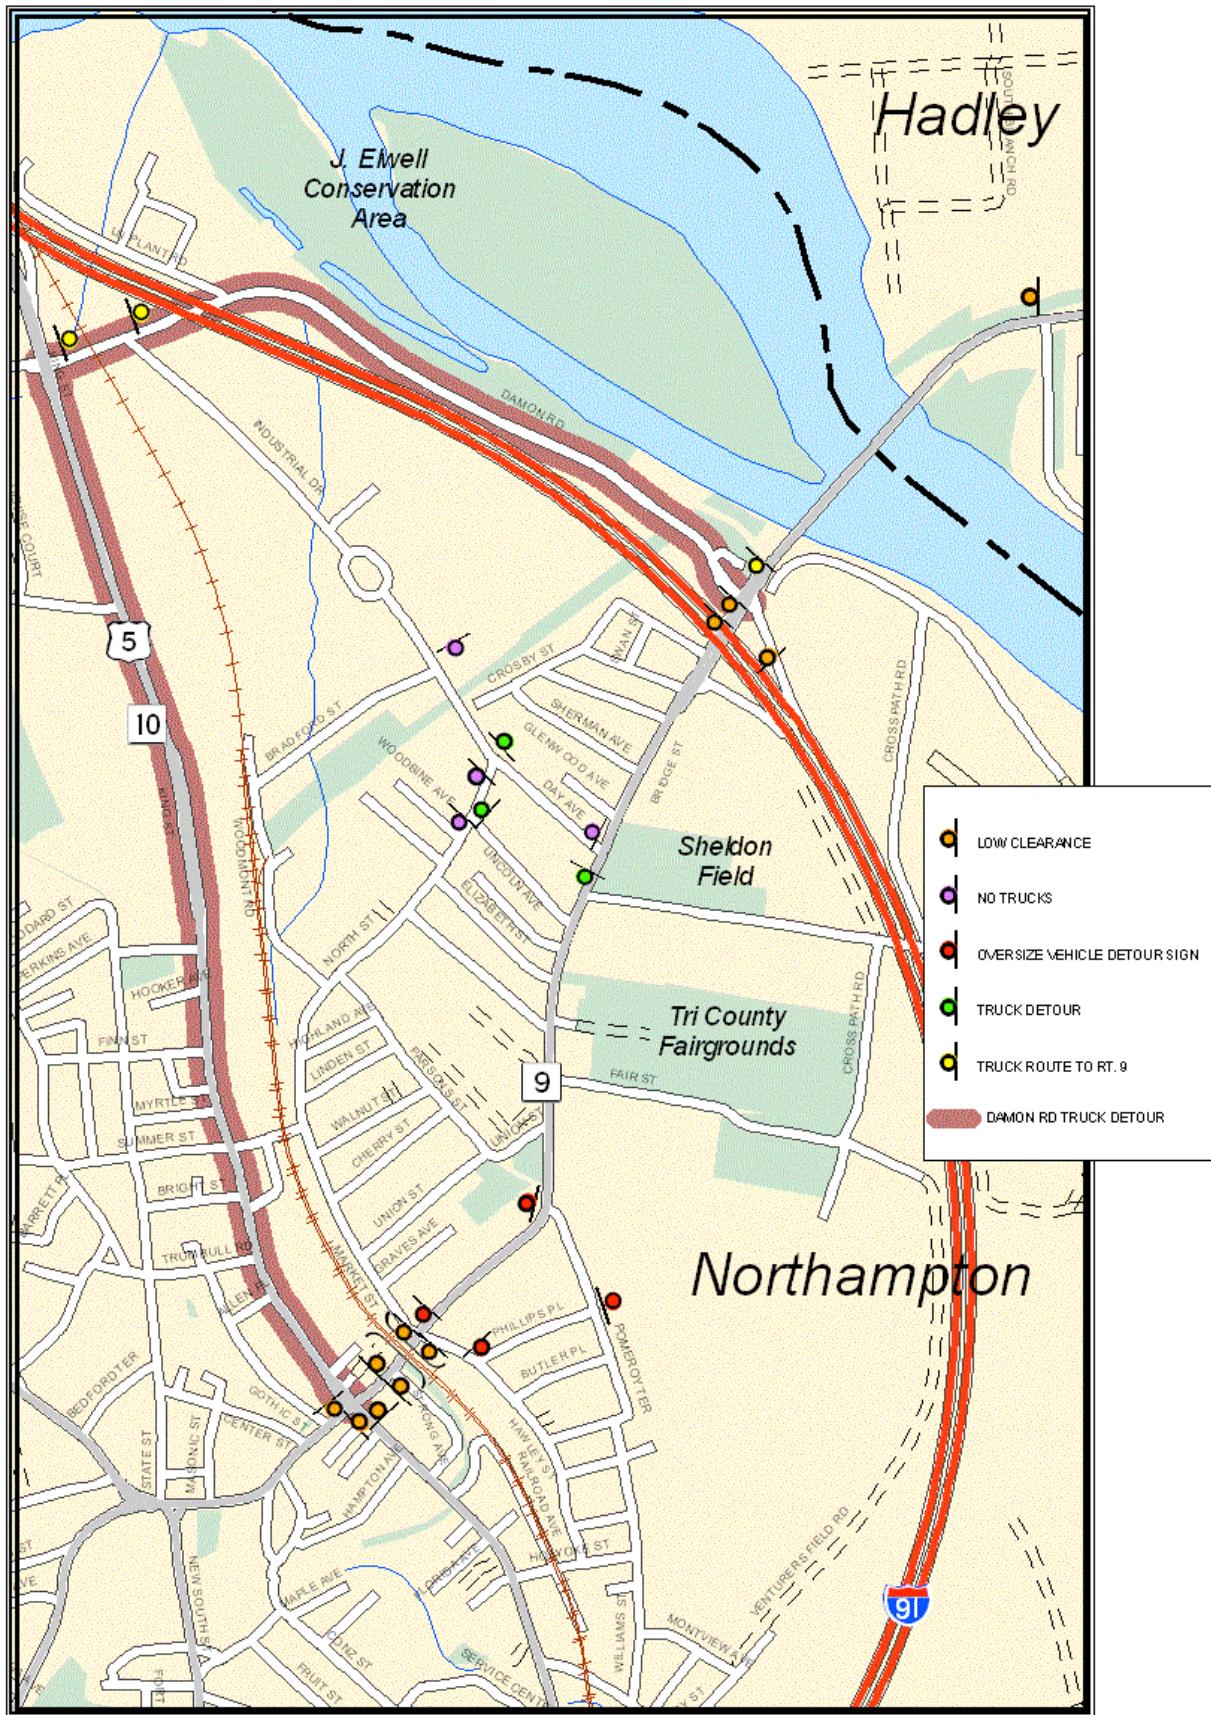
Figure II-1 - Existing Truck Signs

Low-clearance signs are located one and a half mile's from the railroad bridge on Bridge Street, beginning at the Calvin Coolidge Bridge. There are also low-clearance signs provided to the west of the railroad bridge throughout some areas of downtown. It was noted that many of these low-clearance signs are hard to see due to their size and height. Some of them were also noted to be obstructed by growing vegetation. A map of existing low-clearance warning signs for the area is presented in Figure II-1.

Alternate truck route signs are located on the westbound approach of Route 9 at its intersection with Damon Road and the I-91 Exit 19 off-ramp. This alternate route directs trucks to utilize Damon Road to access King Street (Route 5/10) and bypass downtown. An additional alternate route is posted on Route 9 to use Lincoln Street to access Industrial Avenue and King Street (Route 5/10). However, trucks are only permitted to travel along this route in the southbound direction. Signs are posted restricting trucks from using Day Avenue and other side streets in this area. Currently, there are no marked alternate routes in the downtown area to the west of the railroad bridge. It was noted during the field inventory that many of the alternate route signs were white, and therefore difficult to find among other signs that were in their close proximity. In addition, some of the signs were posted too low, which combined with their small size, could cause them to not be easily observed by truck drivers.
