## TRANSPORTATION AND SAFETY STUDY

LUDLOW

### WEST AVENUE AND FULLER STREET INTERSECTION

SEPTEMBER 2010

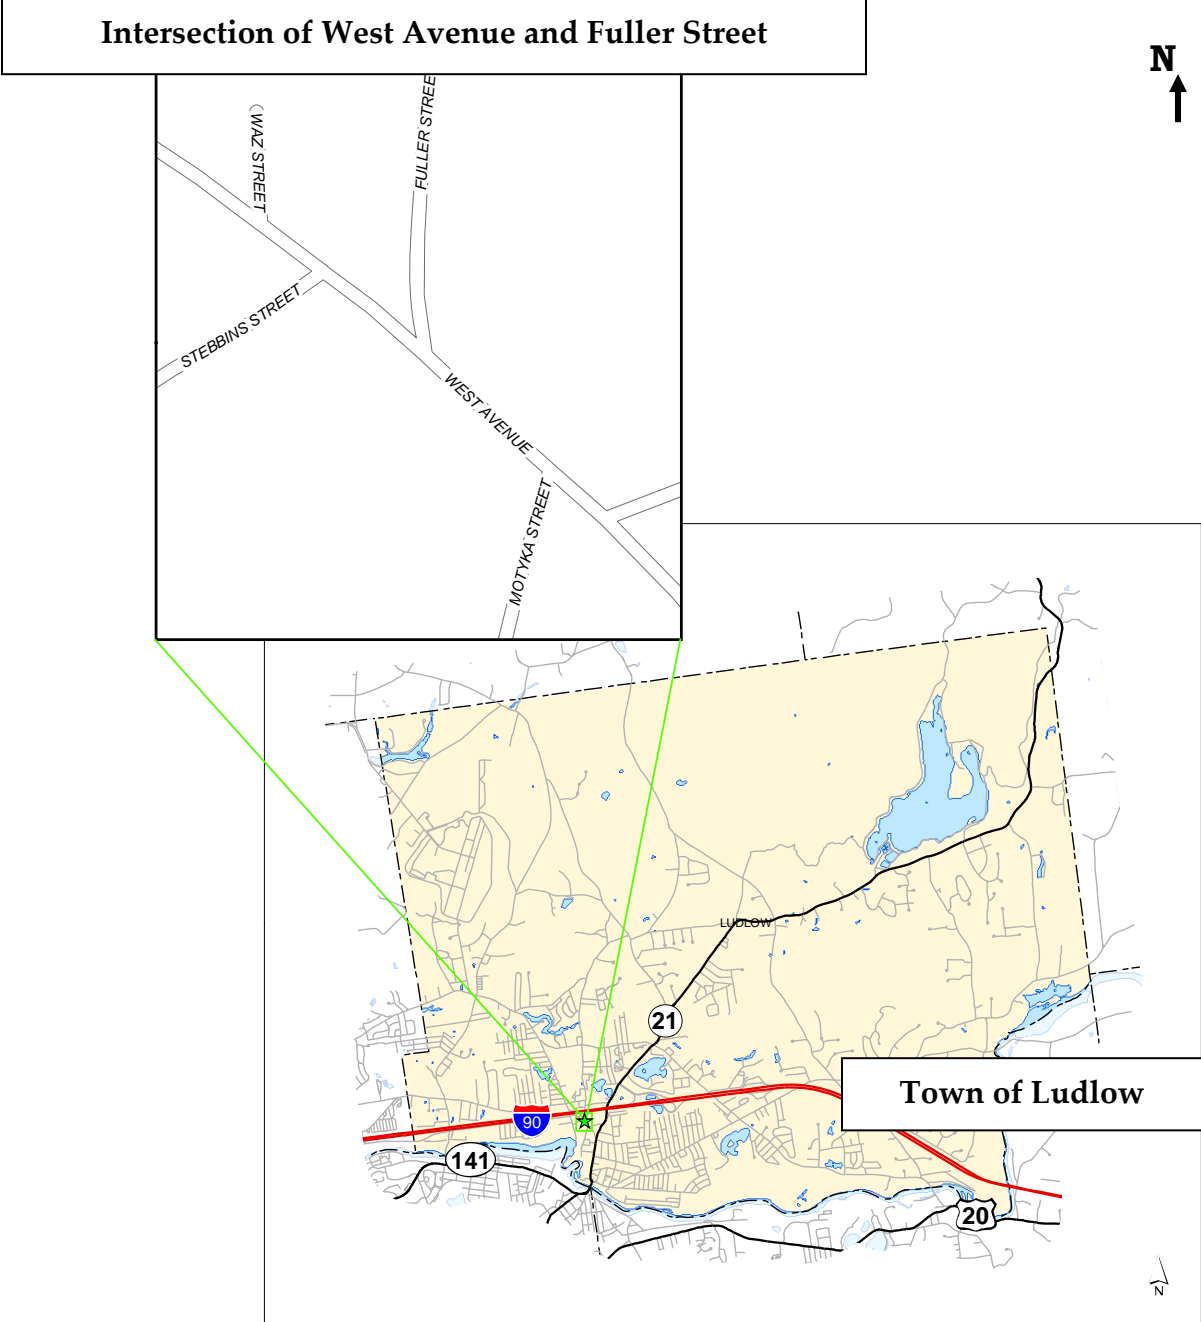
Figure 1: Study Area

The intersection of West Avenue and Fuller Street is a three way intersection located in the southwest section of the Town of Ludlow. It is an unsignalized intersection with Fuller Street operating as the minor street under 'STOP' sign control. Land use in the immediate vicinity of the intersection is a mix of commercial and residential. There are also several side streets off of West Avenue in close proximity to the intersection that provide access to additional residences. The intersection is characterized by a large uncontrolled curb cut providing access to a restaurant and hair salon to the northeast of the intersection. The geometry of the intersection also creates an acute angle that restricts sight distance from Fuller Street to the northwest and interferes with right turns from Fuller Street onto West Avenue. As a result, this movement is prohibited for large vehicles such as trucks.

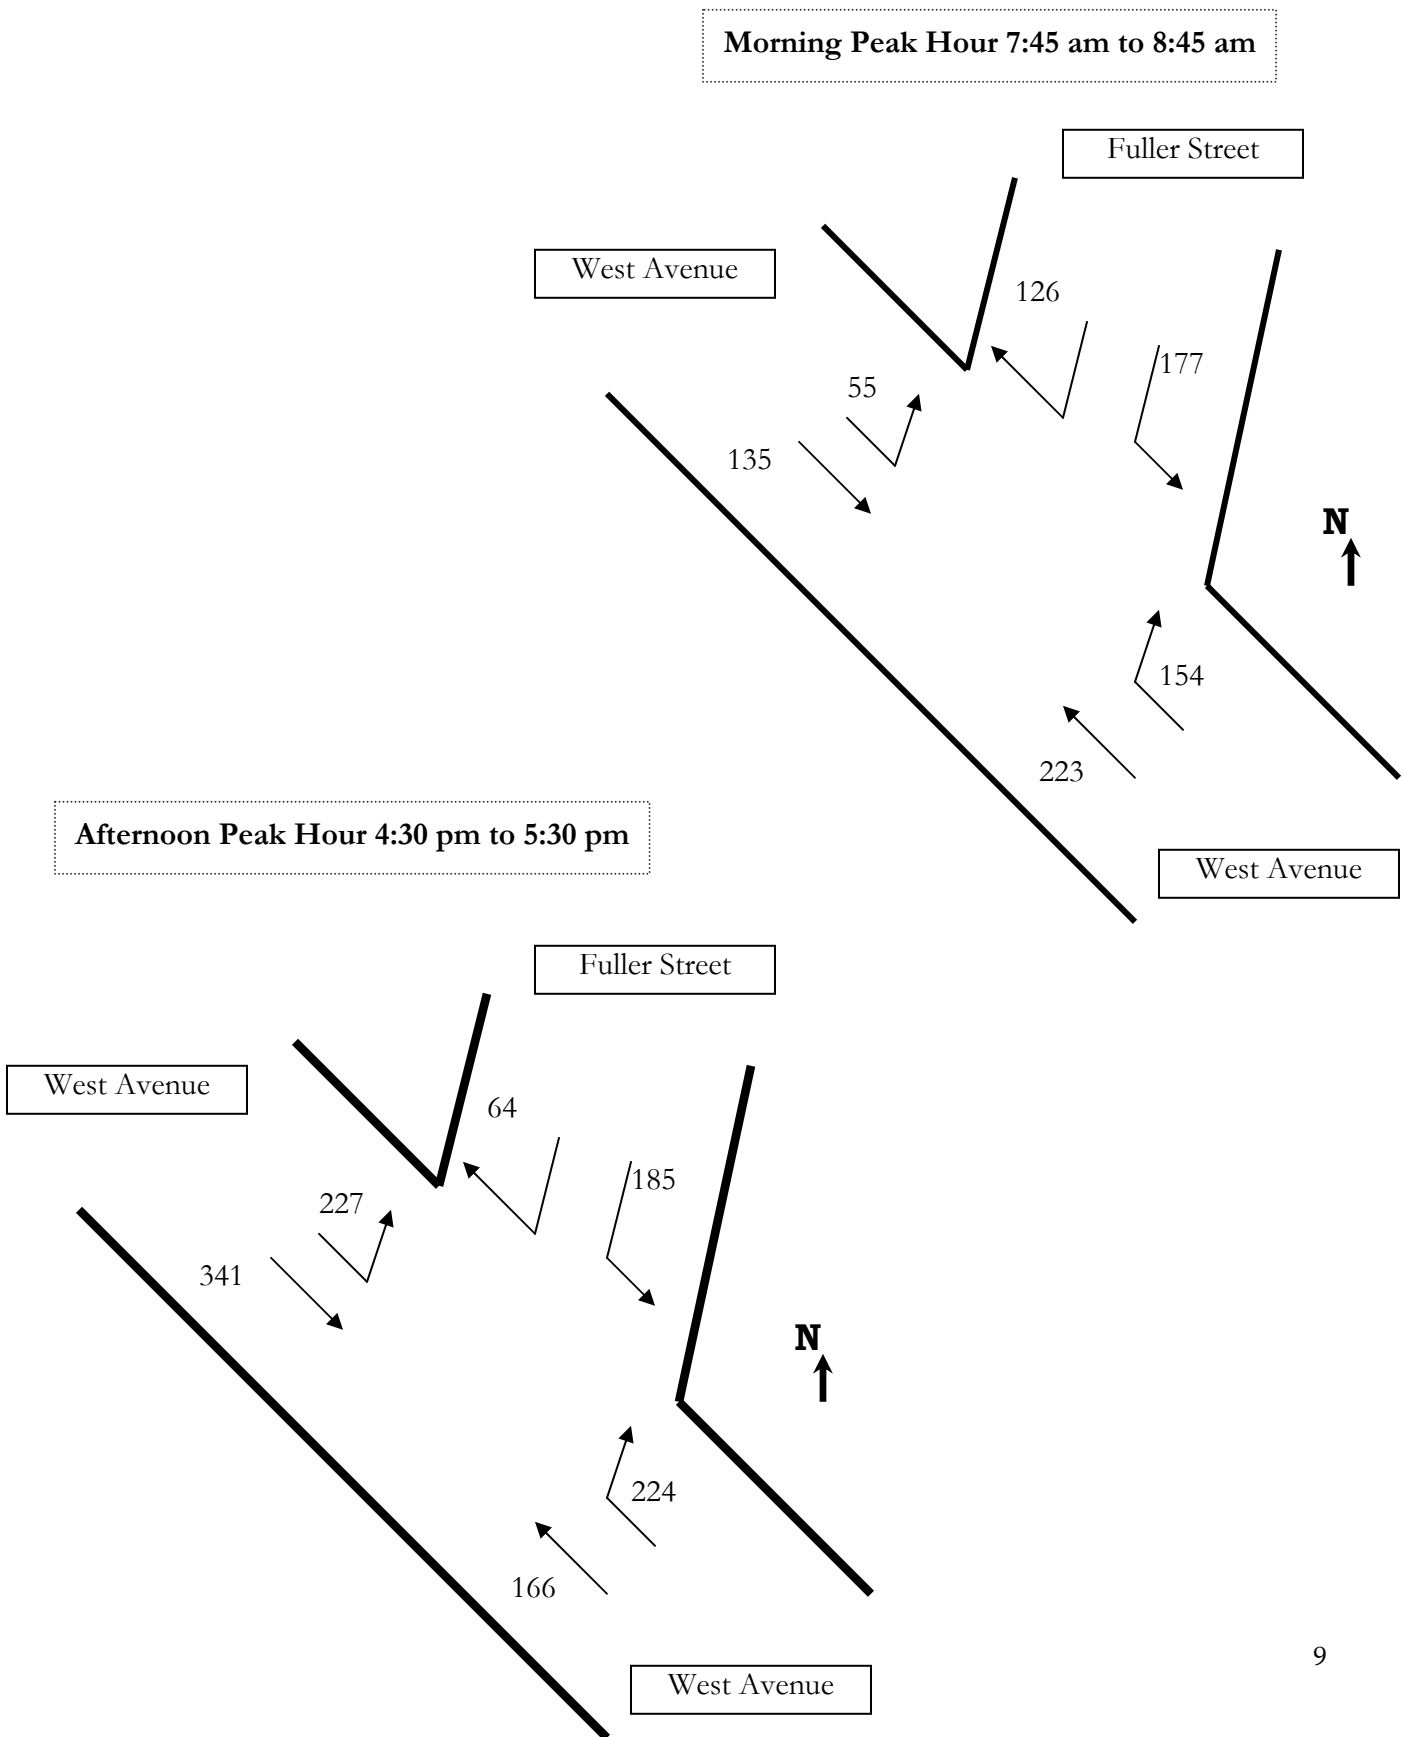
Figure 3: Turning Movement Counts

Turning Movement Counts (TMC's) were conducted for the intersection during the peak commuter periods. The weekday peak commuter period occurs during the morning hours of 7:00 AM to 9:00 AM and the afternoon hours of 4:00 PM to 6:00 PM. The TMC's were conducted to identify the peak four consecutive 15 minute periods of traffic through the intersection. These consecutive peak 15 minute periods constitute a location's Peak Hour Volume. The peak hour of traffic volume represents the most critical period for operations and will be the focus for some of the analysis conducted in this study.

It can be seen from the TMC diagrams that Fuller Street has a high approach traffic volume despite operating as the minor street. Most of the vehicles at this approach were observed to make a left turn onto West Avenue during the afternoon peak hour.

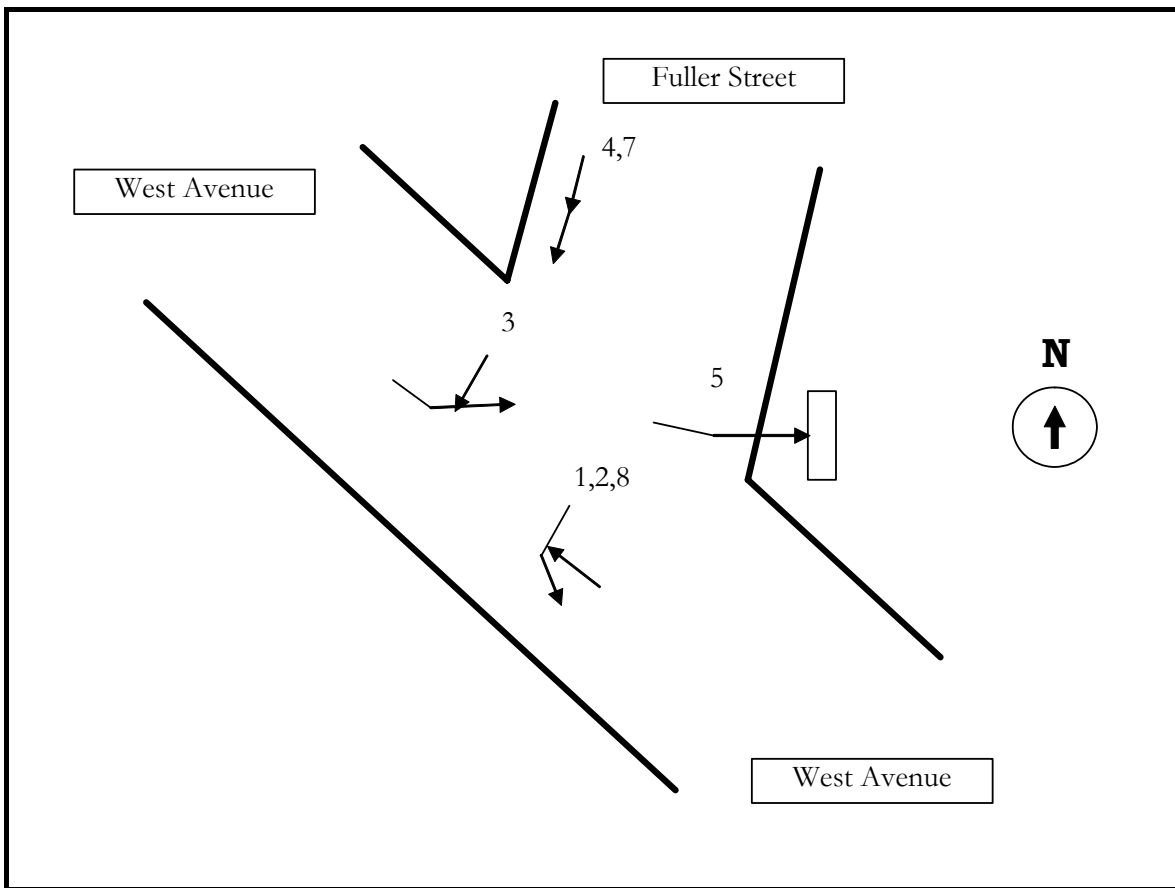
Figure 4: Collision Diagram

Based upon the data in the crash reports, each crash has been depicted graphically in the collision diagram and crash patterns have been identified. Figure 4 shows the collision diagram for the intersection. The details of the crashes shown in the figure are summarized in Table 4.

A total of 8 crash reports were obtained from Ludlow Police Department for reported crashes for the 2007 to 2009 calendar years. One of these 8 crashes could not be depicted in the collision diagram because it was reported late after its occurrence and the pattern, manner of collision and other details are not known for this crash.

Crash numbers 1, 2, 8 and 3 occurred between left bound vehicles from Fuller Street and through moving vehicles from West Avenue. Crash number 5 was the result of a collision between a left turning vehicle from West Avenue and a vehicle parked in the lot located on the northeast corner of the intersection. Two of the eight reported crashes were rear end collisions on the Fuller Street approach.

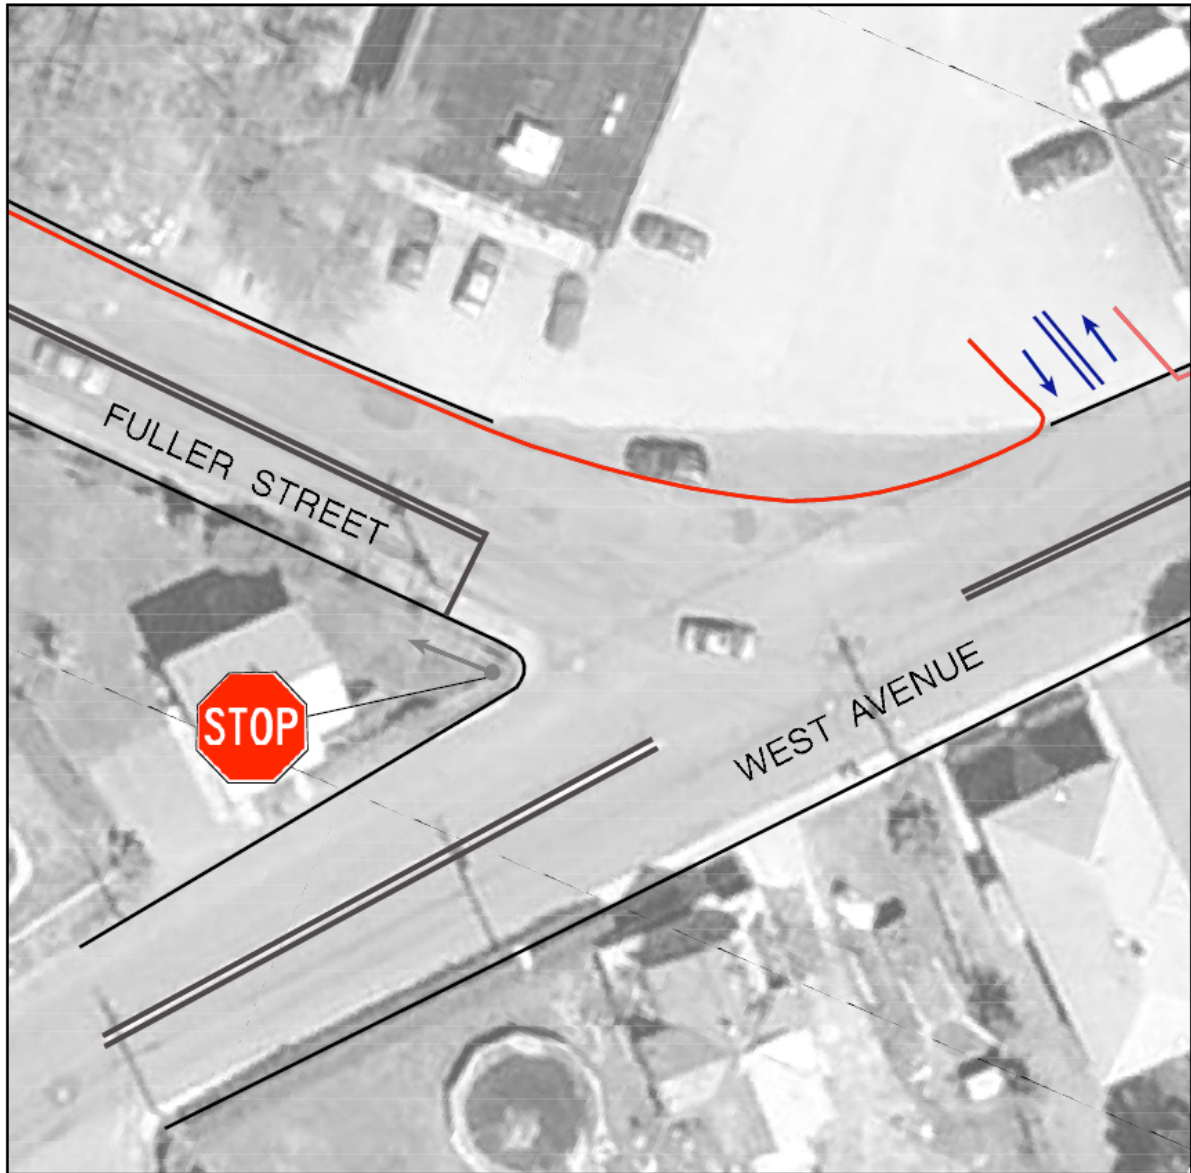
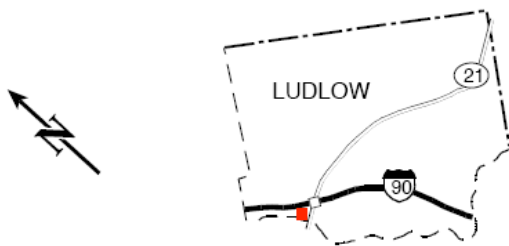
Figure 5: Proposed Curbing and Driveway Improvements

Figures 5 and 6, show two different alternatives of changing the geometry of the intersection and defining the right turn lane for the vehicles turning right from West Avenue approach. It is recommended that the Town of Ludlow consider undertaking an engineering study to determine the suitability and feasibility of each alternative to improve the existing intersection geometry.

Prepared by the Pioneer Valley Planning Commission, June, 2010.  
Conceptual purpose only. Illustration is not to scale.

An unrestricted driveway on the northeast corner of the intersection contributes to confusion in this area and encourages drivers to turn right from West Avenue onto Fuller Street at high speeds. The absence of curbing has also resulted in the deterioration of the pavement in this location. It is recommended that the Town of Ludlow consider reducing the existing curve radius and installing granite curbing in this area to prevent further damage to the pavement and define driveway entry and exit points.

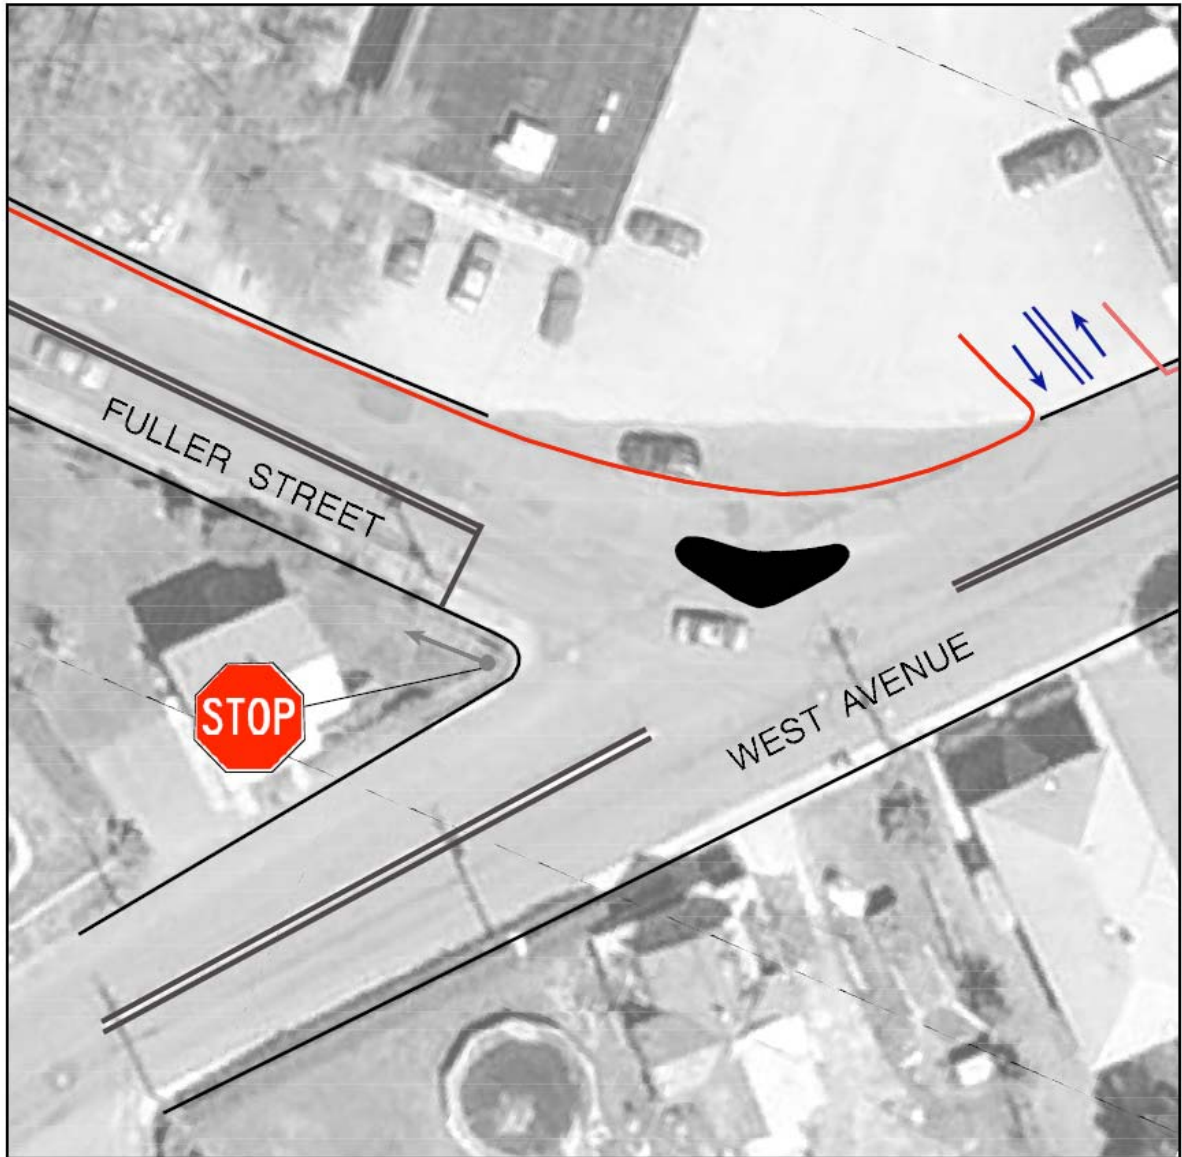
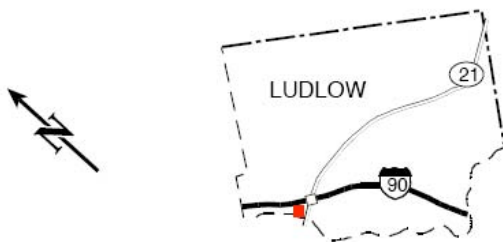
**Figure 6: Proposed Turning Lane separated by an Island**

Prepared by the Pioneer Valley Planning Commission, June, 2010.  
 Conceptual purpose only. Illustration is not to scale.
