# TRANSPORTATION SAFETY STUDY

## SPRINGFIELD

**Intersection of Cottage Street, Robbins Road, and  
Industry Avenue**

**Prepared Under the Direction of Pioneer Valley MPO By:  
Pioneer Valley Planning Commission  
60 Congress Street  
Springfield 01104-3419**

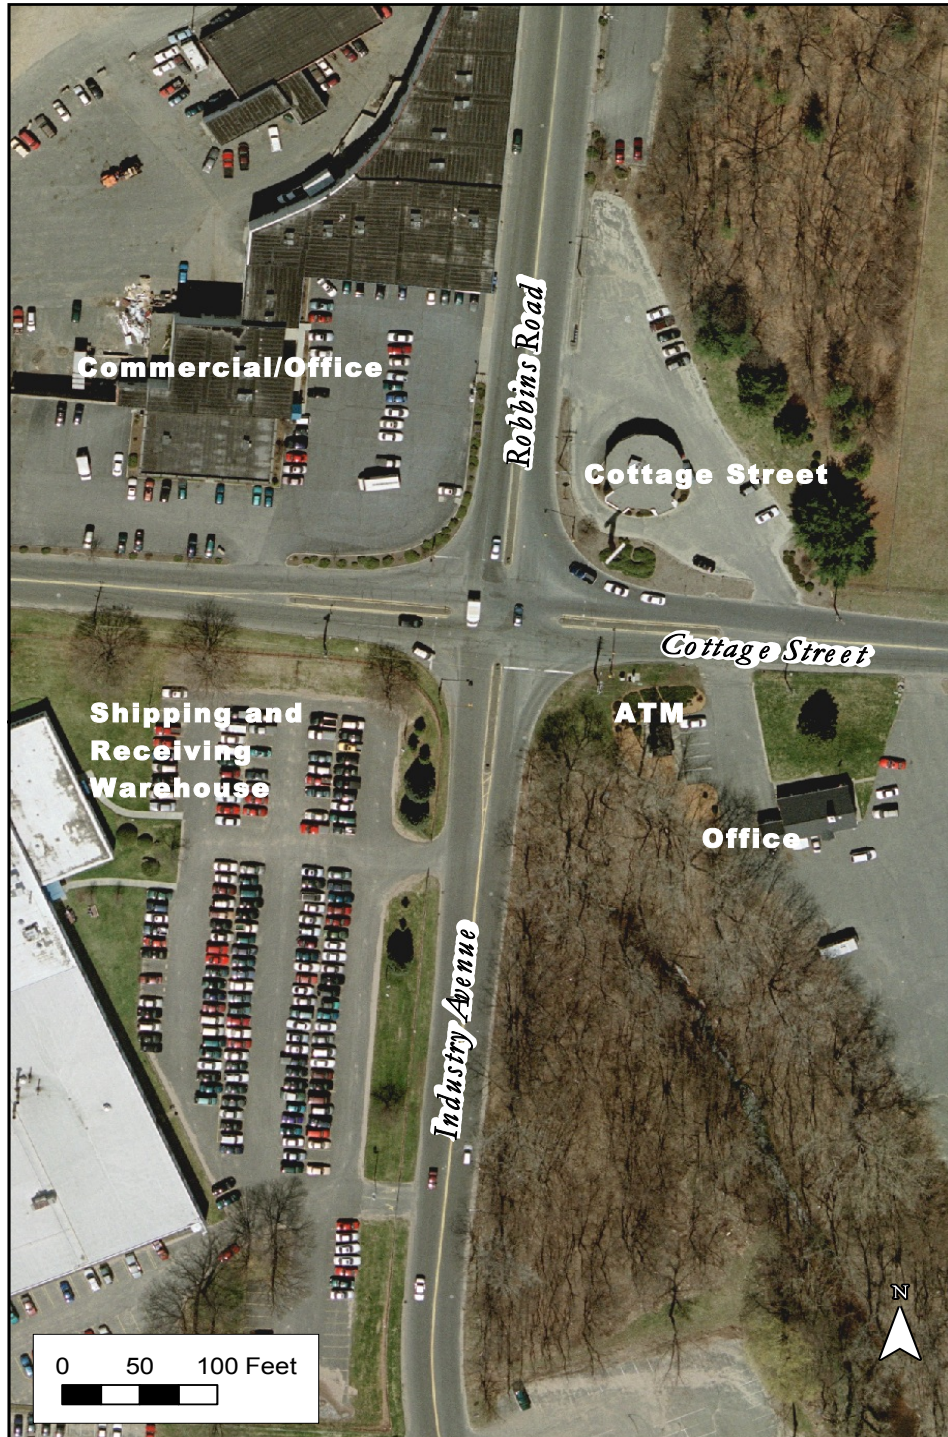
Figure 2: Aerial Image of the Intersection

Figures 1 and 2 depict the study area and the Ariel image of the intersection of Cottage Street, Robbins Road, and Industry Avenue.

The intersection of Cottage Street, Robbins Road, and Industry Avenue is a four way intersection located in the northern part of the City of Springfield. It is a signalized intersection characterized by high percentage of truck traffic because of its location in an industrialized area and its proximity to Interstate 291.

Raised medians separate entering and exiting traffic on all four approaches to the intersection. Exclusive left turn lanes are provided for all but the westbound approach of Cottage Street which provides one left turn/ through lane and one exclusive right turn lane.

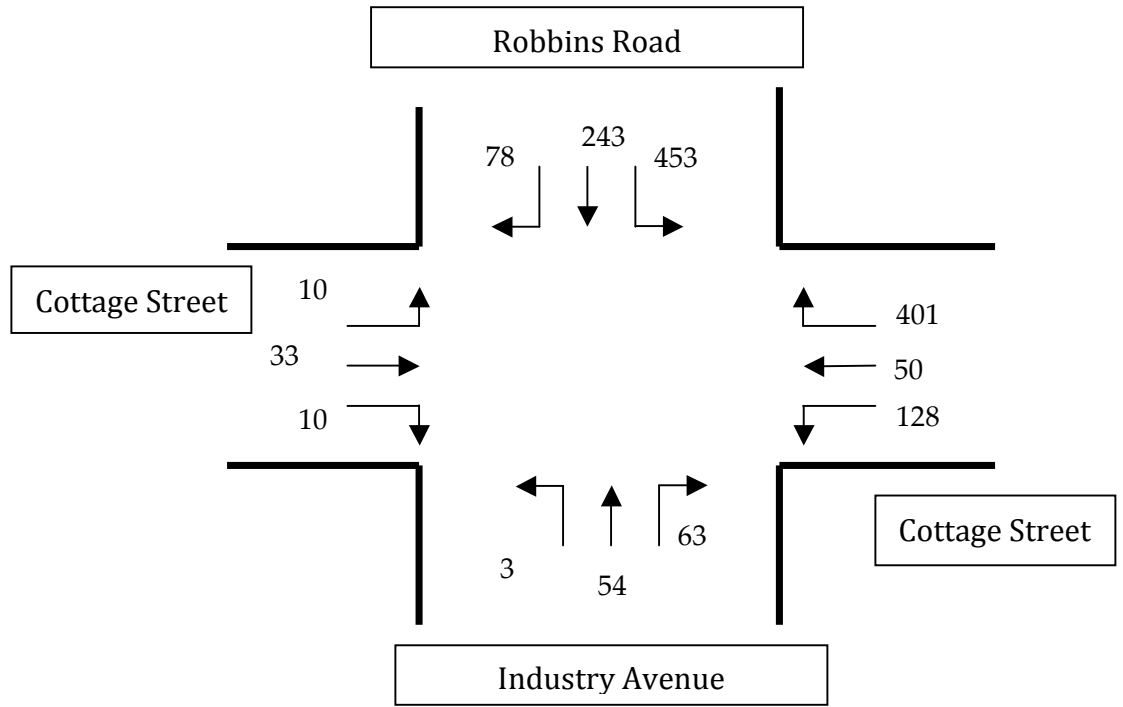
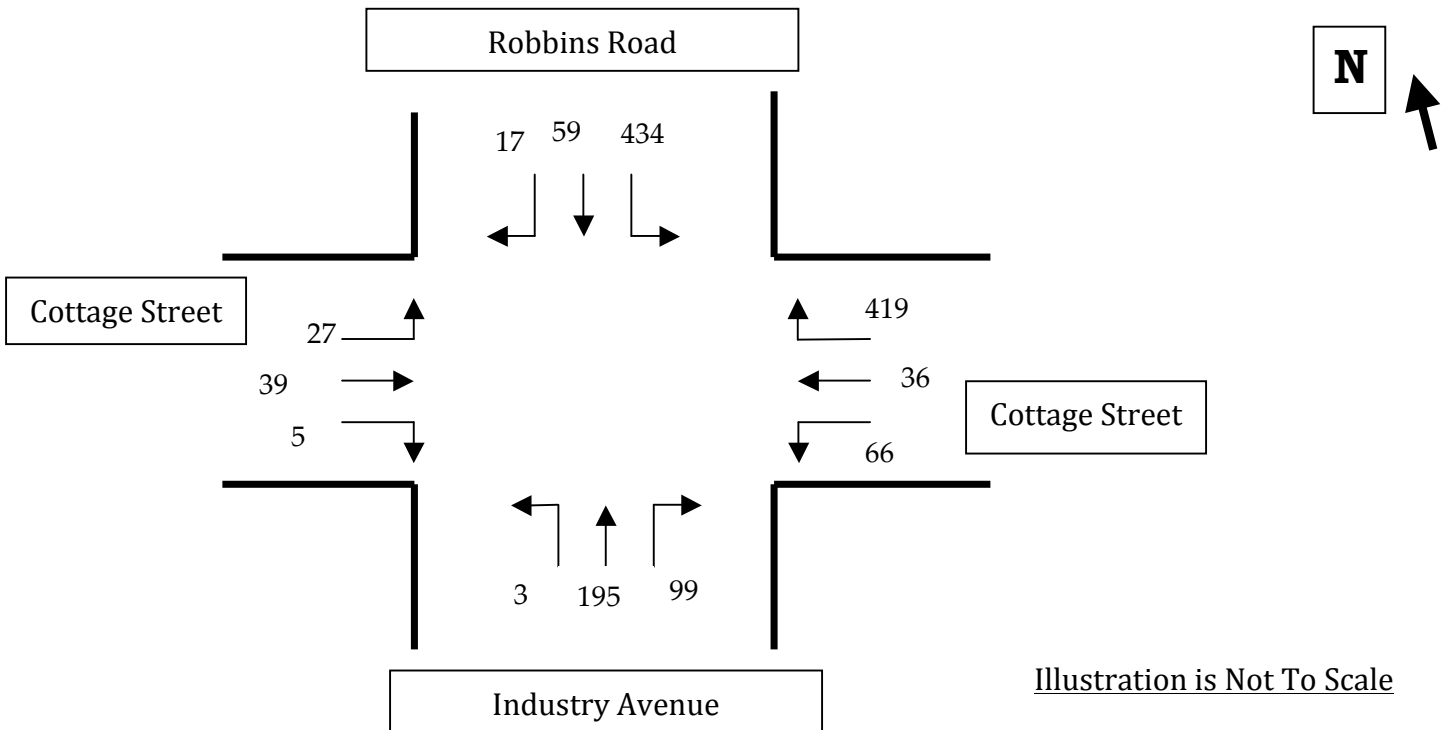
**Figure 3: Turning Movement Counts**

The TMC data was obtained during weekday peak periods. As traffic volumes tend to fluctuate over the course of the year, the Massachusetts Department of Transportation (MassDOT) develops traffic volume adjustment factors to reflect monthly variations. These factors were examined to determine the traffic conditions at the intersection of Cottage Street, Robbins Road, and Industry Avenue. Figure 3 depicts the turning movement counts during the morning and afternoon peak hours at the intersection.

A majority of the vehicles at this intersection commute along Cottage Street to access I-291 via Robbins Road. As a result, the Cottage Street westbound and Robbins Road approaches have higher traffic volume compared to the remaining two approaches. During the morning peak hour a substantial number of vehicles commute southbound from Robbins Road travelling straight across the intersection to access Industry Avenue. This pattern is reversed during the afternoon peak hour.

Morning Peak Hour (7:30 am - 8:30 am)

Afternoon Peak Hour (4:15 pm - 5:15 pm)

The volume of heavy vehicles at the intersection was approximately 6% of the total traffic volume during morning peak hour and 3% during the afternoon peak hour. The majority of heavy vehicles were observed on the Cottage Street and Robbins Road approaches.

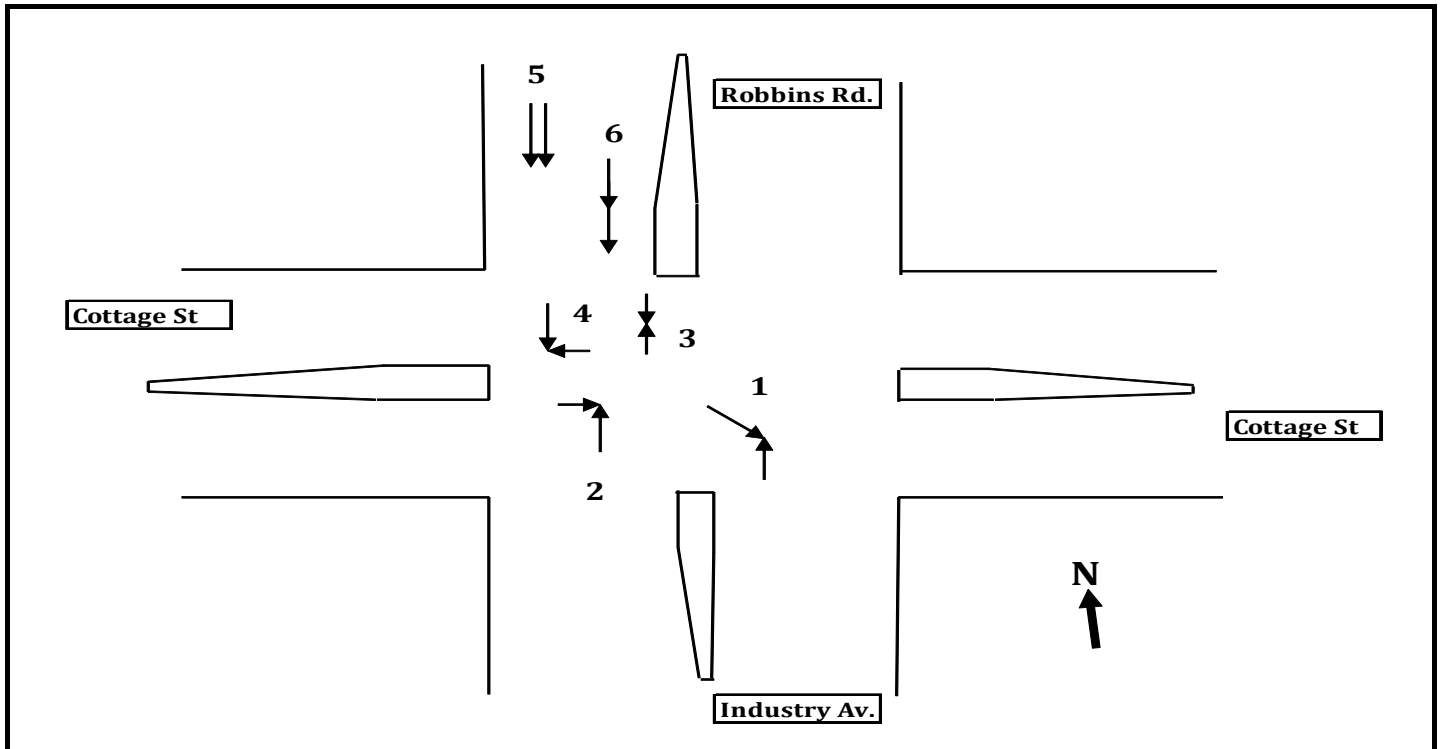
Figure 4: Collision Diagram

Based upon the data in the crash reports, each crash has been depicted graphically in the collision diagram and crash patterns have been identified. Figure 4 shows the collision diagram for the intersection. The details of the crashes shown in the figure are summarized in Table 2.

A total of 6 crashes were recorded during the 2008 and 2009 calendar years. The crashes did not follow a notable trend or pattern.
