Main Street Bus Stops and Parking Study

Downtown Springfield, Massachusetts

February 6, 2009

Prepared under the direction of the Pioneer Valley Metropolitan Planning Organization for the Pioneer Valley Transit Authority by the Pioneer Valley Planning Commission

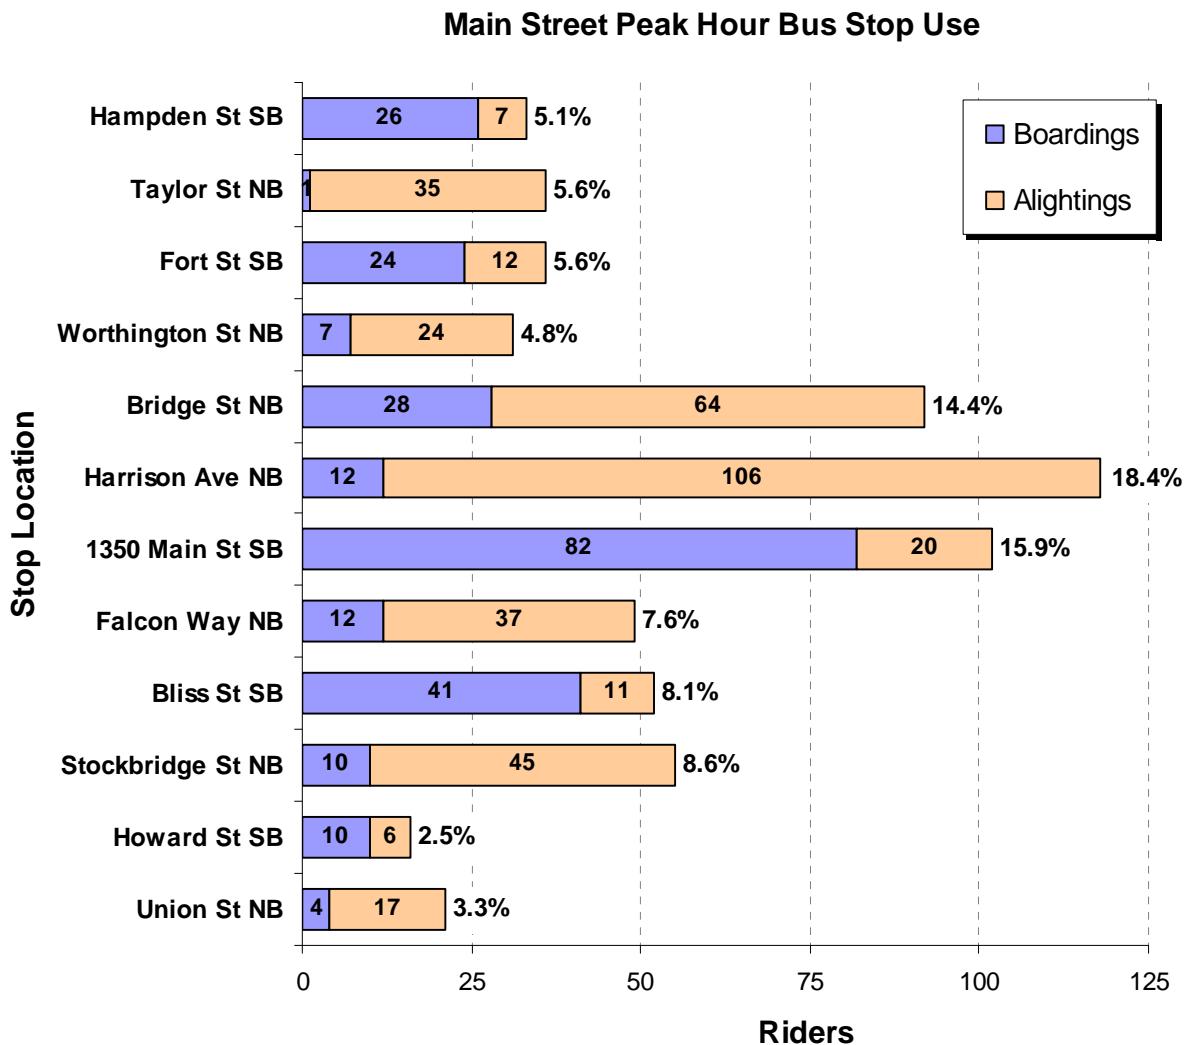
1. Bus Stop Boardings and Alightings

The figure below presents total boardings and alightings observed at each of the 12 bus stops during the two-hour morning peak (7:00 to 9:00 a.m.) and afternoon peak (3:00 to 5:00 p.m.) on typical weekdays, a total of four hours. Counts were recorded on weekdays from November 3 through November 24, 2008 (holidays and Election Day were excluded) for a total of 48 hours of observation. The figure presents all boardings and alightings recorded at each stop during the four hours of observation, as well as the percentage of all bus riders observed who used the stop (N=641).

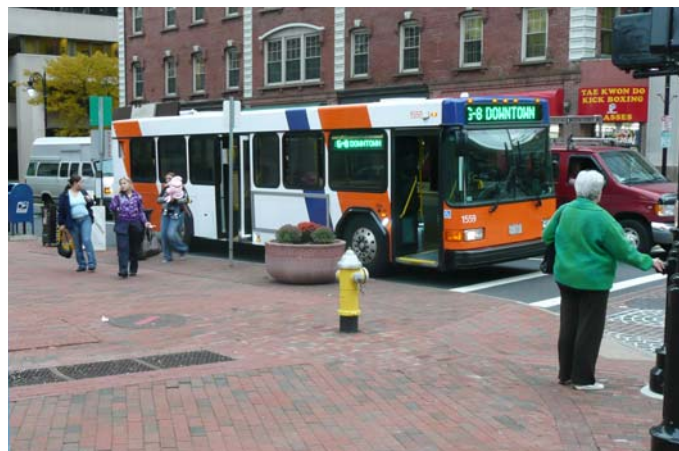
Site assessments of the 12 bus stops in the study area show a variety of conditions. Photographs and complete assessments are provided in Appendix 2. Bus stops are typically marked by a single sign. There are no pavement marks to delineate the actual area of the street where the bus is to pull over. In other cases, newspaper boxes, mailboxes, utility equipment or street furniture may obstruct curbside boarding areas. This can lead to the bus having to overshoot standing passengers to find a safe place to stop. At right is an example of this

is at Harrison Avenue northbound. In such case, bus passengers must walk and re-queue at the bus door, which lengthens dwell times.

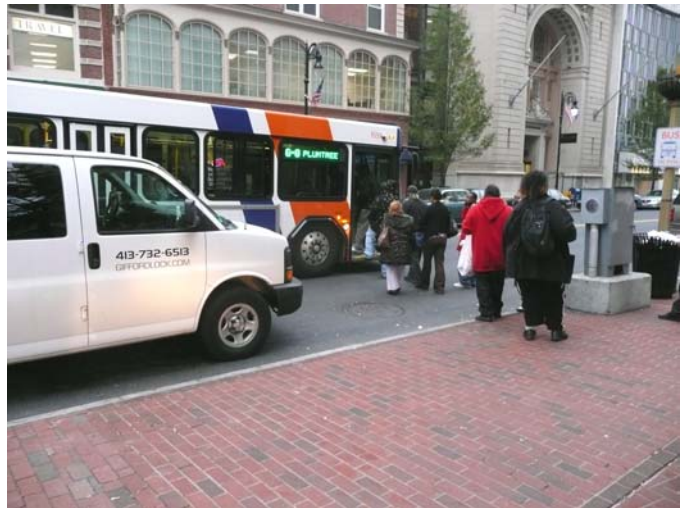
In some cases, newspaper boxes, mail boxes, traffic signal control units and traffic signal poles block the convenient access to buses. An example of this problem is seen in the photo of 1350 Main Street at right. This is a mid-block stop, which requires extra space for buses to pull in (as opposed to the preferred near-side or far-side of block stops at other locations). Illegal blocking of bus stops compounds this problem.

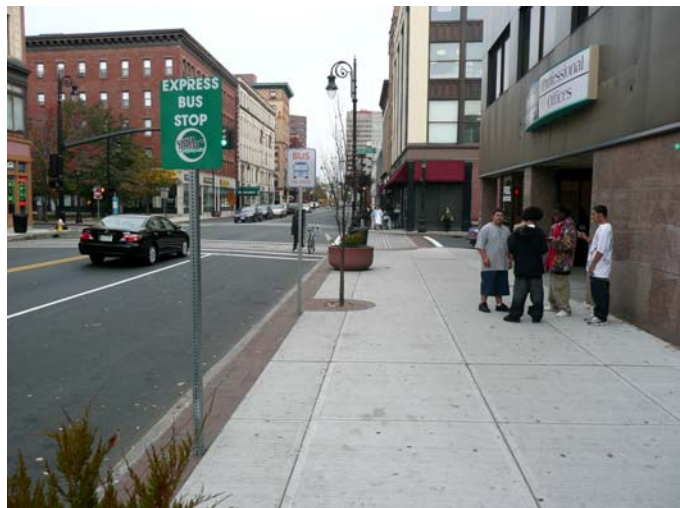
Significantly, bus riders were observed to be in general distinct from other groups of congregating pedestrians and passersby on downtown streets. Bus patrons tended to wait for their buses near the posted stop or in shelters where available. Other pedestrians pass by and do not interact with bus patrons. In addition, some pedestrians, many of whom arrived by private auto, congregated around the entrances of convenience stores and service-oriented establishments. These groups were noted during late morning and early afternoon hours, generally outside the morning and afternoon peak travel times. At right, an example of non-passenger congregation is seen at Hampden Street.

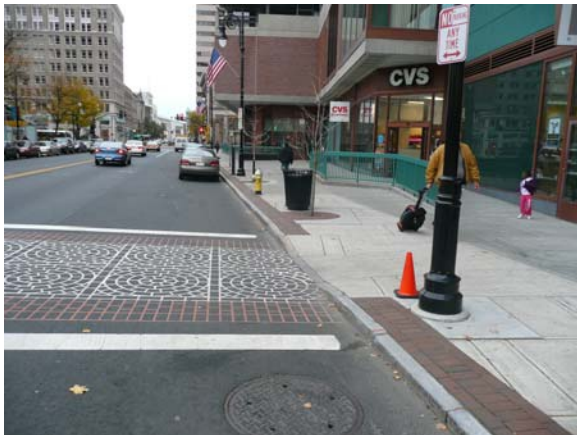
Near the middle of the study area, Town Square, Monarch Place and other large buildings are major trip generators.

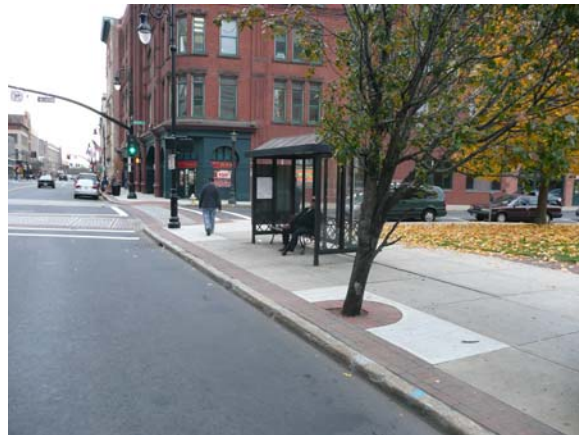
Street furniture and landscaping provide a welcoming pedestrian environment in several areas of the Main Street corridor.

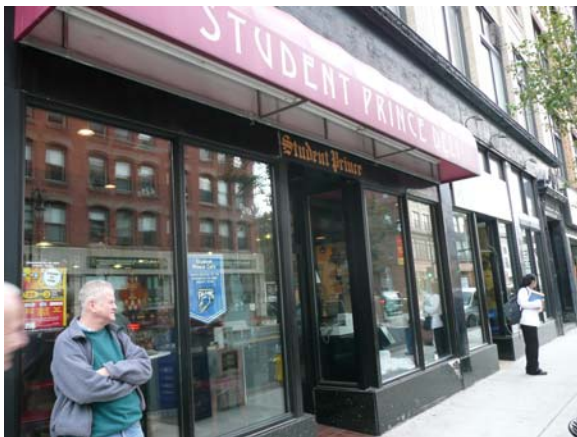
In the northern part of the study area, short setbacks and traditional storefronts create pedestrian interest (and provide shelter, especially during inclement weather).

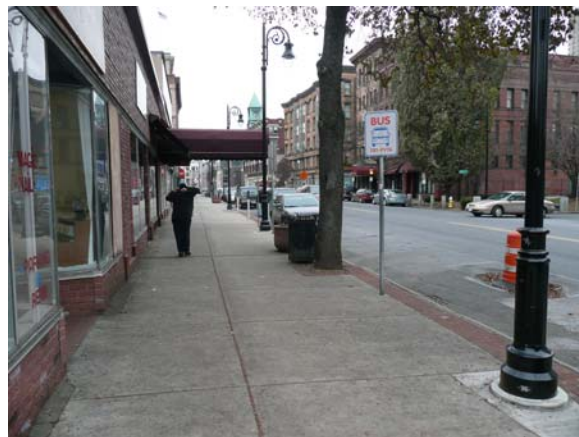
Near Union Street, storefronts are also close to the street, with awnings and architectural details.

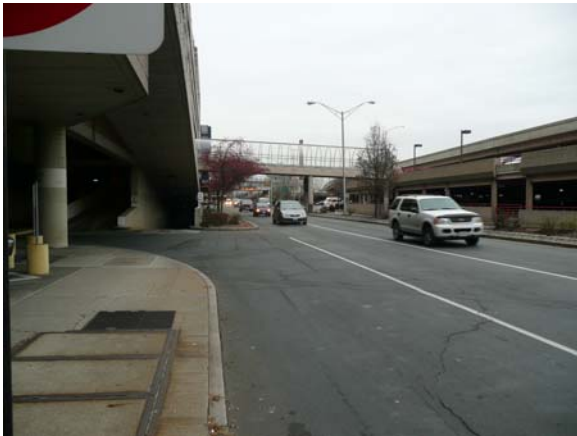
Seen above is the entrance to the Town Square parking ramp, which is the rear of the building. This structure blocks pedestrian egress and passage along the street.

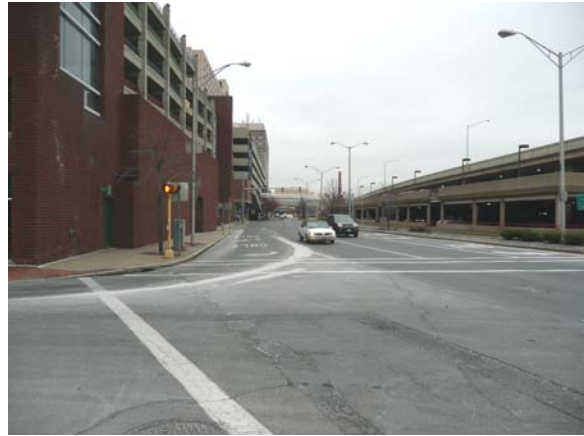
There are no parking lanes along this section of East Columbus Avenue. Bus operations to pick up passengers on this street configuration would cause vehicle backups and degrade traffic safety without significant roadway reconfiguration.

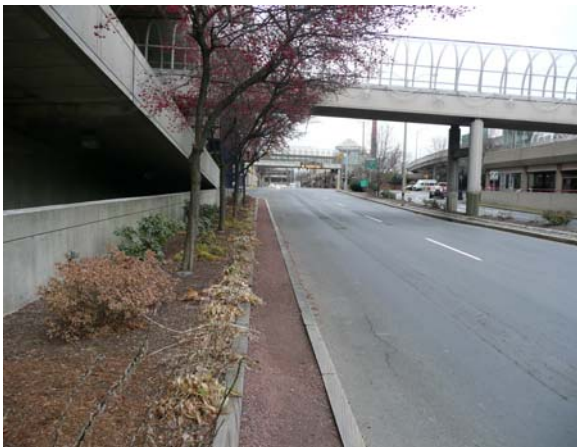
Some sections along East Columbus Avenue have no sidewalk; pedestrians must use this dirt path instead.

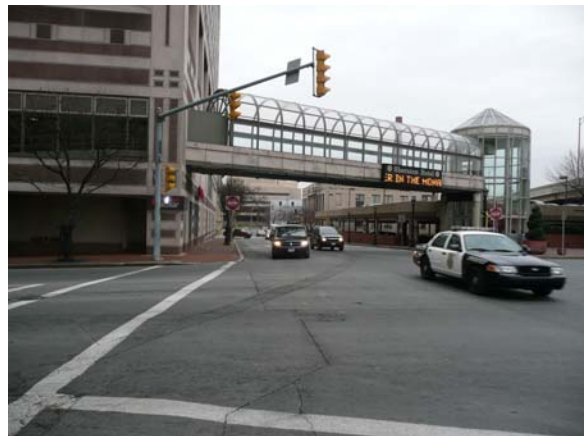
One measure to improve pedestrian access along East Columbus Avenue is seen above: a bridge to take the pedestrians off the street.

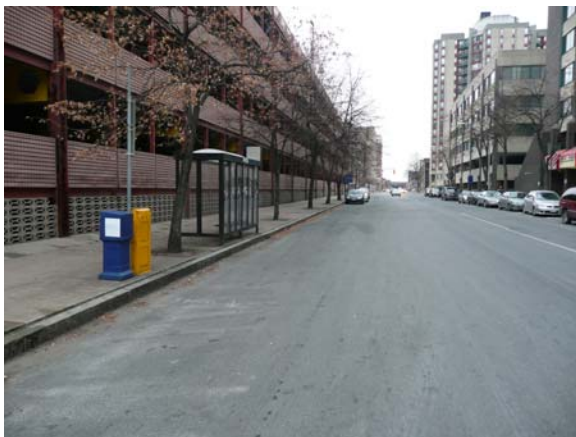
Bus stop at Dwight Street and Falcons Way is seen above. The parking garage reduces pedestrian appeal along this block.

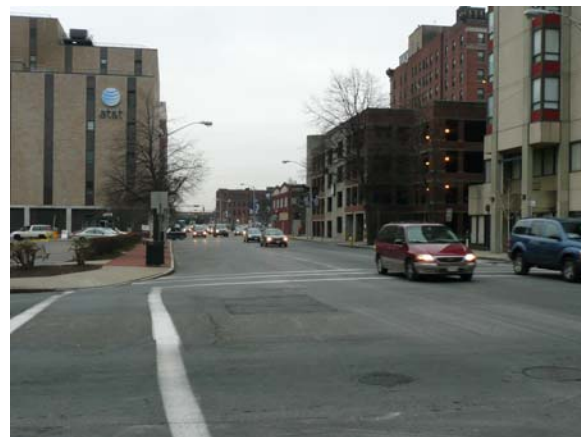
Dwight Street at Harrison Avenue, where parking lots and larger buildings reduce the attractiveness of the area to pedestrians.

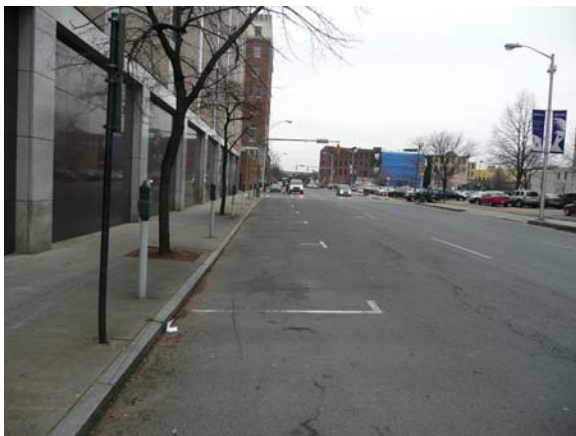
Dwight Street at Worthington. There is ample street width for on-street parking on both sides, as well as bus stops (currently used by up to five PVTA routes).

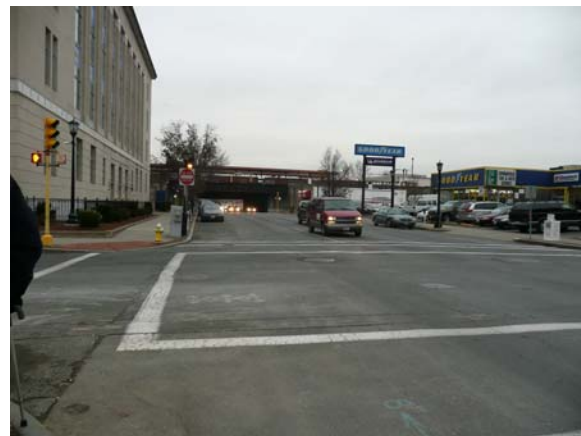
Dwight Street at Taylor Street (State Office Building seen at left). Crosswalks with signals offer pedestrians safety along this portion of the corridor, but there is relatively little street furniture.

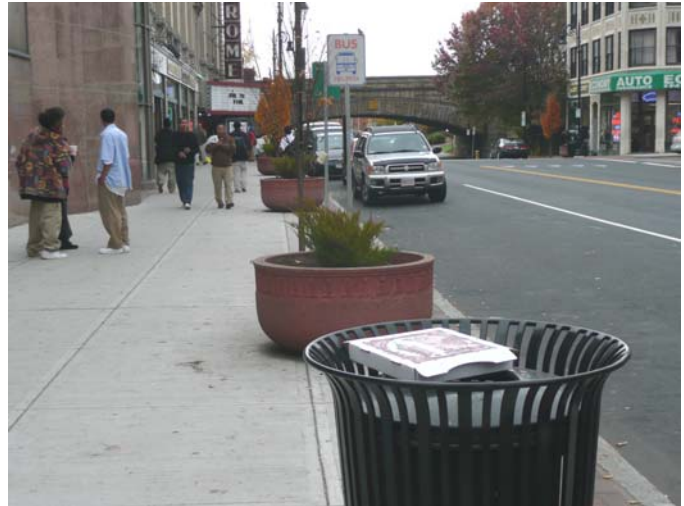
Notes: A wide sidewalk provides sufficient area for bus rider queuing and pedestrian passage. Frequent non-passengers arrive by private auto, bike or foot and tend to congregate near storefronts and building entrances. Non-passengers, many of who are students (depending on time of day), often call to others across the street. Bus passengers tend to wait quietly near the bus stop sign at the curb.

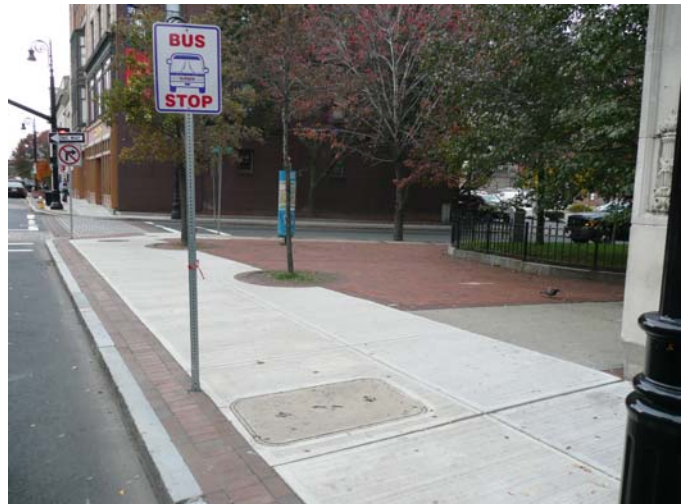
Location: Main and Taylor Streets

Notes: Frequent conflicts with non-PVTA ADA vans, delivery vehicles and private autos in bus stop. Few users or non-passengers congregating.

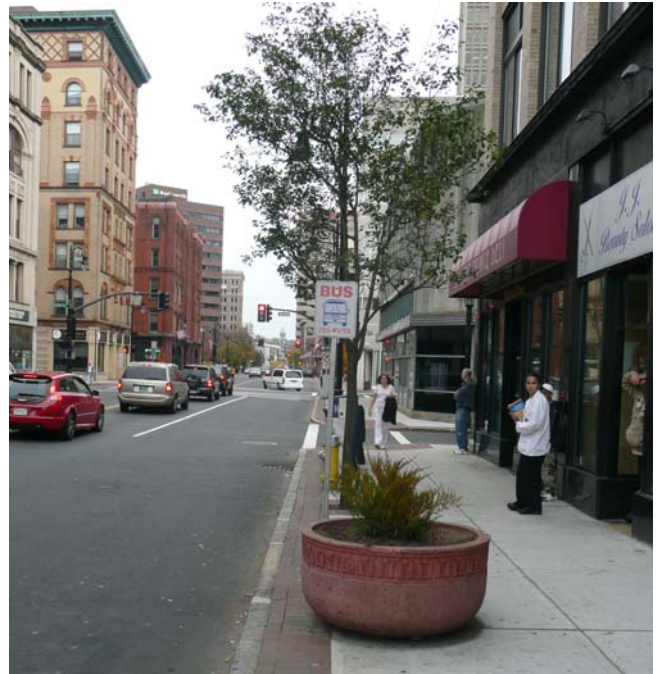
Location: Main and Fort Streets

Notes: Nearside stop is very close to intersection, creating conflicts with other vehicles turning right; safety concern for riders exiting buses and crossing street. Buses frequently pick up and discharge in travel lane. No immediate crosswalk to east side of Main. Passengers tend to congregate under Student Prince awning for shelter, creating conflicts with passersby. Relatively few non-passenger pedestrians congregating at stop, but groups of 6-12 students congregate further up the block, depending on time of day.

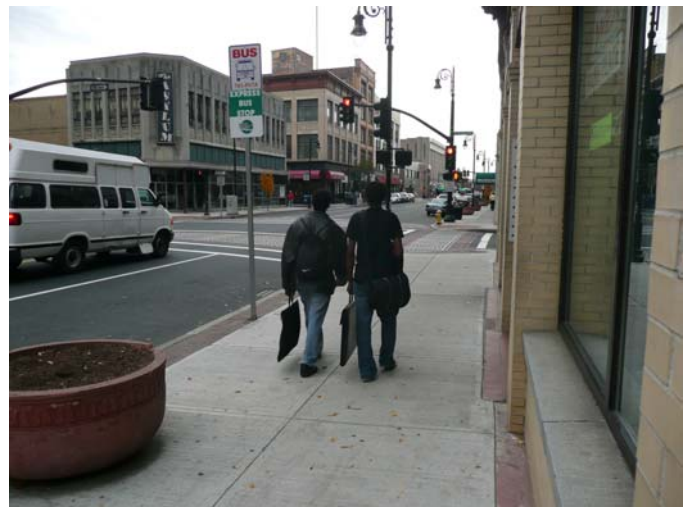
Location: Main and Worthington Streets

Notes: Groups of non-passengers tend to congregate near Worthy Apartments entrance and turnaround loop. Narrow sidewalk width and street furniture creates conflicts between waiting passengers and passersby. Frequent ADA pick ups at Worthy Apartments block bus stop.

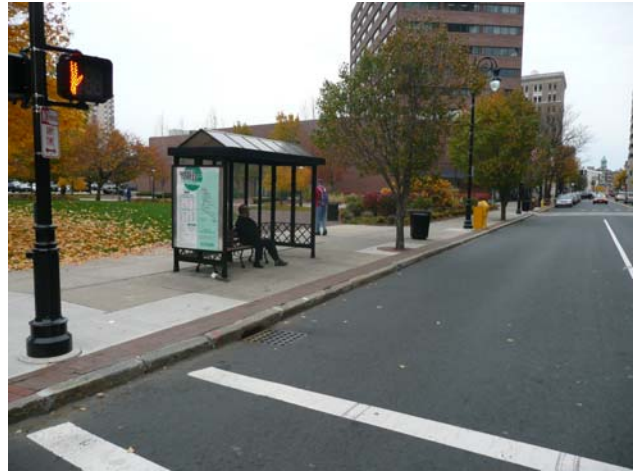
Location: Main and Bridge Streets

Notes: One of Main Street’s most attractive stops. No opposite side pairing. Little rider/passerby conflict. Ped-activated walk signal. System map/schedule holder.

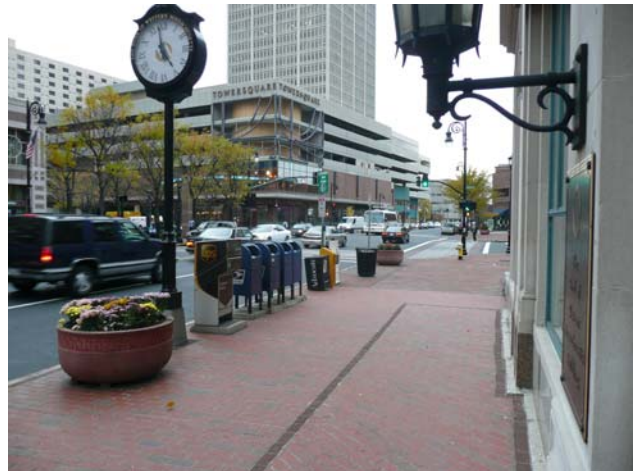
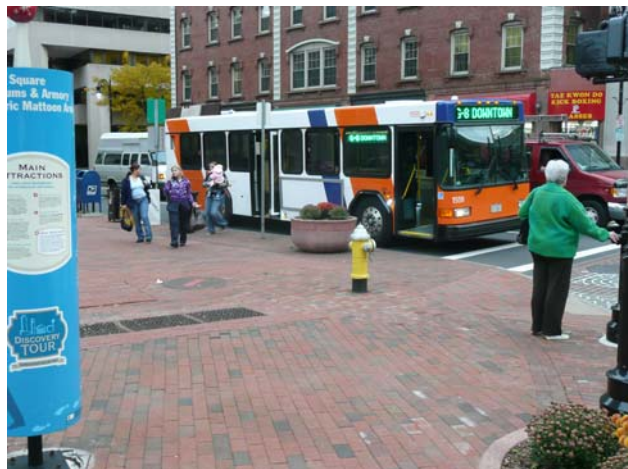
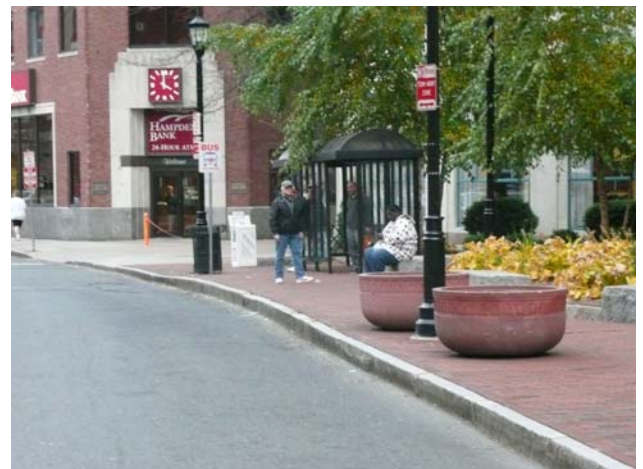
Location: Main Street and Harrison Avenue

Notes: Mail/courier and newspaper boxes blocks bus boarding/alighting. Often windy.

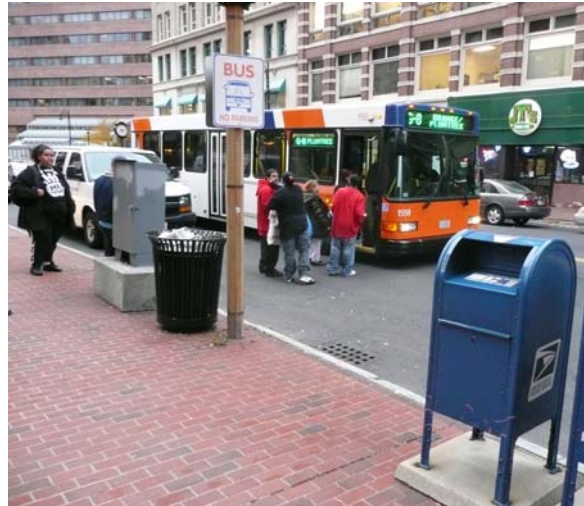
Location: 1350 Main Street (Monarch Place)

Notes: Mid-block stop with prominent street furniture obstructions. No nearby crosswalk. Illegal parking in bus stop and on sidewalk forces frequent boarding/alighting in travel lane. Traffic backups observed, especially during afternoon peak. Riders seek shelter near buildings.

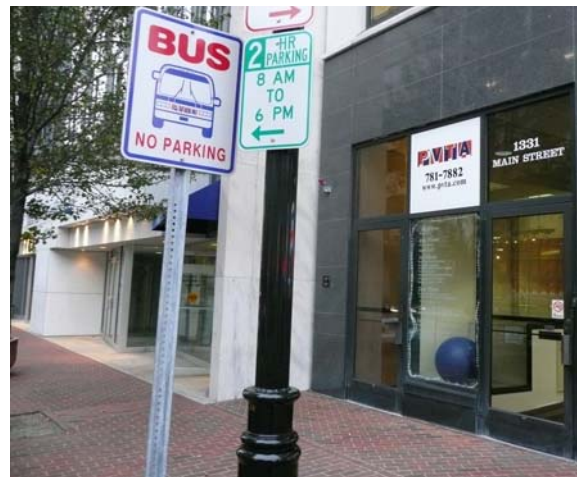
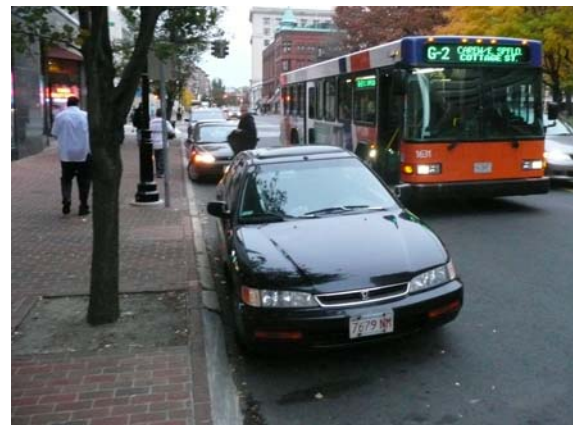
Location: Main Street and Falcon Way (1331 Main)

Notes: Stop provides convenient access to Info Center; however, continual illegal parking in bus stop during peak hours forces buses to discharge passengers in travel lane. This creates a safety concern for many Info Center customers (typically purchasing monthly passes) who are disabled and/or elderly. Those with mobility assistance devices (i.e., walkers) must go to curb cut at end of block. Short bus pull-in length; stop is farside, but very close to Falcon Way intersection, which creates occasional backups into cross traffic.

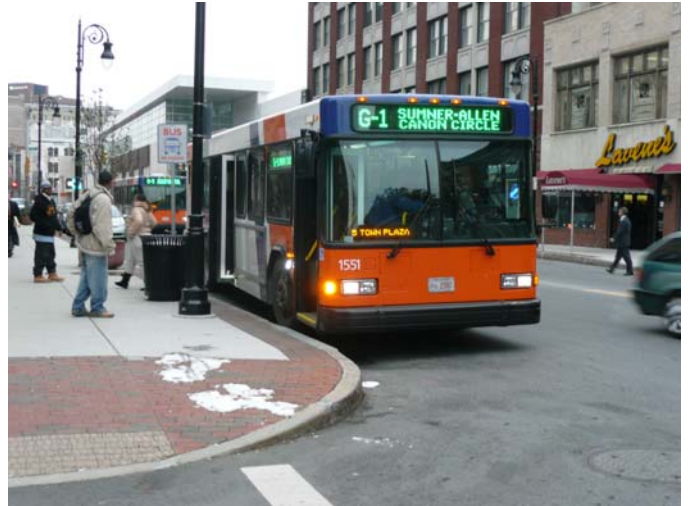
Location: Main and Bliss Streets

Notes: Riders congregate near building for shelter. Few non-passengers congregating. Some street furniture blockage causes buses to overshoot posted sign.

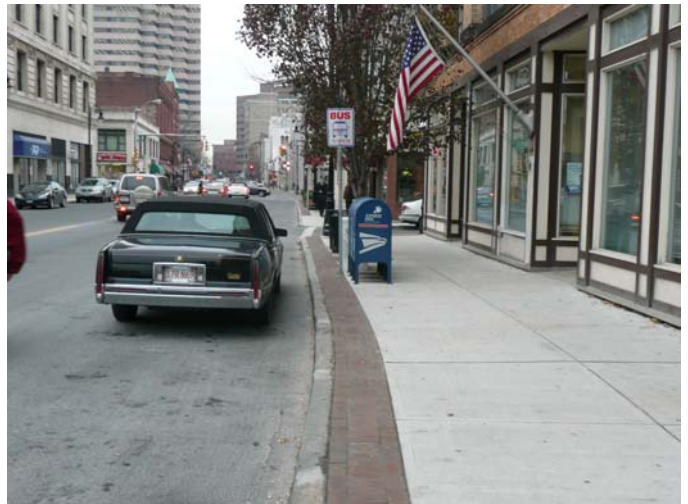
Location: Main and Stockbridge Streets

Notes: Directly opposite Bliss Street stop, creating intuitive pairing.

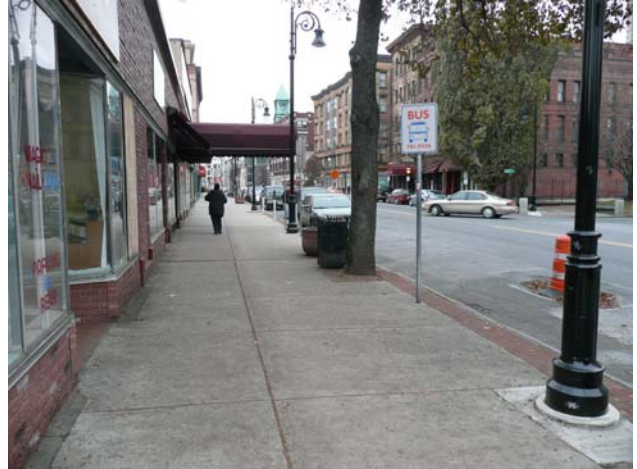
Location: Main and Howard Streets

Notes: Stop is infrequently used during peak hours, but provides important access to elderly/disabled and transit-dependent riders.

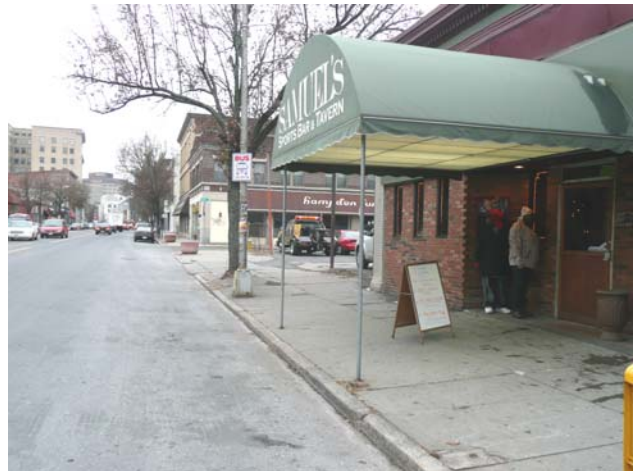
Location: Main and Union Streets (Park St)

Notes: Stop is mid-block between Union and Park Streets. Nearly all riders observed wait under private awning (away from bus stop sign).

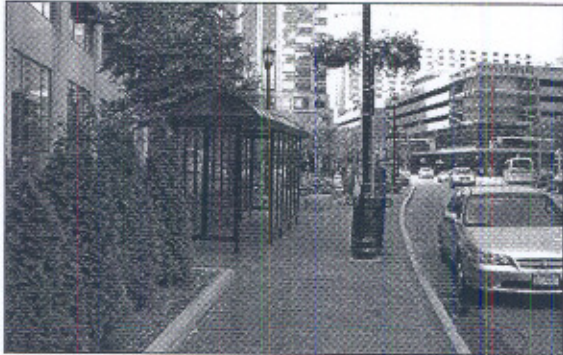
PVTA consider moving the bus shelter to the Bolland Square plaza in order to keep the sidewalk free of pedestrian congestion.

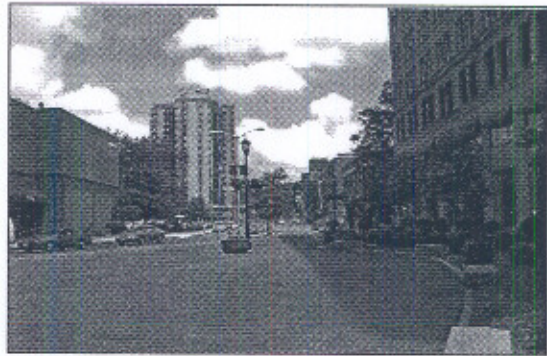
Boland Square

The westbound G3, B6, B7, B13 stop along Harrison Avenue also appears to have sufficient space to handle an increase in pedestrian traffic with the addition of the P21 bus line. There is additional shading and seating available at this location due to the planting bed next to the bus shelter. The width of the sidewalk also appears to be sufficient. Riders transferring to the G1, G2, G5, G8 lines along Main Street from the westbound line also have the benefit of a mid-block crosswalk which can quickly and efficiently move riders from the Harrison Ave lines to the Main Street lines.

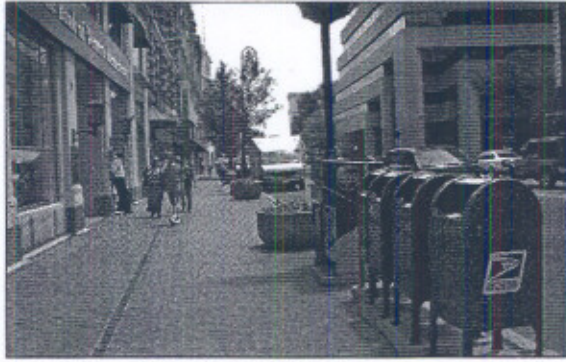
A greater concern is for the location of amenities, particularly the mail boxes, at the northbound stop. While the mail boxes may provide a sense of pedestrian safety to passengers waiting for the bus along a busy Main Street, the location of these mail boxes is odd. They are placed directly next to the bus stop sign, and appear to conflict with the loading and unloading zone for bus passengers. A bus on the northbound line needs to pull at least 20' beyond the designated bus stop in order to safely load and unload passengers and avoid the mail boxes. I recommend that PVTA conduct further analysis to see whether these mail boxes should be moved to provide a safer loading and unloading zone to the new passengers that may utilize this bus line.

Amenities at Main St. northbound stop

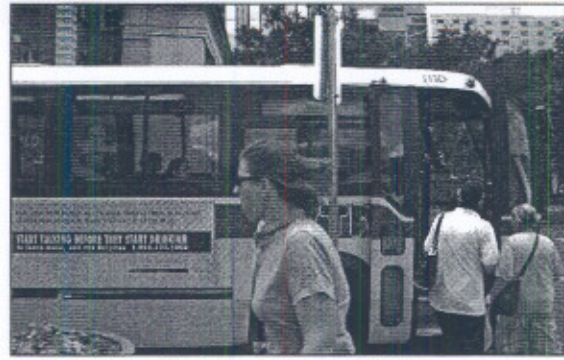
Passengers loading the northbound G8 line

The southbound G1, G2, G5, G8 stop along Main Street also appears to have sufficient space to handle an increase in pedestrian traffic and riders to these lines. The major recommendation for this location would be for the City of Springfield to consider a mid-block cross walk adjacent to this bus stop, to allow riders to easily and efficiently transfer from the bus lines on Harrison Street to Main Street. For safety reasons, the City may prefer for pedestrians to use the crosswalks at the lights at Main and Harrison; however, PVTA should coordinate the bus schedules on these two lines to ensure pedestrians have enough time between transfers to safely move from the G3, B6, B7, B13 routes to the G1, G2, G5, G8 routes.
