# AT-GRADE SHARED USE PATH AND ROADWAY INTERSECTIONS IN THE PIONEER VALLEY

## ADDENDUM REPORT

OCTOBER 2020

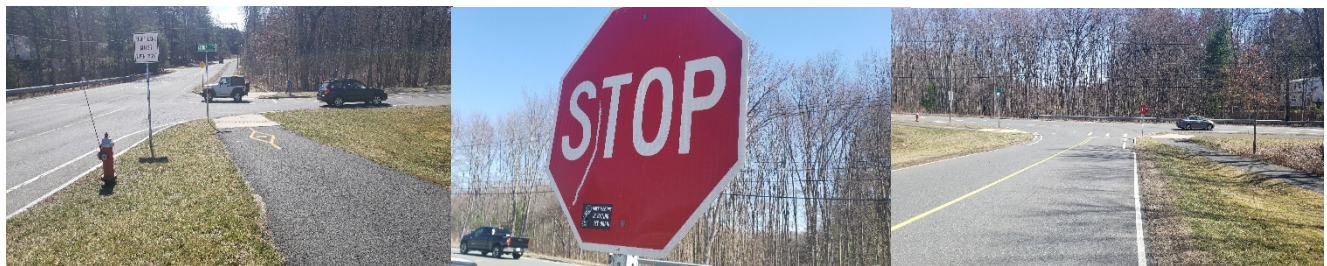
The crosswalk markings are in poor condition. The southbound approach of the side path has pavement markings that indicate an uninstalled bollard.

From Left: (i) Southbound approach of the Side Path depicting the location of uninstalled bollard and street name signs, (ii) Vandalized Stop sign at the Kendall Drive approach, (iii) Eastbound approach of Kendall Drive depicting the westbound branch of the SIDE PATH parallel to the road.

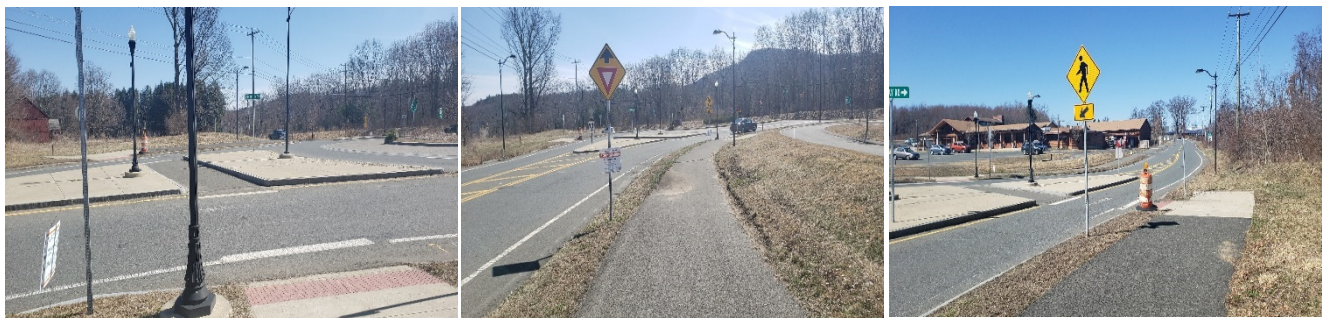
The side path crosses West Bay Road in the vicinity of the roundabout. The side path has two branches: one continues westbound along West Bay Road and the other continues northbound along West Street (Route 116). The crosswalk markings are in poor condition.

*From Left: (i) Northbound approach of the side path depicting the median and faded crosswalk markings, (ii) Eastbound approach of West Bay Road, (iii) Westbound approach of West Bay Road depicting the crosswalk sign*

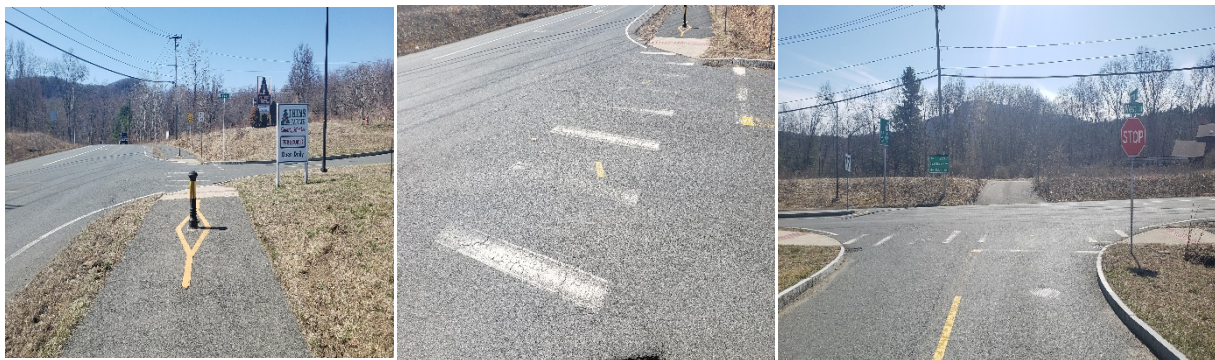
The side path is aligned parallel to West Street separated by a grass shoulder. Bollards are located along both approaches of the side paths to separate bicycles and pedestrians. There is a sign posted at the intersection of the side path with Lannon Lane which guides bicyclists to stay to the left side and pedestrians to the right side of the path.

*From Left: (i) Southbound approach of the side path with bollard, (ii) Faded crosswalk markings and stop line for Lannon Lane, (iii) Eastbound approach of Lannon Lane and driveway to the east of the intersection with West Street (Route 116)*

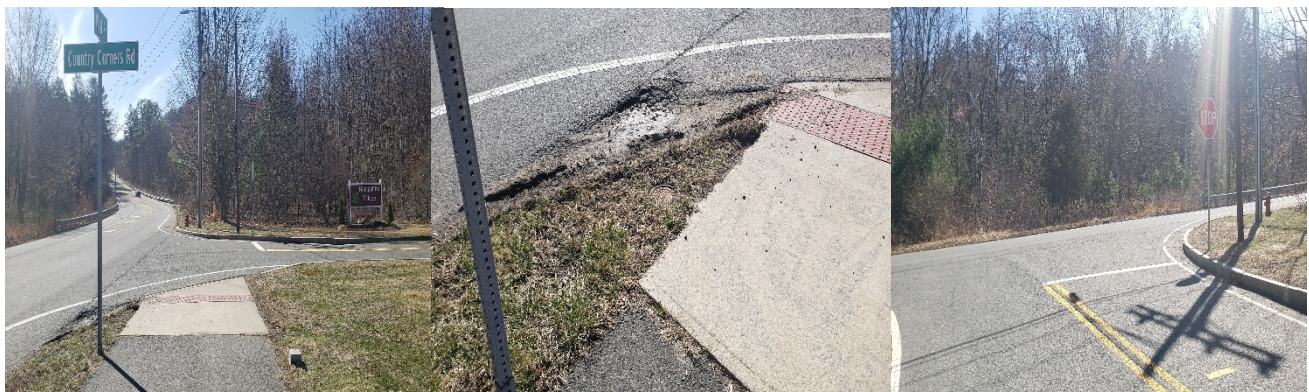
The side path is aligned parallel to West Street separated by a grass shoulder. The intersection does not have curbing. Poor drainage along the northwest corner of the intersection at the edge of the grass shoulder that separates the side path from West Street has resulted in damage to the existing pavement.

*From Left: (i) Southbound approach of the side path, (ii) Northwest corner of the intersection of West Street (Route 116) and Country Corners Road, (iii) Eastbound approach of Country Corners Road*

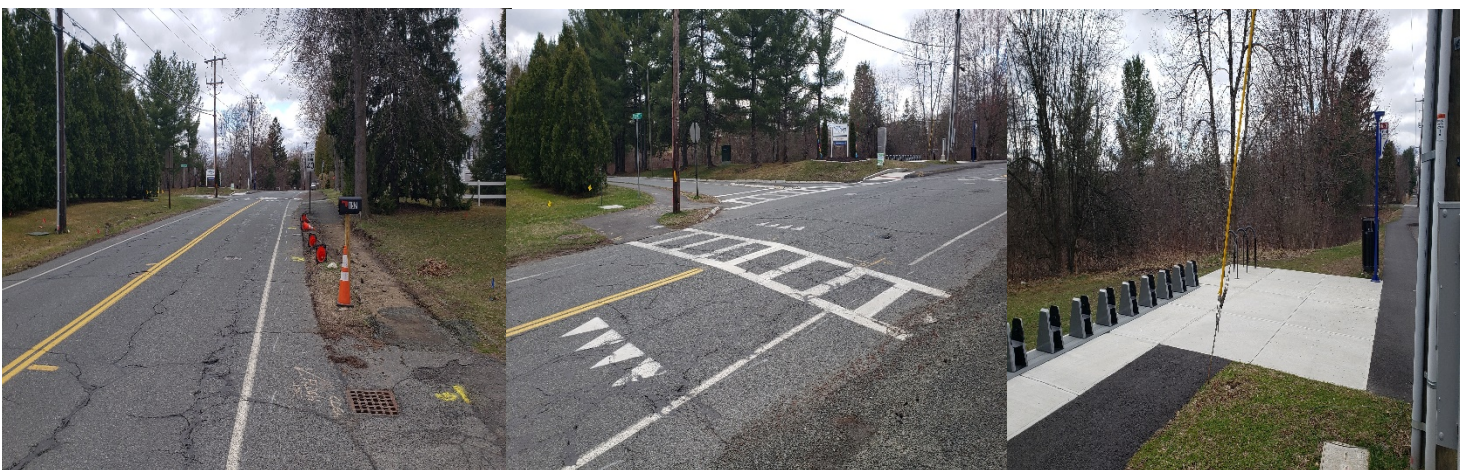
The side path terminates at this location. There is a crosswalk along East Hadley Road which connects the side path with the sidewalk along the northern side of East Hadley Road.

*From Left: (i) Westbound approach of East Hadley Road, (ii) Crosswalk and Shark Teeth Yield markings, (iii) PVTA Bus Stop and Bike Racks located in the west of the crossing*

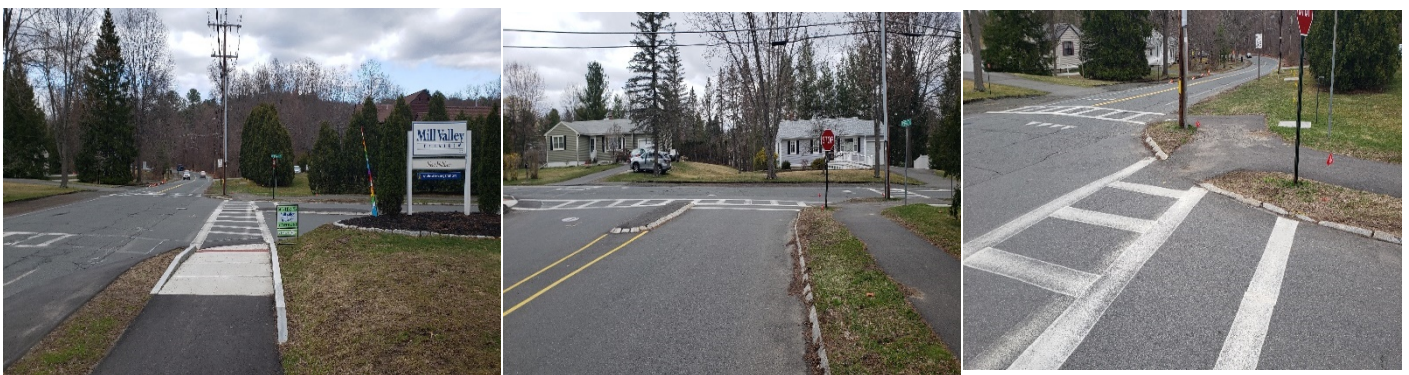
*From Left: (i) Eastbound approach of side path with concrete ramp, (ii) Northbound approach of Riverdale Drive with median, (iii) Crosswalk and ramp along westbound approach of the side path*

The pavement in the vicinity of this crossing was under construction. This crossing is in the vicinity of the PVTA bus stop with a ValleyBike station. The side path currently terminates at this location. The westbound approach ramp of the side path did not have tactile warning plates at the time of the survey.

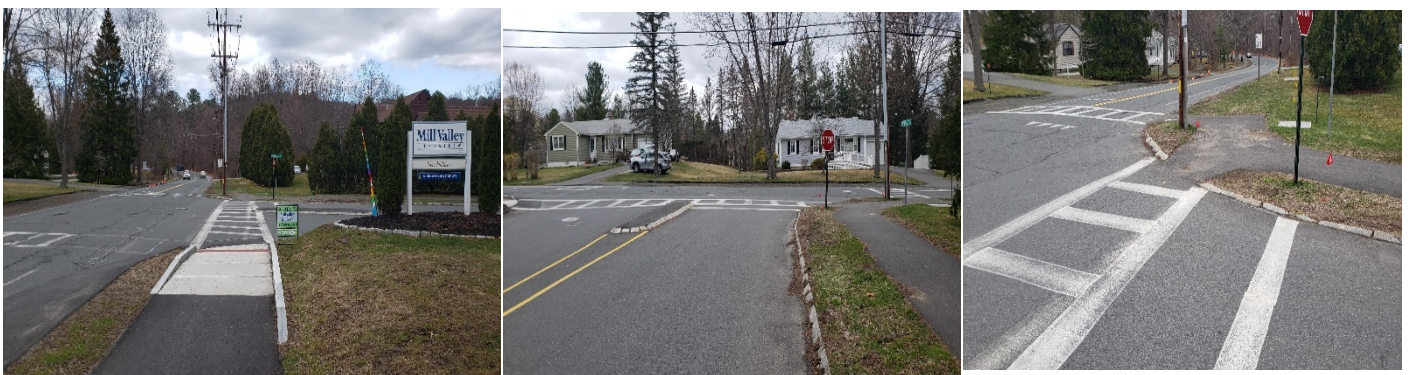
*From Left: (i) Eastbound approach of side path with concrete ramp, (ii) Northbound approach of Riverdale Drive with median, (iii) Crosswalk and ramp along westbound approach of the side path*

The pavement in the vicinity of this crossing was under construction. This crossing is in the vicinity of the PVTA bus stop with a ValleyBike station. The side path currently terminates at this location. The westbound approach ramp of the side path did not have tactile warning plates at the time of the survey.

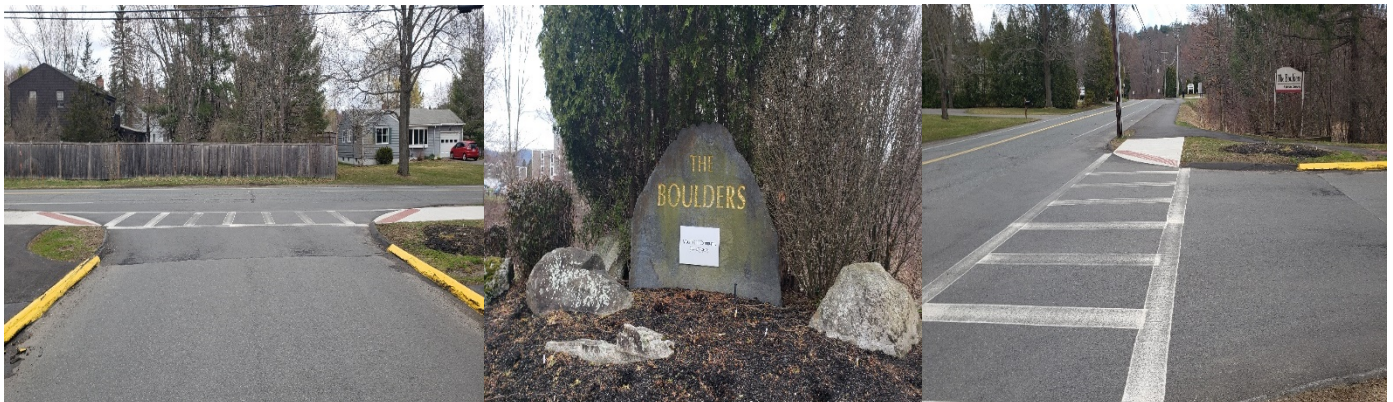
*From Left: (i) Northbound approach of Brittany Manor Lane, (ii) Sign for the residential neighborhood along the driveway, (iii) Crosswalk and view along eastbound approach of the side path*

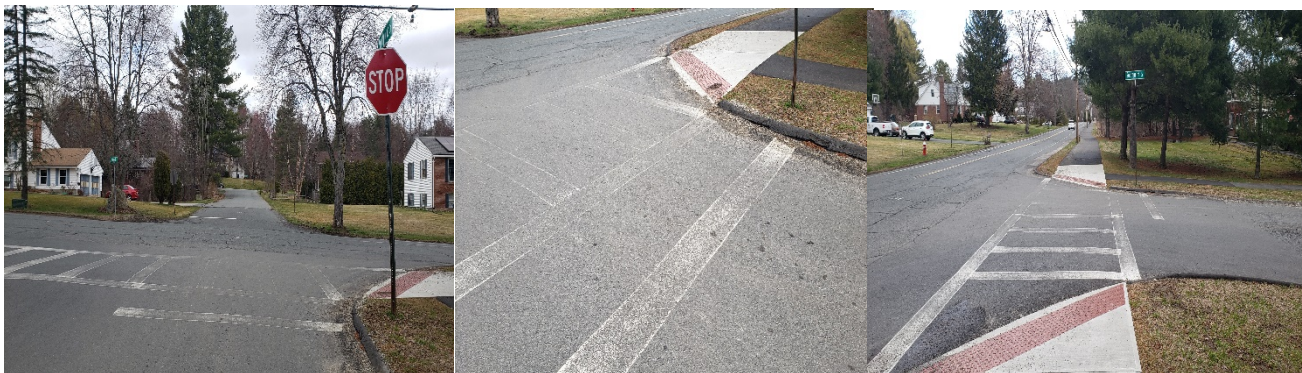
From Left: (i) Northbound approach of Southpoint Drive, (ii) Faded stop line and crosswalk markings, (iii) Eastbound approach of the side path

**Remarks:** The side path is aligned parallel to East Hadley Road. Southpoint Drive intersects the side path and East Hadley Road at a three-way intersection. Overhead street lighting along East Hadley Road is in the vicinity of this intersection. The stop line and the crosswalk pavement markings are faded along several locations at the intersection.

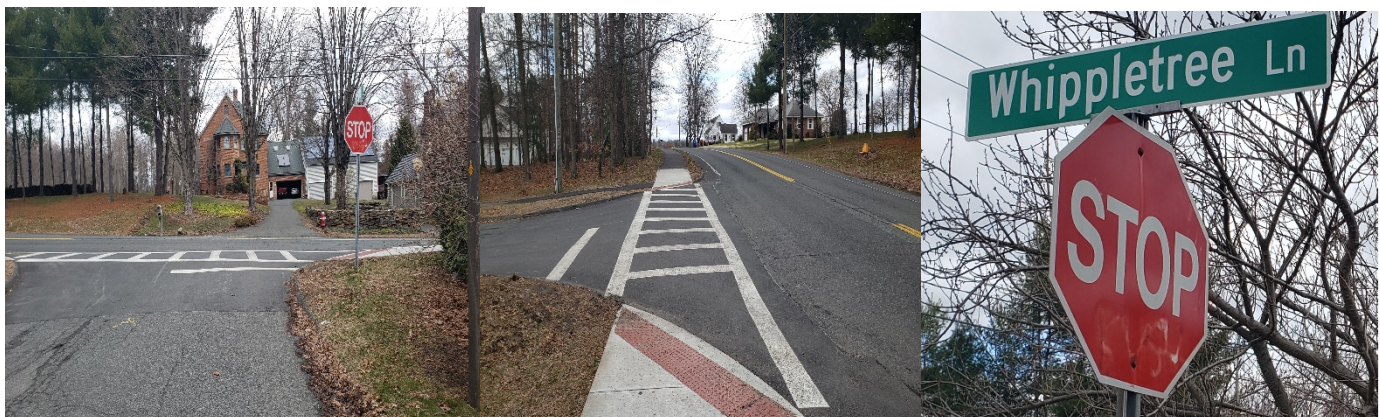
*From Left: (i) Northbound approach of Whippletree Lane, (ii) Westbound approach of the side path, (iii) Graffiti on the 'Stop' sign at the approach of Whippletree Lane*

The side path is aligned parallel to East Hadley Road. Whippletree Lane intersects the side path and East Hadley Road at a three-way intersection. The 'Stop' sign at the Whippletree Lane approach had some graffiti on it.

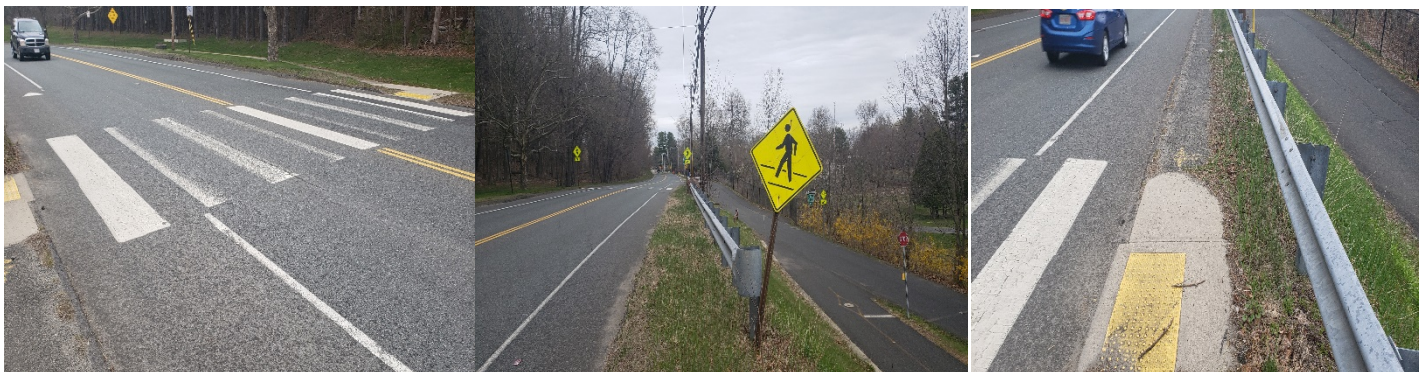
From Left: (i) Crosswalk view from sidewalk along west side of the road, (ii) Southbound approach of North Main Street depicting the damaged sign post, (iii) Ramp along the sidewalk along the west side of North Main Street.

Crosswalk markings and stop lines have faded along several locations along the pavement in the vicinity of this crossing. The shark teeth yield markings are visible in very few locations and need to be repainted.

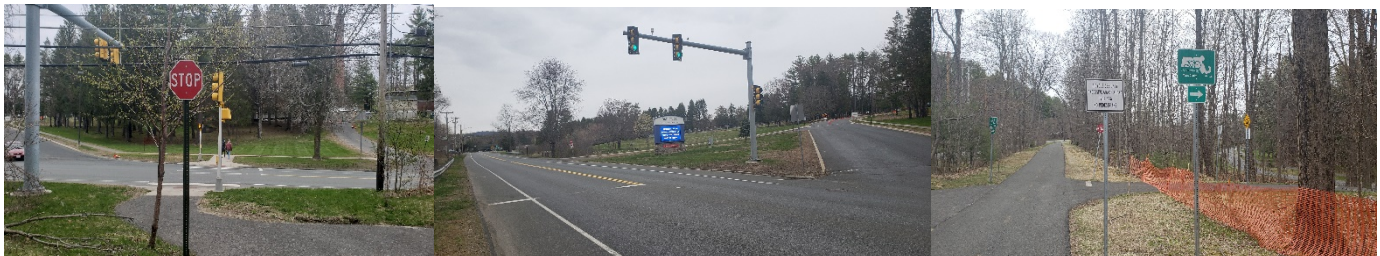
*From Left: (i) Northbound approach of the shared use path depicting the stop sign and the signal head, (ii) Westbound approach of North Main Street with Veteran's Affairs Medical Center Sign and driveway access to MassDOT park and ride lot, (iii) Sign for pedestrians along the shared use path*

Crosswalk markings and stop lines have faded at several locations along the pavement in the vicinity of this crossing. The signal provides approximately 15 seconds of walk time for pedestrians to cross the street.

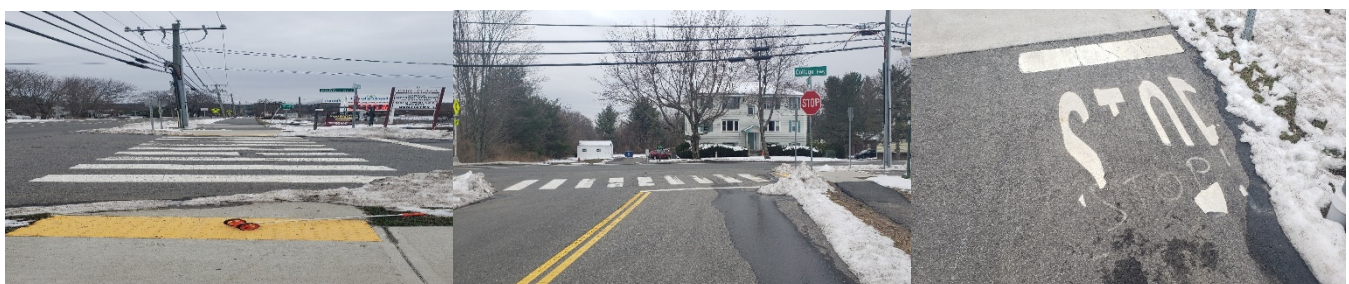
This intersection marks the eastern end of the side path. It is located in the vicinity of a gas station with a convenience store. The side path eastbound approach is controlled by a stop line without a sign. The stop line and pavement markings along the side path are in poor condition. There is a guide sign for users of the path to utilize the crosswalk for crossing Parc Place.

*From Left: (i) Westbound approach of the Side Path, (ii) Parc Place approach, (iii) Pavement markings at the eastbound approach of the Side Path*

There is a push button activated Rectangular Rapid Flashing Beacon (RRFB) in the vicinity of the westbound approach of the side path for pedestrians trying to cross College Highway. The intersection is well lighted by streetlights. The pavement markings along the side path are faded and the approach is missing the Stop sign.

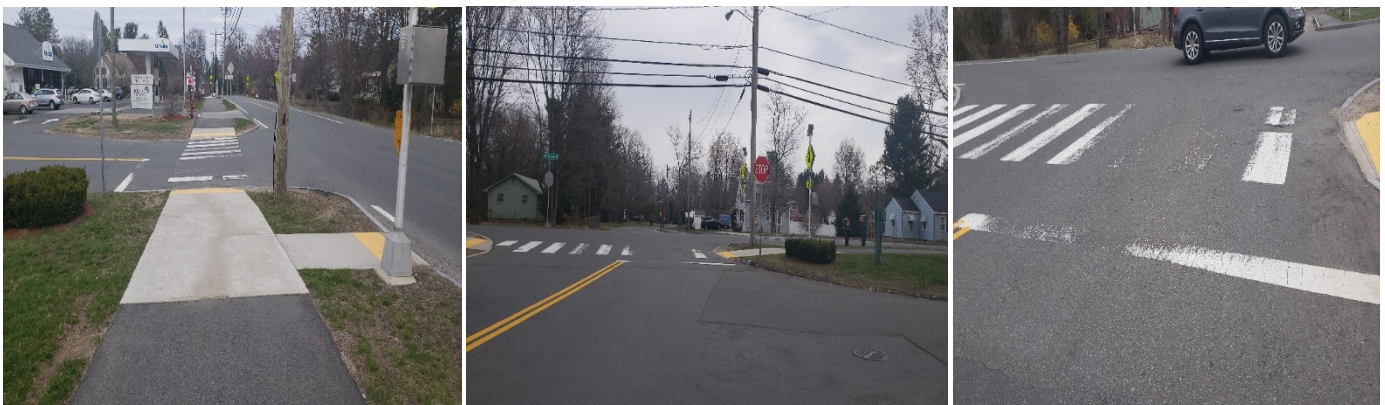
*From Left: (i) Eastbound approach of the Side Path, (ii) Country Garden approach, (iii) Faded crosswalk marking*

Crosswalk markings are faded at several locations.

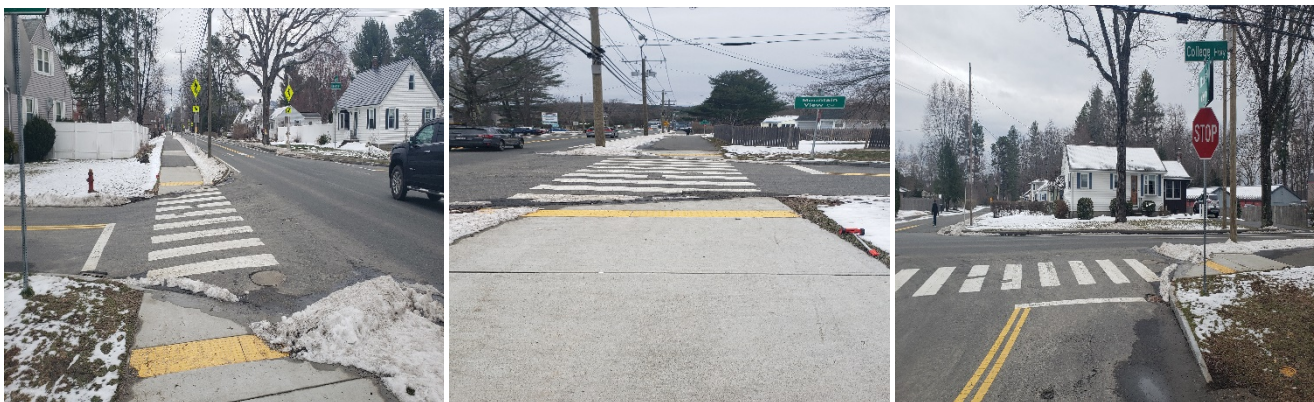
*From Left: (i) Eastbound approach of the side path showing snowbanks, (ii) Westbound approach of the side path, (iii) Mountain View Circle approach*

Snowbanks created from plowing the street were observed to block the ramps of the side path at the time of the field visit.

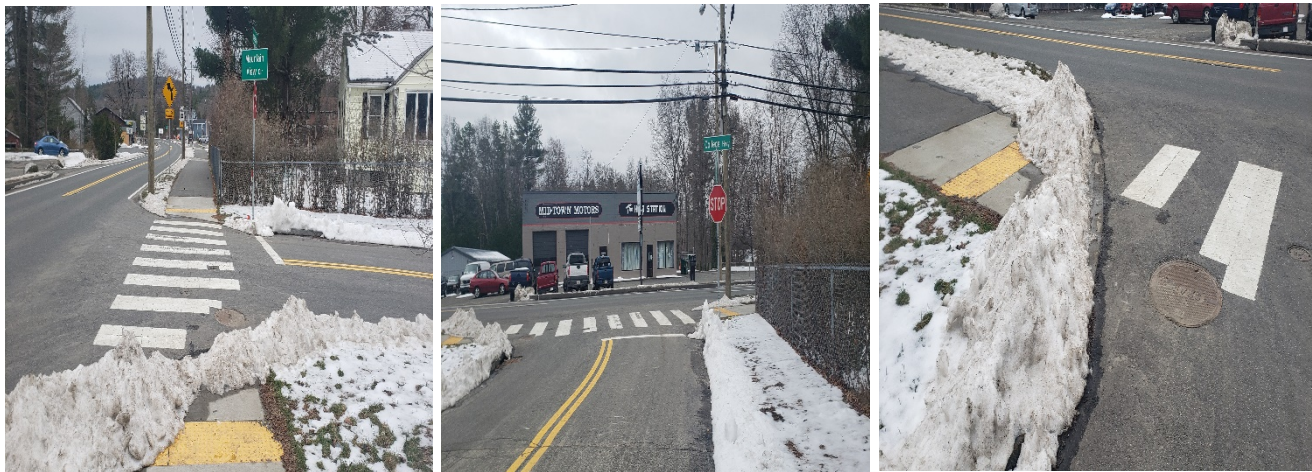
From Left: (i) Westbound approach of the side path depicting the crosswalk, (ii) Mountain View Circle approach, (iii) Snowbanks along the ramp of the side path

Snowbanks created from plowing the street were observed to block the ramps of the side path at the time of the field visit.

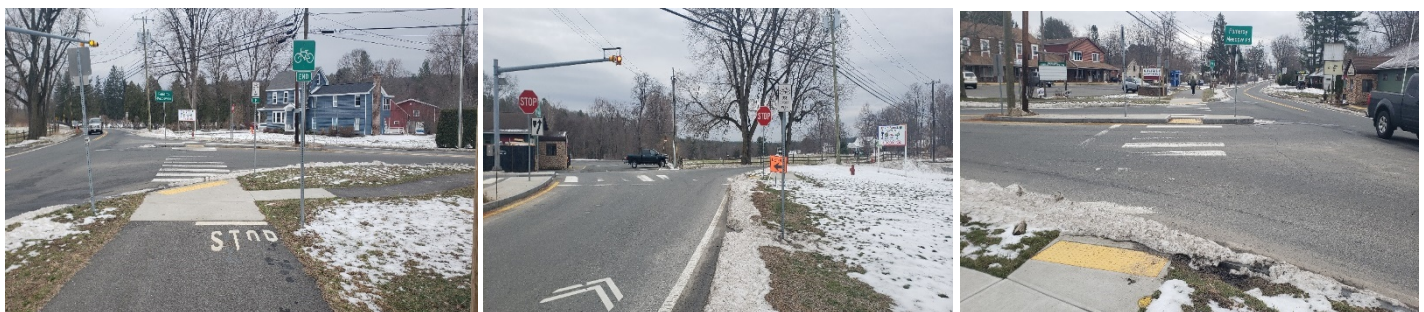
*From Left: (i) Westbound approach of the side path depicting the median and faded crosswalk markings, (ii) Southbound approach of Pomeroy Meadow Road, (iii) Eastbound end of sidewalk and faded crosswalk markings*

Snowbanks created from plowing the street were observed to block the ramps of the side path at the time of the field visit.

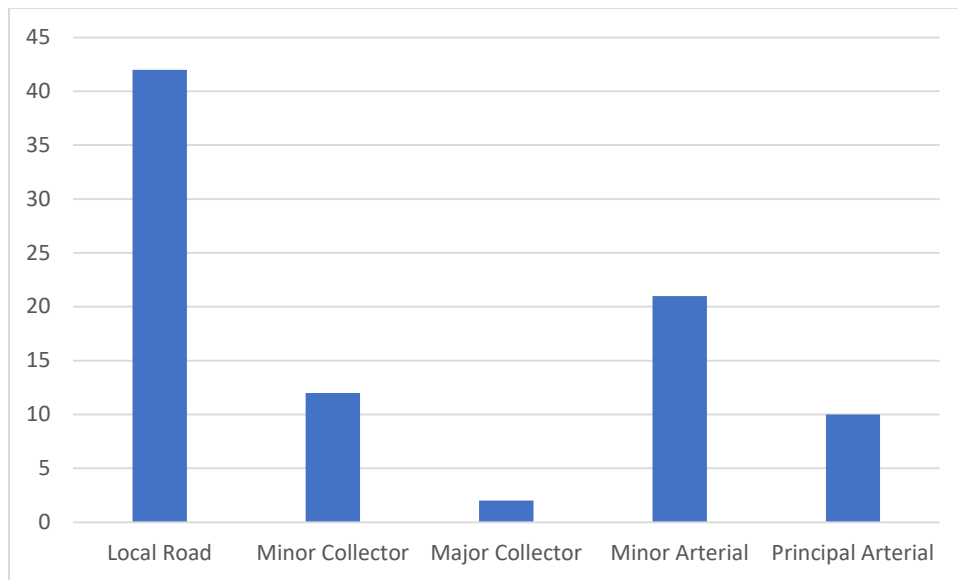
**Figure 2: At-grade Crossings by Roadway Classification**

There is an absence of any uniform theme among transportation treatments at crossings along higher classified roadways. Additionally, there are many differences in the type of existing treatments and features. In the next chapter some of the existing best practices are highlighted which provide an insight into current conditions in the vicinity of at-grade shared use path crossings in the region.

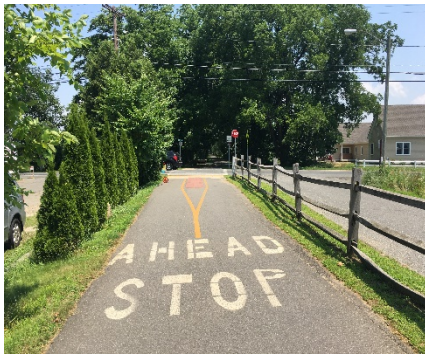
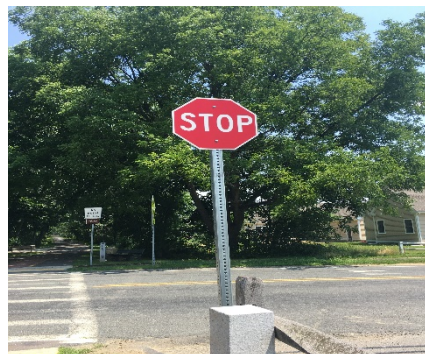
1. Well Defined Advance Pavement Markings
2. Clear Signage for Stop Control
3. Demarcated lanes for separating westbound and eastbound non-motorists

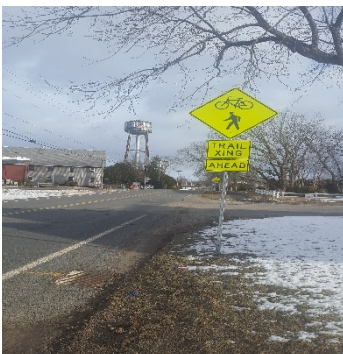
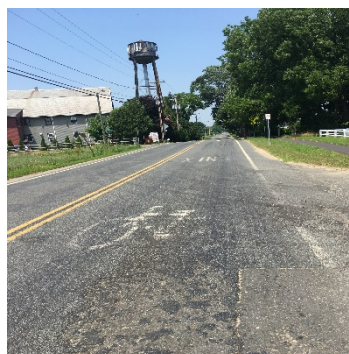
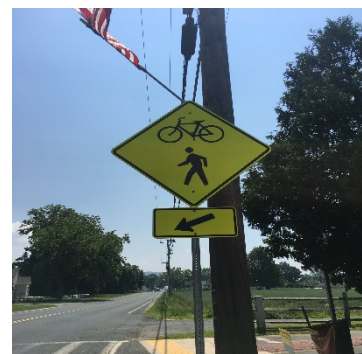
1. Advance Warning Signs
2. Type and location of Advance Pavement Markings (Faded at the time of survey)
3. The type of Shared Use Path Signs that depict both bicycles and pedestrians

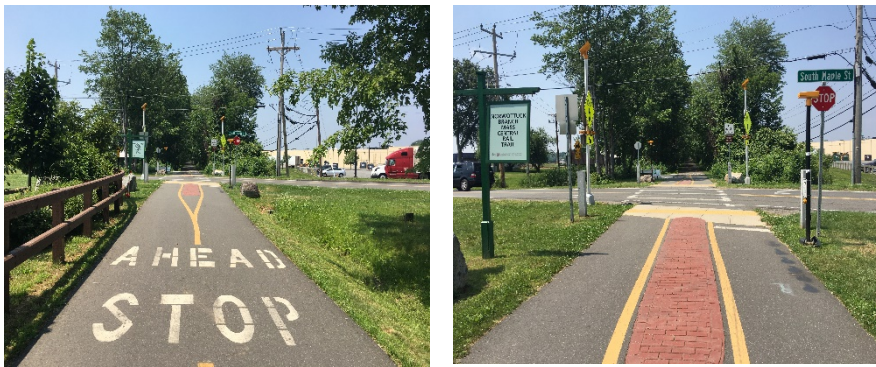
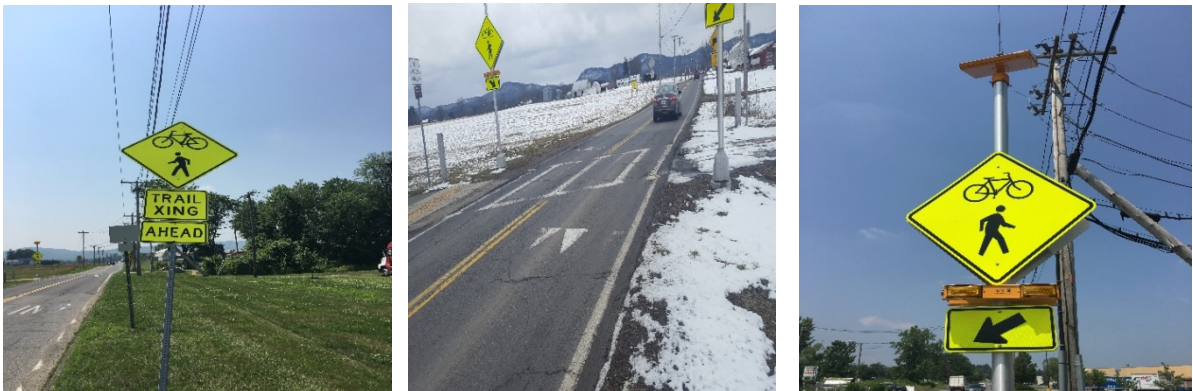
South Maple Street and Norwottuck Branch of MassCentral Rail Trail Crossing in Hadley  
(Minor Arterial, Rectangular Rapid Flashing Beacon (RRFB) for Roadway, Stop Control for Shared Use Path)

1. Well Defined Advance Pavement Markings
2. Clear Signage for Stop Control
3. Demarcated lanes for separating westbound and eastbound non-motorists

\* - While this location is a good example of the use of a RRFB in the region, it was observed that many bicyclists and pedestrians fail to activate the device prior to crossing South Maple Street.

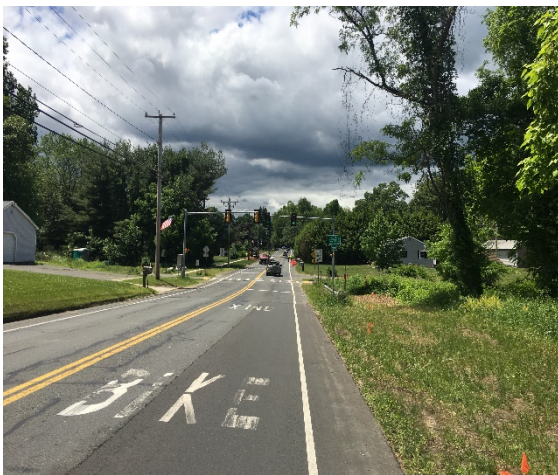
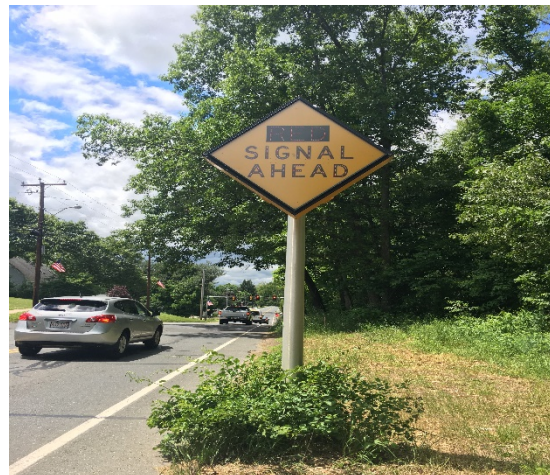
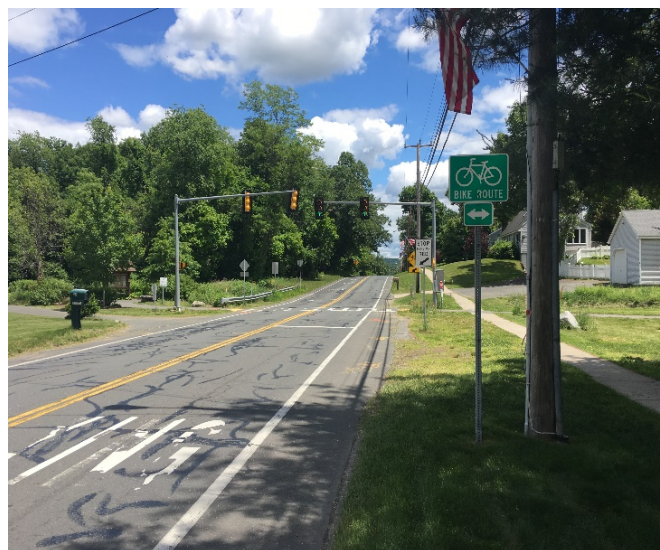
## Feeding Hills Road and Southwick Rail Trail

1. Advance Pavement Markings
2. Advance Signal Ahead Sign
3. Advance Shared Use Path Warning Sign
4. Shared Use Path Sign (Ideally it should depict both bicycles and pedestrians)
