DOWNTOWN HUNTINGTON PARKING STUDY

Prepared under the direction of the
Pioneer Valley Metropolitan Planning Organization

FINAL REPORT

June 2006

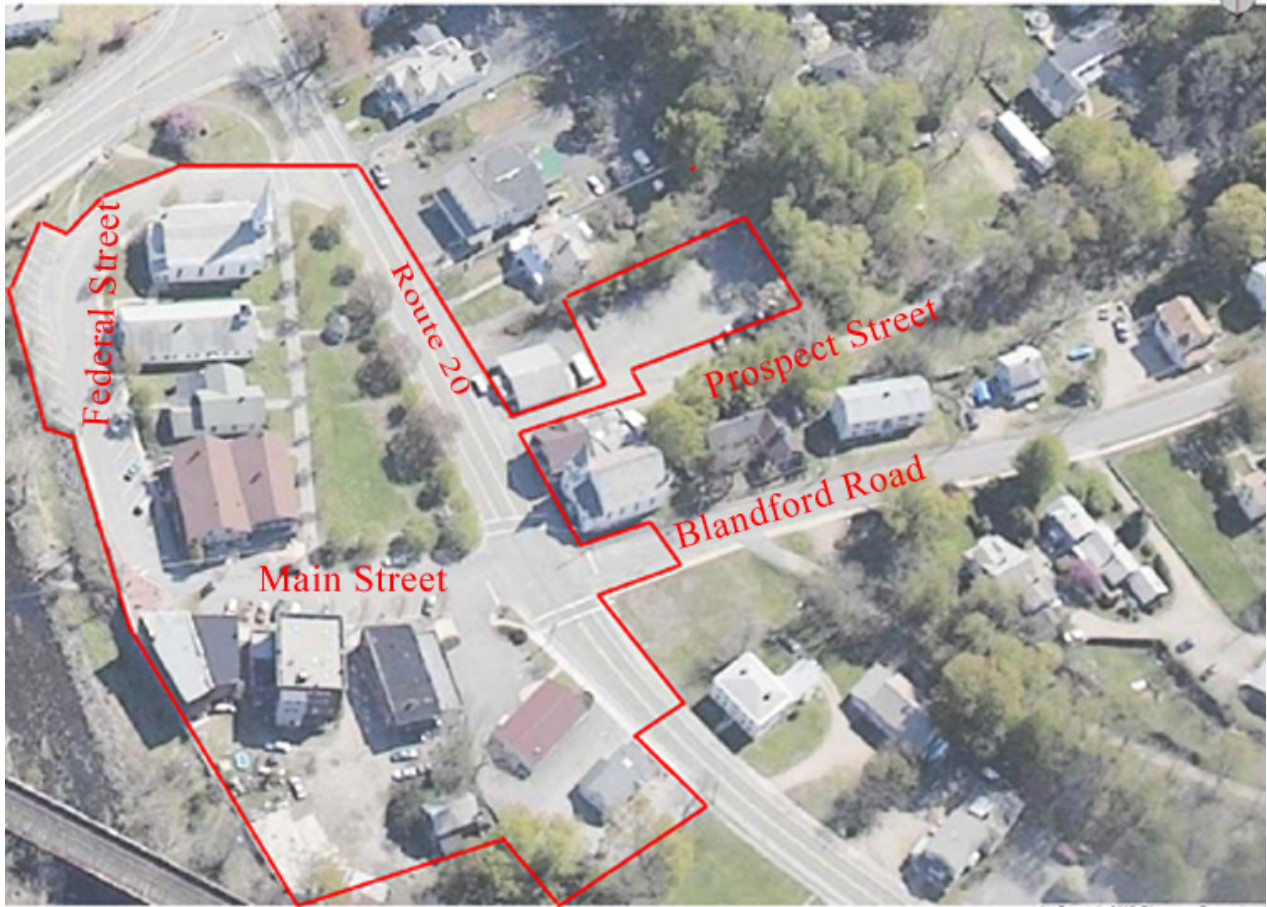
FIGURE 1
Downtown Huntington Parking Study Area

The study area for the Downtown Huntington Parking Study as shown in Figure 1 includes the public and private parking facilities in the Central Business District (CBD). The major streets in the study area include the Main Street/Federal Street loop, Route 20, Prospect Street (Municipal Lot), and a small portion of Blandford Hill Road. Main Street contains 9 active businesses and two vacant storefronts. Currently one of the storefronts located in the Diamant building is currently in the process of being renovated to house a restaurant. The majority of the buildings on Main Street are mixed-use multiple story buildings containing both business and residential space. Federal Street parking is predominantly used by town employees and Huntington residents with town business; however this parking area is also used for functions at Stanton Hall and the Chapel, associated with the Huntington Evangelical church. Route 20 has wide shoulders through out the downtown which encourages on street parking, and because this section is not signed as no parking consumers mainly use the shoulders for quick stops at either the package store or the pizza shop. This section of Route 20 does see some overflow parking on nights when there are town meetings or other large events in the Downtown.

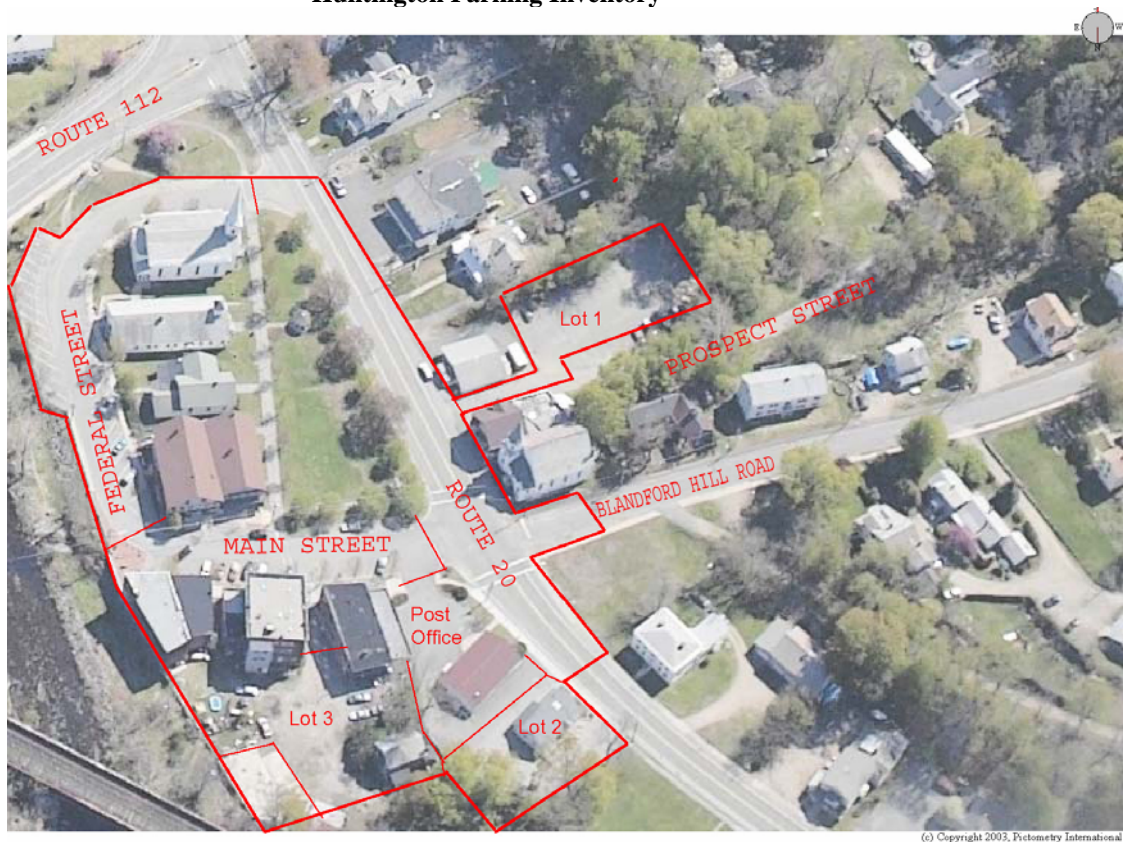
FIGURE 2
Huntington Parking Inventory

As the initial component of the parking survey, an inventory of the number of both on-street and off-street parking systems in the study area was conducted. This information is shown in Figure 2. Since some curb spaces were not marked, it was assumed that each space would occupy 18 feet of curb within the study area. A total of 124 parking spaces were identified in the downtown area. Public parking in the Downtown consists of Main Street with 20 parking spaces, Federal Street with 33 spaces one of which is handicap, Route 20 has the potential to have 22 spaces and the Municipal lot was estimated to have of 25 parking spaces for a total of 100 public parking spaces. Private lots consist of the bank which was estimated to have 9 unmarked spaces available for its customers; the Post Office has 7 marked spaces one of which is for handicapped parking and 2 unmarked spaces on the bank side of the building used by Post Office employees. Lot 3 off of Main Street was estimated to have 6 unmarked parking spaces totaling 24 private spaces including 1 handicapped space.

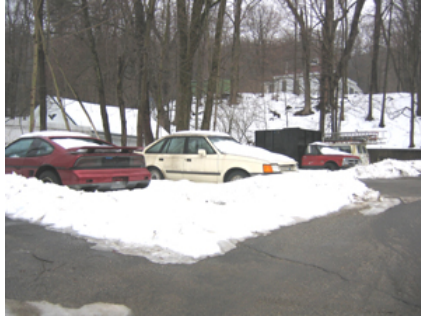
FIGURE 4

Abandoned Vehicles (Municipal Lot)

- Huntington should have the abandoned vehicles located on publicly owned land removed.
- The Town of Huntington should re-evaluate the existing parking supply in the downtown to ensure that parking spaces are laid out in the most efficient way.

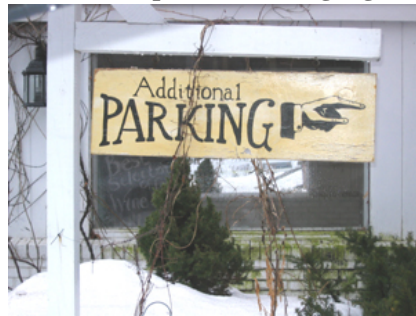
Municipal Lot Parking Sign

- Signs should be placed in appropriate locations directing patrons to the municipal lot
- The Town of Huntington should consider opportunities as they become available to expand the existing parking supply. This could include the acquisition of private land for use as parking areas.

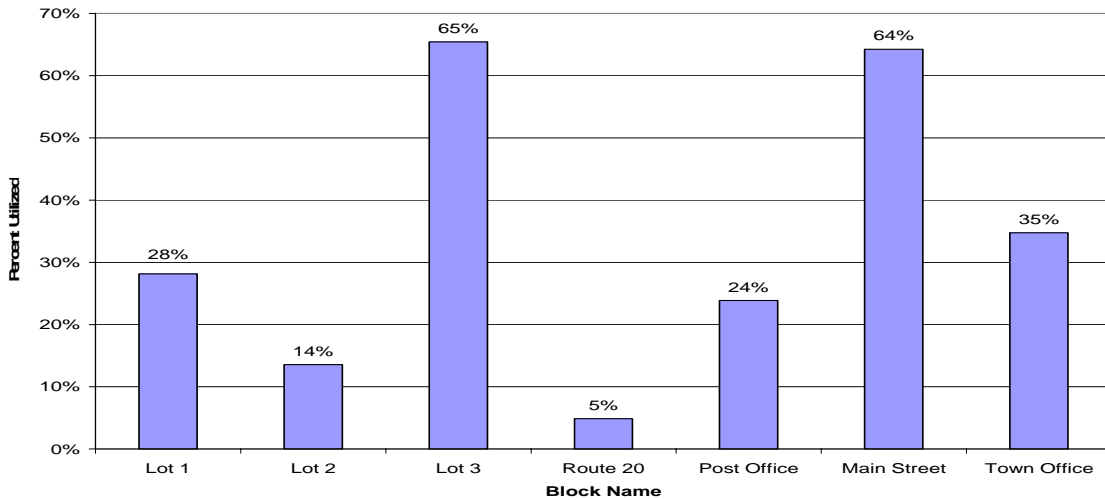
**FIGURE 5
Utilization per Block**

As shown in Figure 5, Main Street is the most highly used area for parking within the study area excluding Lot 3. This block averaged 15 occupied spaces out of 20 per observation period, with an average utilization of 64%.

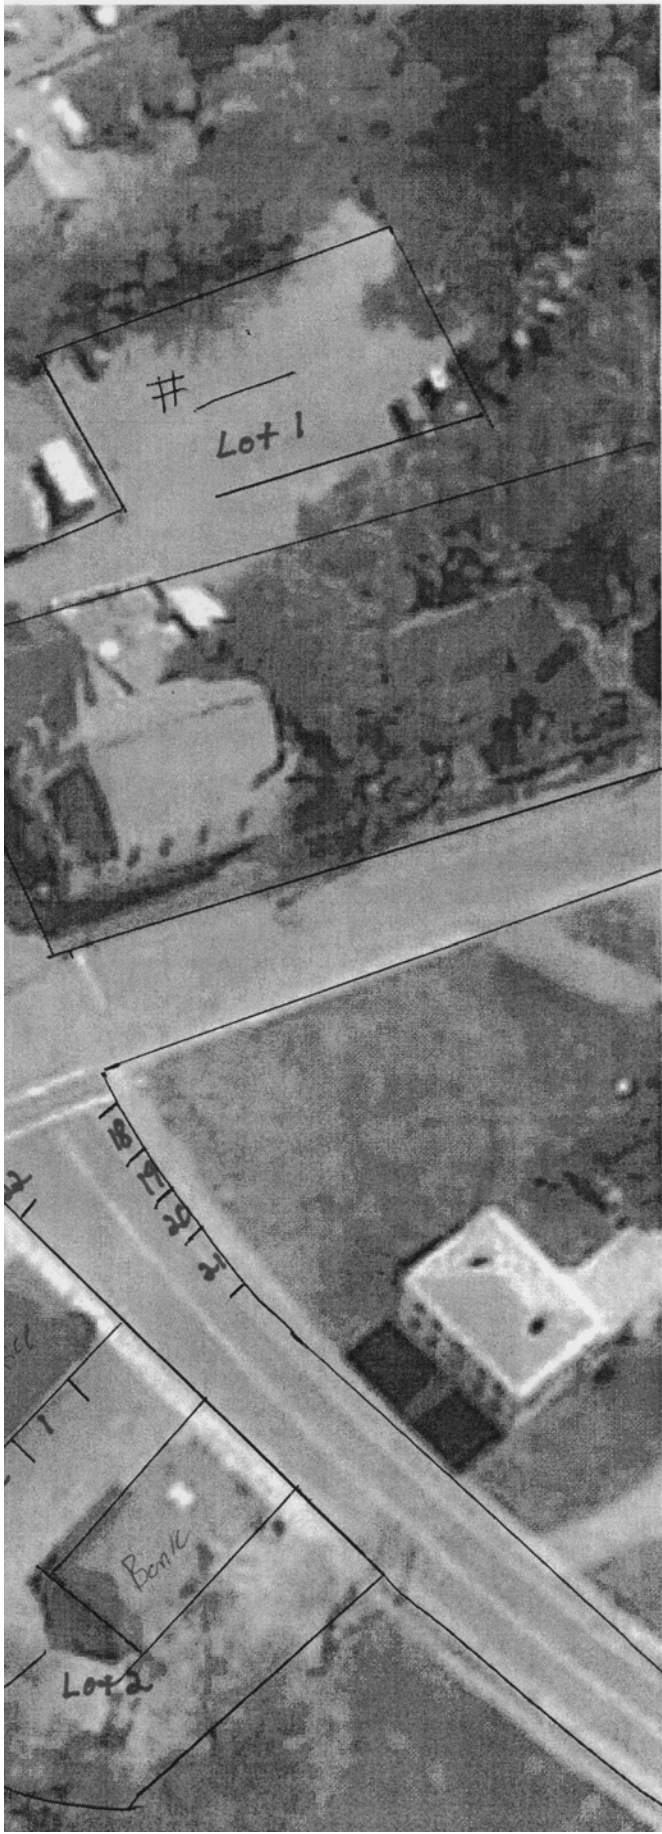
Huntington Parking Study Survey Sheet

1. Start each round of the survey at the Asterisk, and survey in the same direction every half hour.
2. Record the last 3 digits of license plates in the appropriate parking space. Count cars only in lots specified on the survey form (Include abandoned cars each time)
3. Draw in any cars parked illegally
4. Be as accurate as possible when entering data and write neatly in order to make data processing easier.
5. Use comment section for any observations or notes dealing with the parking study.
