***Rebecca Johnson Elementary School  
Walk Audit  
Springfield, MA***

March 4, 2015

Centers for Disease Control and Prevention Division of Community Health/Community Transformation Grant

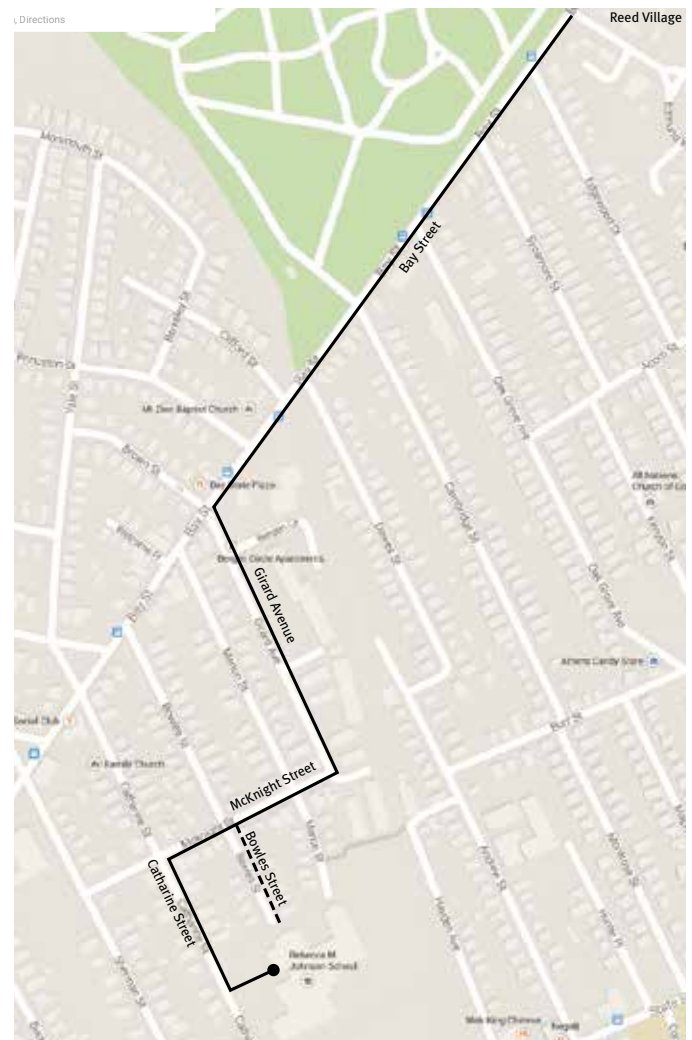
Map of proposed walking school bus route from Reed Village

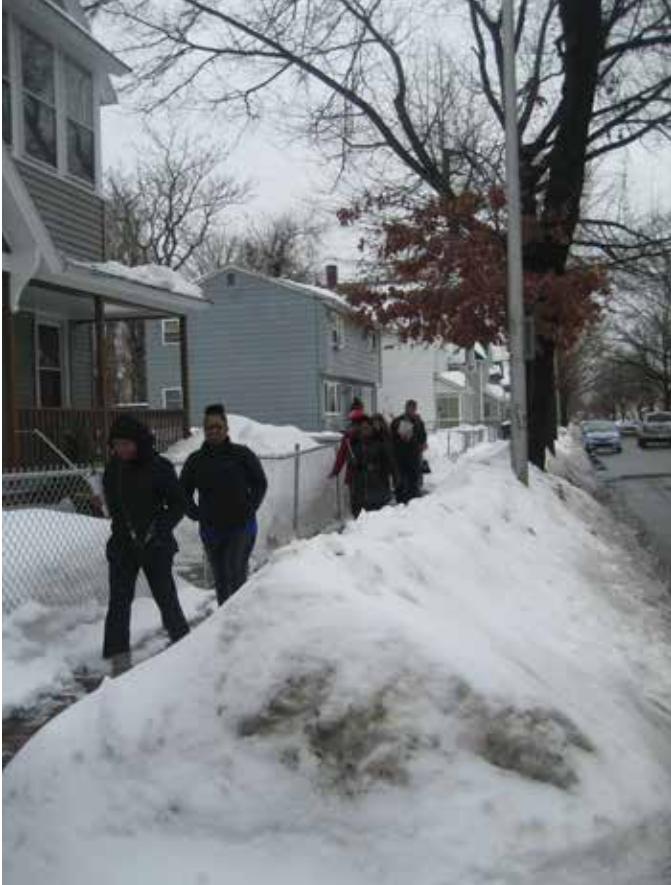
*Walk audit participants walk along Catharine Street on snow-covered sidewalks*

Sidewalks approximately 4 to 5 feet in width run along both sides of Catharine Street between Bay and State Streets. Narrow green, grassy strips (called a verge) separate the sidewalks from the curbs along Catharine Street that provide some separation between fast-moving traffic and people walking. Trees line both sides of the street, which provide shade and further define the edge of the street. The condition of the sidewalks was hard to determine given the amount of snow on the ground.

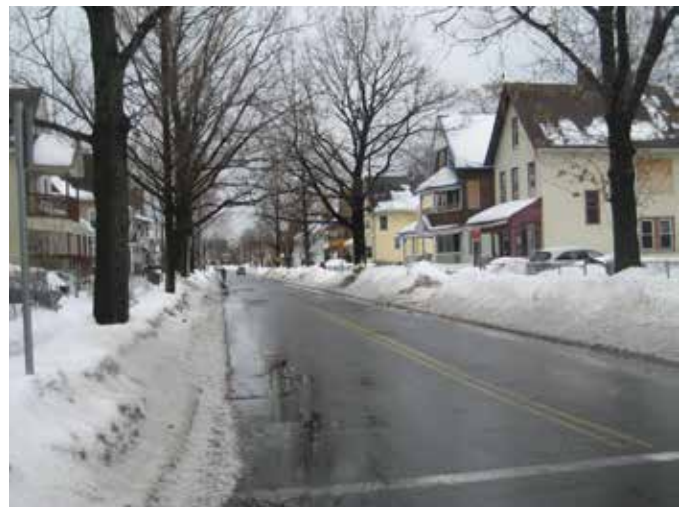
*View down Catharine Street*

The street crossings across Catharine Street had marked crosswalks with minimal striping, except at the State Street intersection where the crosswalks are enhanced with a red, stamped asphalt brick pattern. The crosswalks at the entrance and exit drives at Rebecca Johnson had no curb ramps and terminate in driveways rather than leading to the sidewalks. The crosswalks at the Catharine/McKnight Streets intersection have curb ramps, but are missing detectable warning strips.

School zone signage is missing along Catharine Street and pedestrian crossing signs appear only at the crosswalk adjacent to the school exit drive. There are no signs placed in advance of the crosswalk to warn of pedestrians crossing. On-street parking is prohibited south of the McKnight Street intersection.

1. Slow traffic down on Catharine Street
  - Place in-street pedestrian signs in the crosswalks adjacent to the entrance and exit drives to Rebecca Johnson (short-term)

- Install raised crosswalk(s) across Catharine Street near entrance and exit drives to Rebecca Johnson (long-term)
  - Work with law enforcement to continue monitoring speed and enforcing speed limits near the school

2. Improve visibility of street crossings
  - Consider relocating crosswalks adjacent to the entrance drives away from driveways
  - Install curb ramps and detectable warning strips

- Repaint crosswalks using a zebra or continental design
3. Delineate school zone
  - Install school zone signs with 20 mph speed limits in highly visible locations at all approaches to the school

- Consider painting SCHOOL ZONE pavement markings on Catharine Street
  - Install wayfinding signs to Rebecca Johnson from major intersections at Catharine/State and Catharine/Bay Streets for people walking and driving.

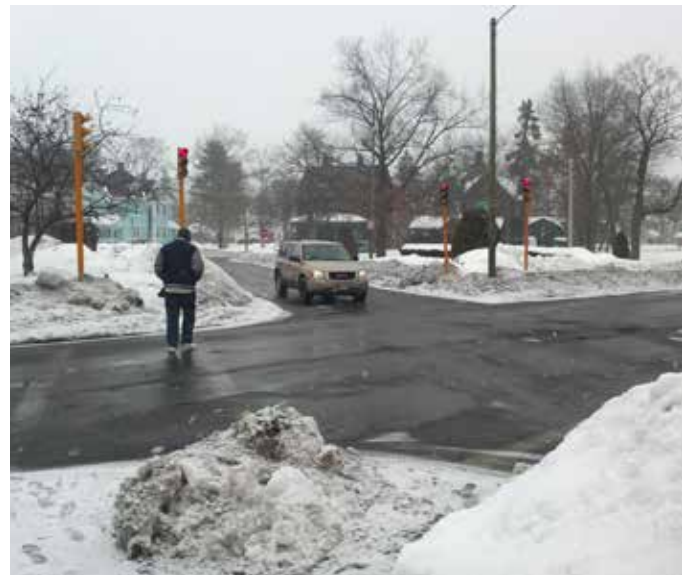
The Catharine Street/Bay Street intersection is a dangerous crossing point for students walking to Rebecca Johnson. The angle at which the streets cross poses a challenge, lengthening crossing distances and limiting visibility. There is a crossing guard posted at this intersection at arrival and dismissal times, which improves student safety. The intersection is signalized, but there are no pedestrian signals and therefore no protected pedestrian signal phase. Marked crosswalks exist on three of the four legs of the intersection, but not on the side that provides the most direct route for students traveling from northeast of the school. The crosswalks have only minimal pavement markings.

*Catharine/Bay intersection has no pedestrian signals*

1. Improve visibility of street crossings
  - Repaint crosswalks using a zebra or continental design and mark all four legs
  - Install missing curb ramp and detectable warning strips
2. Provide protected pedestrian crossing phase
  - Install pedestrian signals on all legs of the intersection
  - Consider concurrent phase with an automatic WALK signal

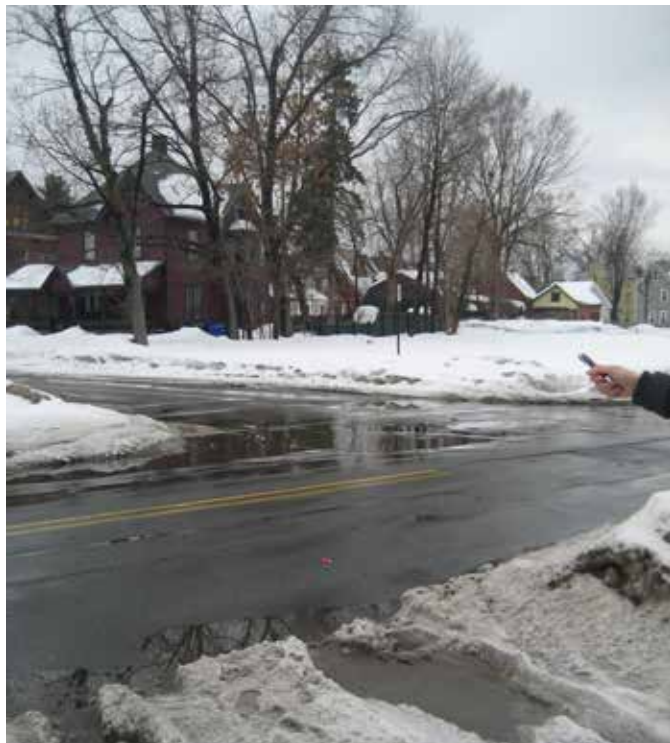
Students cross Bay Street at Dartmouth Street despite the fact that there is no marked crosswalk. A crossing guard is posted at this intersection to improve safety, but students crossing at times other than arrival and dismissal have no protection.

*The Bay/Dartmouth intersection has no marked crosswalk, but students and other pedestrians cross here frequently*

1. Improve safety of pedestrians crossing from the north side of Bay Street to the south side at the Catharine Street and Dartmouth Street intersections
  - Study safety implications of painting a crosswalk at the Dartmouth and Bay Street intersection; paint crosswalk if deemed appropriate
  - Repaint crosswalks using a zebra or continental design along Bay Street at the Bowles Street, Marion Street and Girard Avenue intersections
2. Improve drainage along Bay Street
  - Evaluate effectiveness of storm drains to remove water from Bay Street; any major redesign should address known drainage issues (long-term)

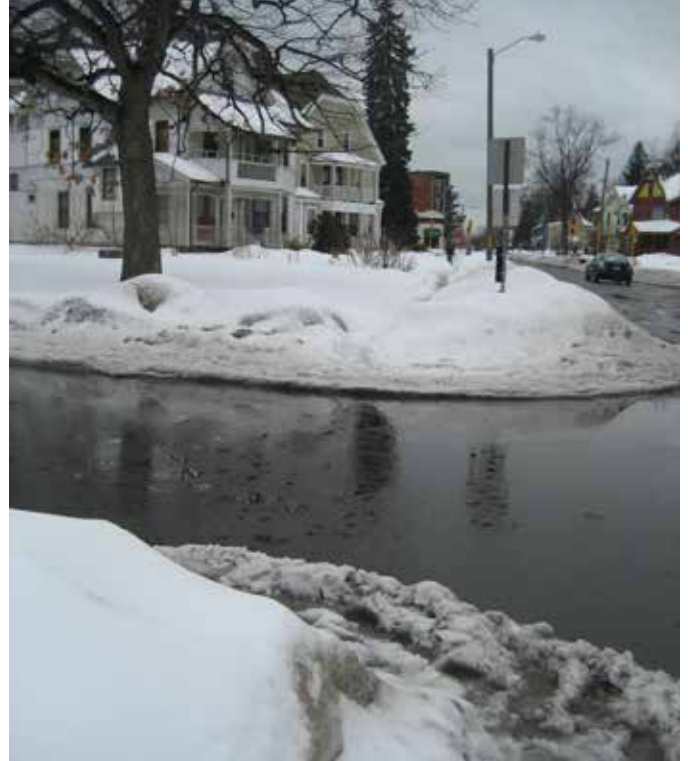
*Bay Street was flooded where drainage structures were blocked by snow.*

Bay Street has significant drainage issues. While the snow depths were higher than average, water was ponding across intersections making them impassable for pedestrians. Participants found themselves in the middle of the road to avoid deep puddles. Storm drains were either obstructed or ineffective in moving water off the streets.

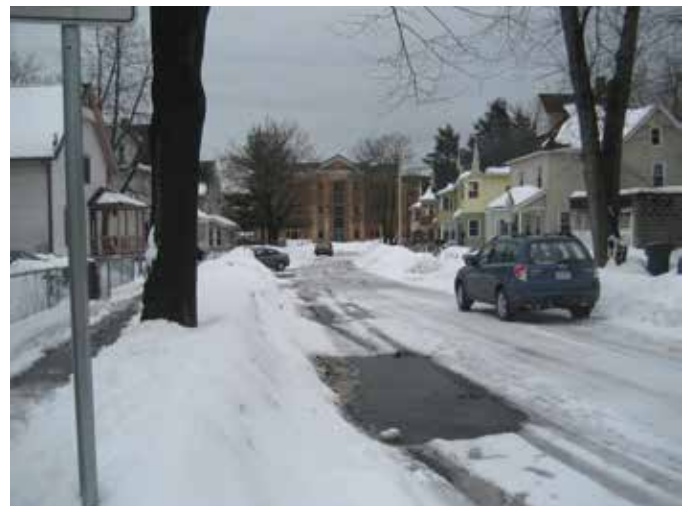
Both Bowles Street and Marion Street are neighborhood residential streets that terminate at Rebecca Johnson’s campus. There are sidewalks on both sides of each street. As described above, parents dropping off and picking up students use these streets to access the school. Neither street was designed as a cul de sac and therefore both have limited space to accommodate vehicles turning around. Homeowners on both streets are often parked in by parents waiting for school to be dismissed.

*View down Marion Street to Rebecca Johnson*

Snow removal on these streets was a primary concern. City plows had pushed snow into towering piles up against the school property at the base of both Bowles and Marion Streets. The snow obstructed pathways and limited the visibility of students coming out of school. Students were forced to walk single file in some cases around these mounds to the street. Snow removal responsibilities were complicated due to the overlapping property boundaries of the school, street right-of-way, and the adjacent park. School staff participating in the audit suggested that the school staff needs to improve snow removal on its property in this area.

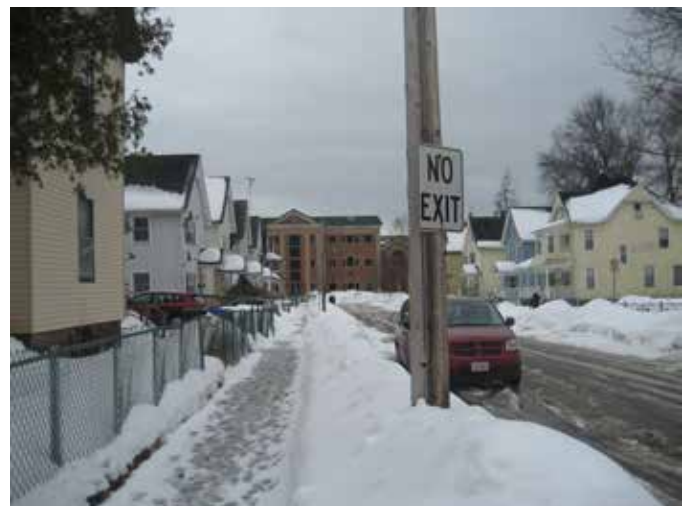
*View down Bowles Street to Rebecca Johnson*

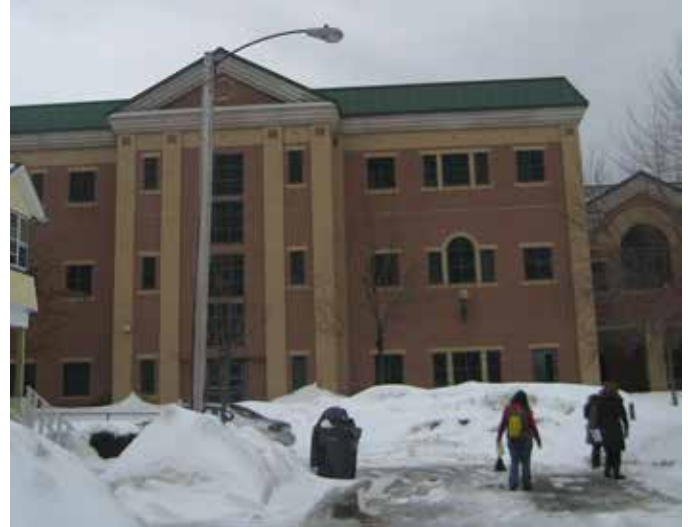
*Snow piled in front of the school entrances at the end of Bowles Street*

2. Prioritize snow removal along Bowles and Marion Streets
  - Resolve property boundary issues and determine responsibilities for snow removal
  - Ensure that walks and stairs on Rebecca Johnson property along the north side of the school are cleared of snow

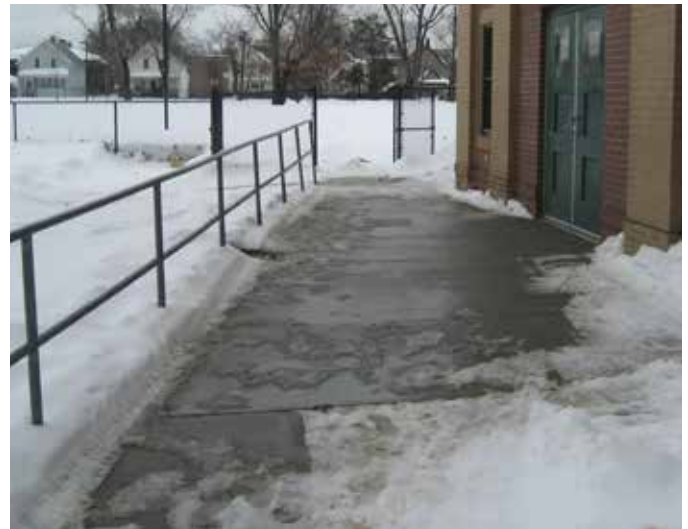
*School walkways were not cleared near entrance doors along the northern side of the school*

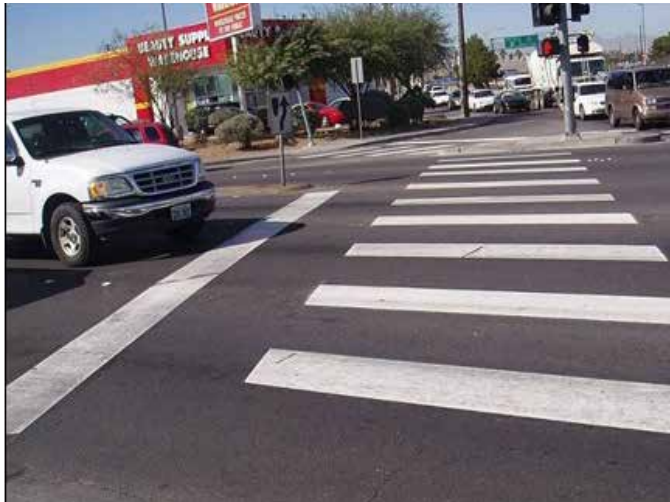
Crosswalks can be painted in a variety of ways, some of which are more effective in warning drivers of pedestrians. Crosswalks are usually accompanied with stop lines. These lines act as the legally mandated stopping point for vehicles, and discourage drivers from stopping in the middle of the crosswalk.

*Crosswalk and stop line*  
Source: [http://safety.fhwa.dot.gov/ped\\_bike/tools\\_solve/ped\\_scdproj/sys\\_impact\\_rpt/images/fig16.jpg](http://safety.fhwa.dot.gov/ped_bike/tools_solve/ped_scdproj/sys_impact_rpt/images/fig16.jpg)

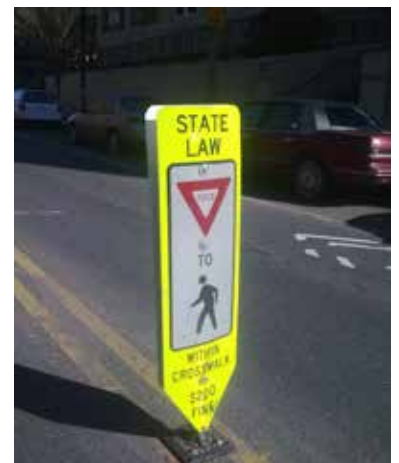
In-street pedestrian crossing signs are used at the road centerline within crosswalks to increase driver awareness of pedestrians in the area. These signs are a relatively low-cost, highly effective tool in slowing traffic by the narrowing travel lanes. They are popular with road maintenance departments since they can be easily moved for snow removal.
