***Elias Brookings Elementary
School Walk Audit
Springfield, MA***

July 1, 2013

MAKING MASSACHUSETTS MORE WALKABLE

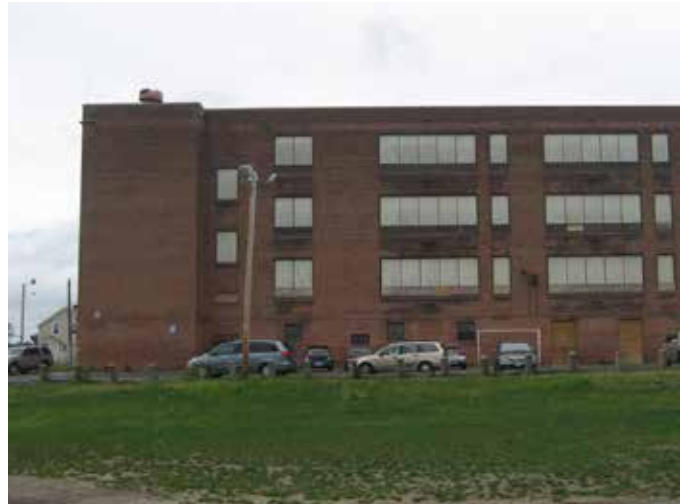
Brookings School damaged by 2011 tornado

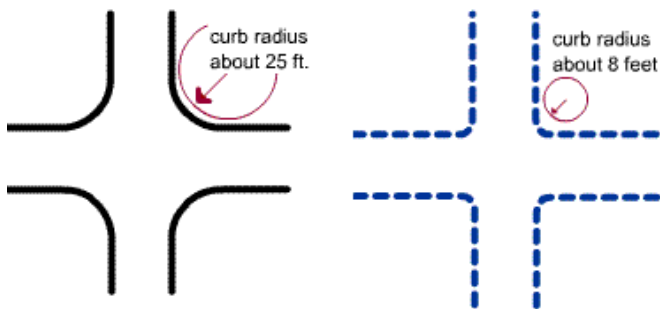
Figure 1. A longer curb radius (left) allows vehicles to turn more quickly and creates longer crossing distance for pedestrians. A shorter curb radius (right) slows turning speeds and provides pedestrians shorter crossing distances.

In general, the walking conditions around the school are challenging, both in terms of the layout of intersections and the quality of the sidewalks. The intersection design gives priority to cars with free right turn lanes and generous turning radii, which facilitate higher driving speeds (Figure 1). While sidewalks do exist on most of the streets we surveyed, in many cases they are too narrow, not separated from the roadway (no verge - Figure 2), and interrupted with multiple large curb cuts and driveways. Many infrastructure improvements are planned for this area of the city and we encourage school officials to actively participate in the design process to ensure that pedestrian issues are addressed. Below is our assessment of the walking route and key intersections, as well as recommendations for improvement.

At the intersection of Hickory and Walnut Streets, the curb radii on Hickory are excessive. Tightening the radii as shown on Figure 1 on page 4, would require cars to slow down when turning onto Hickory and Walnut Streets.

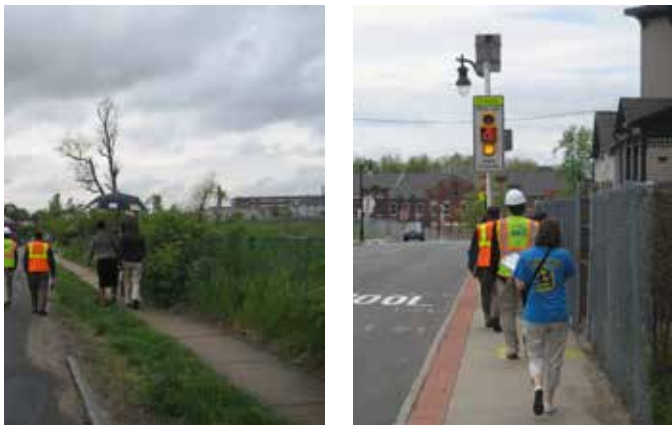
Figure 2. A verge (left) separates the pedestrian from the roadway. No verge (right) provides no distance between curb edge and the sidewalk.

The majority of sidewalks on the walk audit route have no roadside verge, which is a narrow strip of grass located between the roadway curb and the edge of the sidewalk (Figure 2). The verge is particularly important in geographic areas where snow is a factor because it provides a space for snow to be stored between the roadway and the sidewalk. Also, the additional distance from the curb further separates walkers from vehicles traveling in the roadway. When sidewalks and streetscapes are replaced, the provision of space for a verge should be considered.

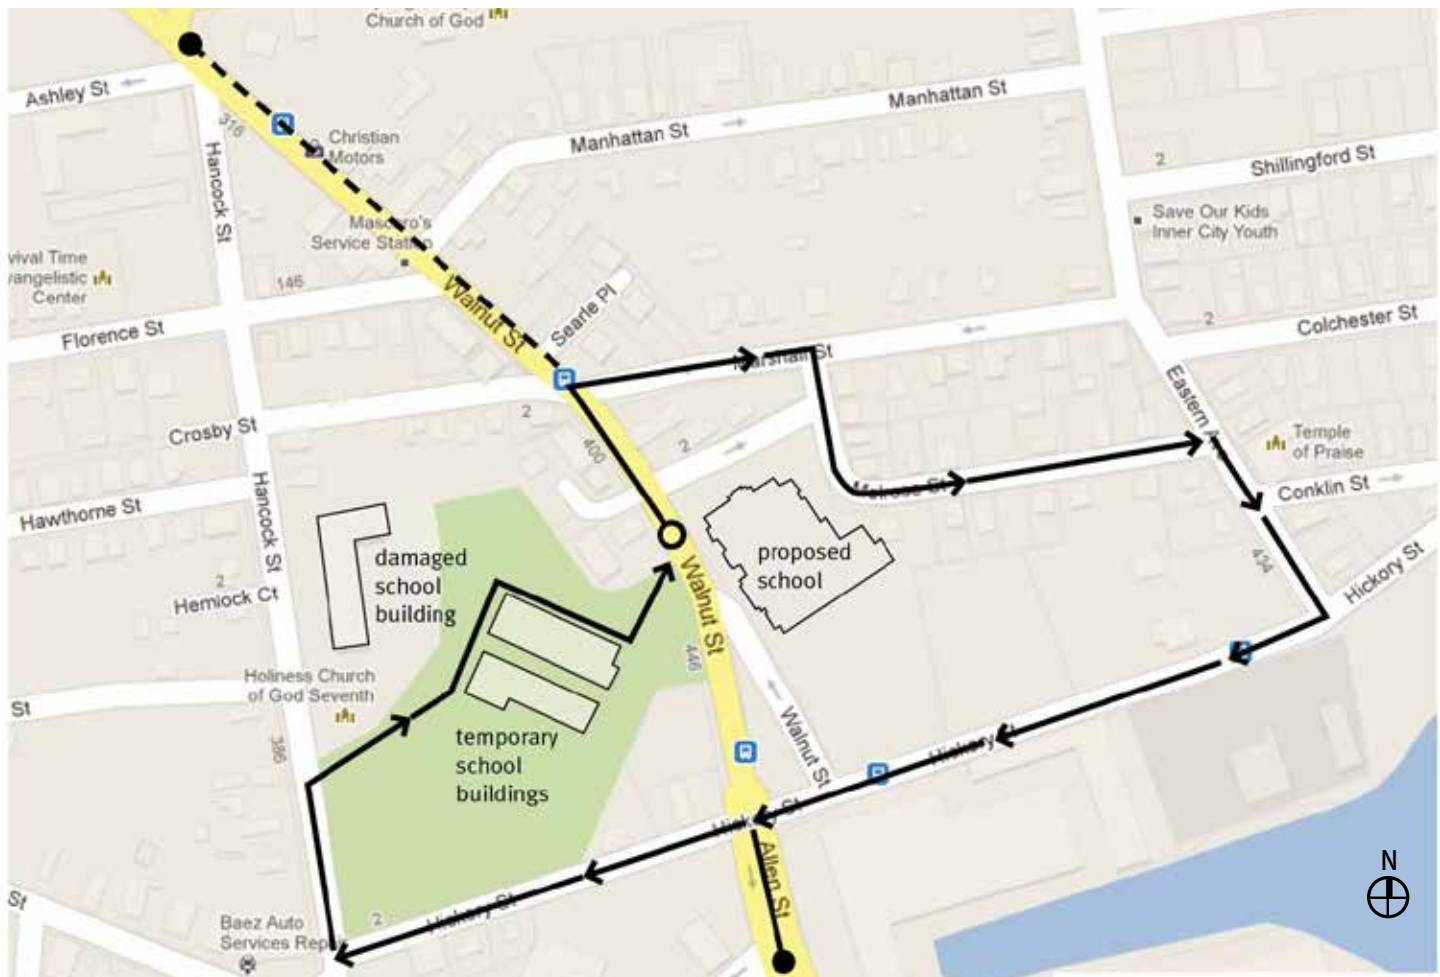
The walk audit route began at the proposed site of the new school and proceeded down Marshall Street to Melrose Street until it intersected with Eastern Avenue. The group walked south down Eastern Avenue to Hickory Street; went west on Hickory Street and observed both the Hickory/Walnut/Allen Street intersection and the Hickory/Hancock/Central Street intersection. We then proceeded up the hill on Hancock Street through Ruth Elizabeth Park and back to the temporary school buildings. A smaller group then walked north on Walnut Street to observe the traffic patterns at the six corners intersection (Hancock/Walnut/Ashley/Alden).

Walk audit route of Brookings Elementary School

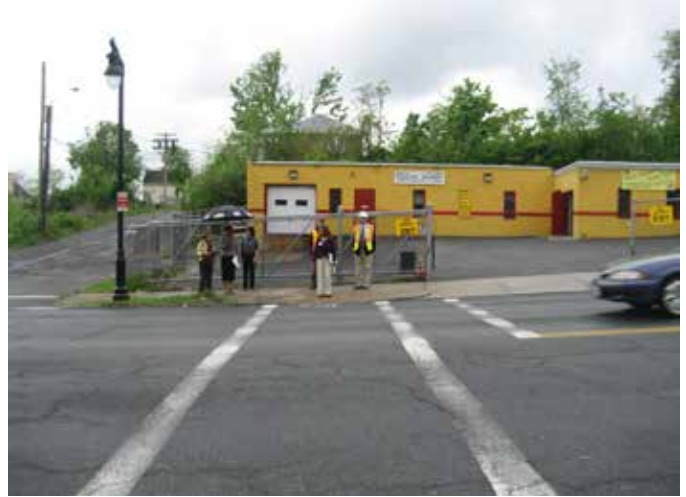
Figure 3. The parallel lines (above) are adequate for low-traffic areas, while the ladder (below) is more visible and should be used in higher-traffic areas.

A low cost, relatively simple way to make improvements to the pedestrian infrastructure is to add paint to the existing roadway. All crosswalks along the walk audit route consist of two lines running perpendicular to the roadway (Figure 3). WalkBoston recommends a ladder style crosswalk, which includes diagonal or horizontal lines connecting the parallel lines, because it increases drivers' visibility of the crossing. Greater awareness of crosswalks increases the possibility that drivers will be conscious of pedestrians and stop for them.

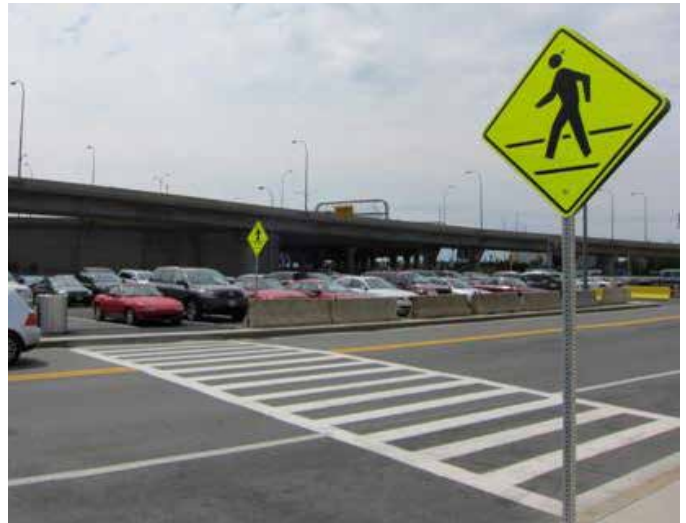
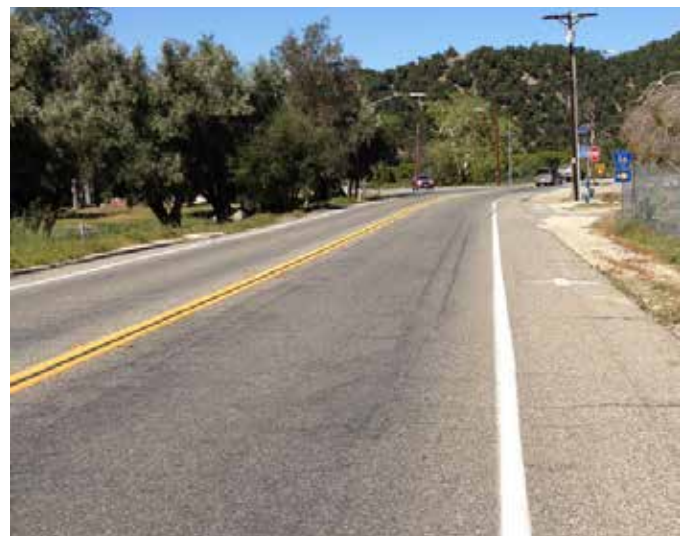
Figure 4. A solid white line (fog line) painted along the roadside curb defines the driving lane and narrows the driver's perspective.

In addition to enhancing the crosswalks, painting solid white lines parallel to the curb (fog lines) will help decrease the speed of traffic because drivers will perceive narrower lanes. Slower traffic will improve pedestrian safety and make for a more enjoyable walking experience. Walnut Street and Hancock Street are perfect candidates for these solid white lines.

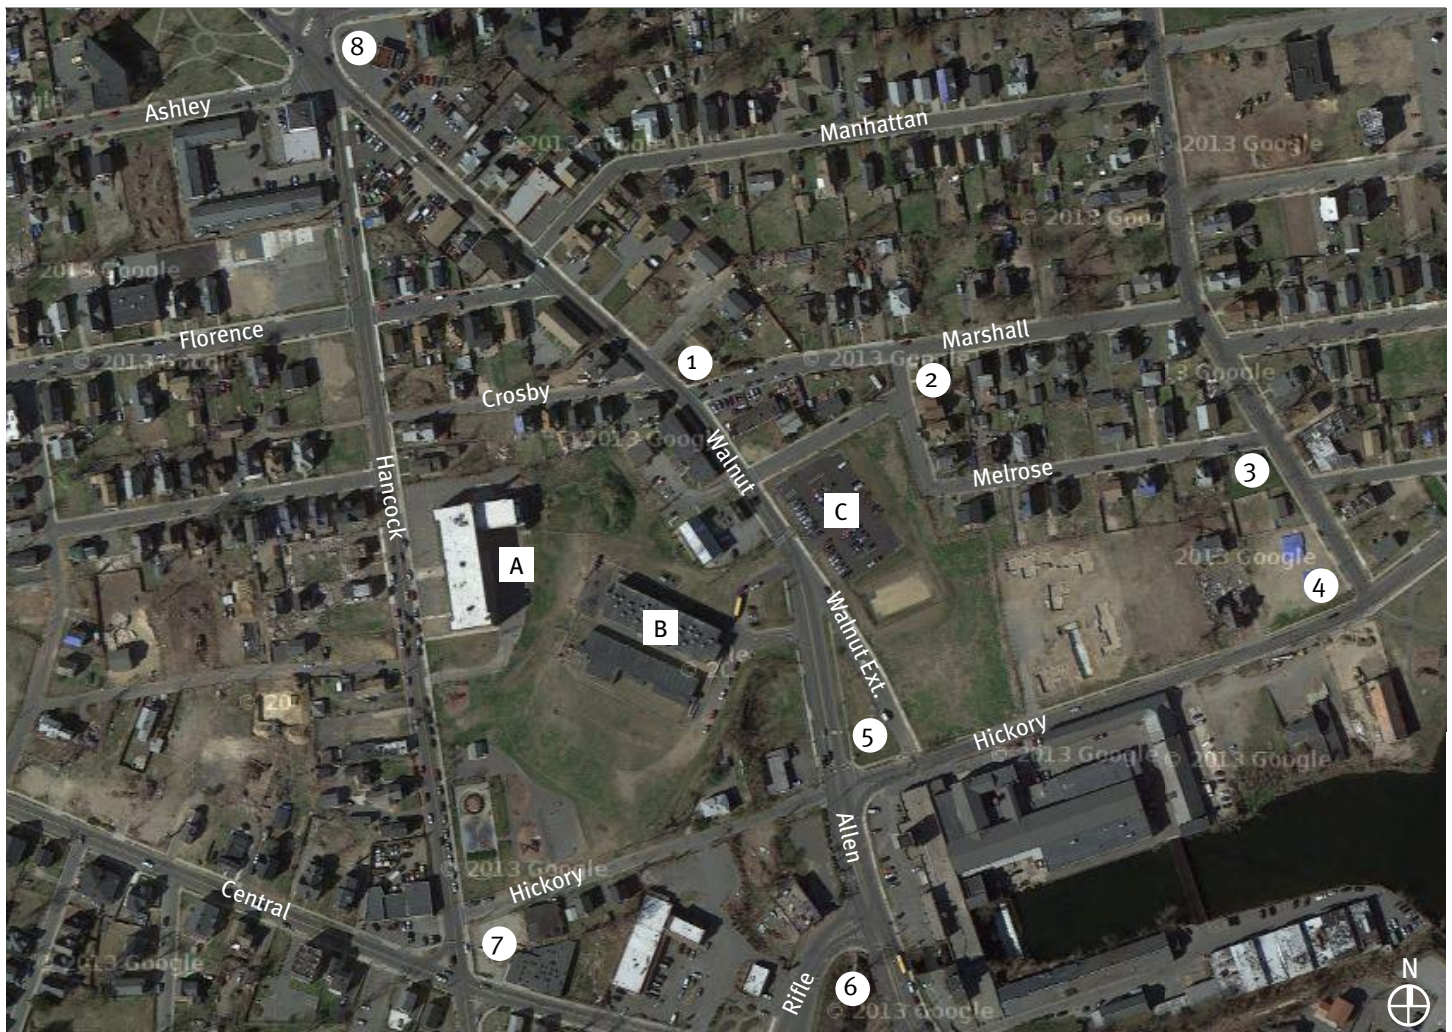
Figure 5. Intesections surveyed during walk audit.

1. Walnut/Marshall/Crosby Streets
2. Marshall/Melrose Streets
3. Melrose Street/Eastern Avenue
4. Eastern Avenue/Hickory Street
5. Hickory/Walnut/Walnut Street Extension
6. Allen/Rifle/Central Streets
7. Hickory/Central/Hancock Streets
8. Hancock/Walnut/Ashley/Alden (Six Corners intersection)

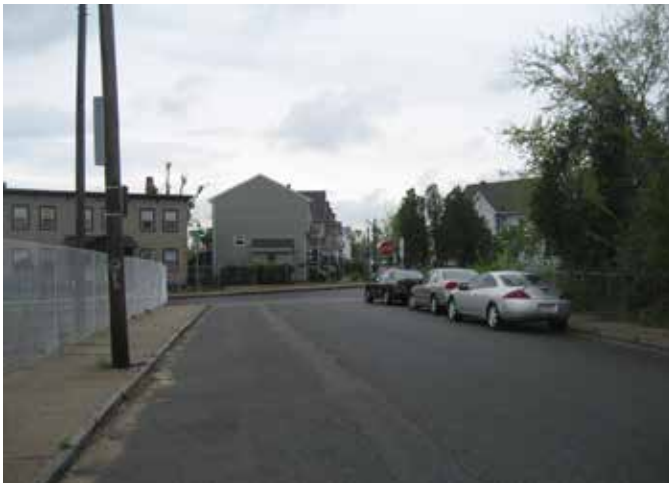
Marshall and Melrose Streets have sidewalks on both sides of the road. Neither street has a roadside verge, which suggests that children walking to school in the snow will most likely be forced to walk in the street. Snow removal should be prioritized in this area. Delineating parking stalls would better organize the cars on the street and may help to slow traffic moving through this residential area. With parking limited to 40 cars in the proposed school parking lot, regularizing parking on these streets may increase the overall capacity and help meet the needs of the school and residents.

View looking west down Marshall Street to Walnut Street. Sidewalks are present, but are narrow with no roadside verge.

- Paint crosswalk and parking stalls
- Install roadside verge when street is redesigned

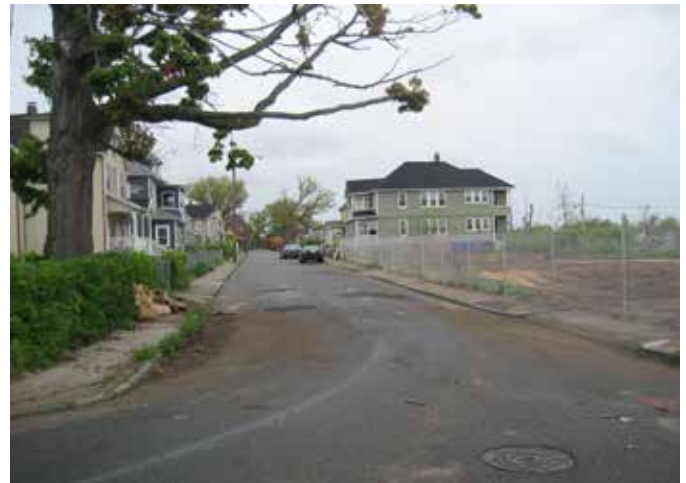
Students walking on Marshall and Melrose will most likely experience an increase in the volume of cars given the new traffic patterns and the new school location. While a crosswalk across Melrose at the Marshall intersection is not necessary now, we recommend that one be painted to make drivers aware of students walking to school.

View looking east down Melrose Street. This narrow residential street may see more vehicular traffic once the new school is completed.

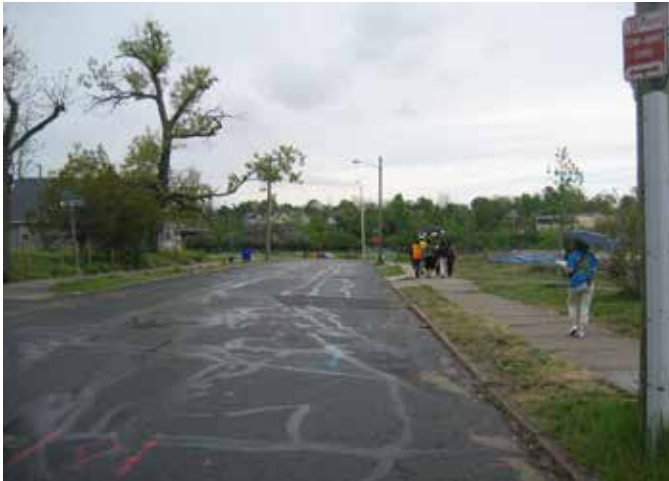
Unlike most streets in the district, Eastern Avenue does not have a roadside verge. There are no crosswalks across Eastern Avenue in this section. If there is a significant number of children crossing at the Eastern/Melrose intersection and traffic volumes warrant it, then a painted crosswalk should be considered. This section of Eastern was hit hard by the tornado. As the area is rebuilt, sidewalk upgrades should be considered.

View looking south down Eastern Avenue to Hickory Street

- Paint crosswalk, if appropriate
- Upgrade sidewalks

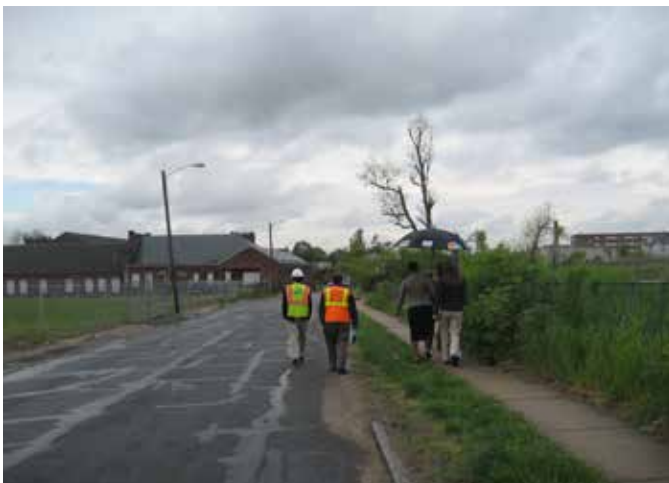
This section of Hickory Street was also devastated by the 2011 tornado. The sidewalk network is incomplete on both sides and the roadway is crumbling and in disrepair. Given its proximity to the new Brookings School, Ruth Elizabeth Park, Springfield College, and the Connecticut River, this road, if improved, could be an important link for walkers.

View looking west down Hickory Street

- Install sidewalks
- Improve roadway

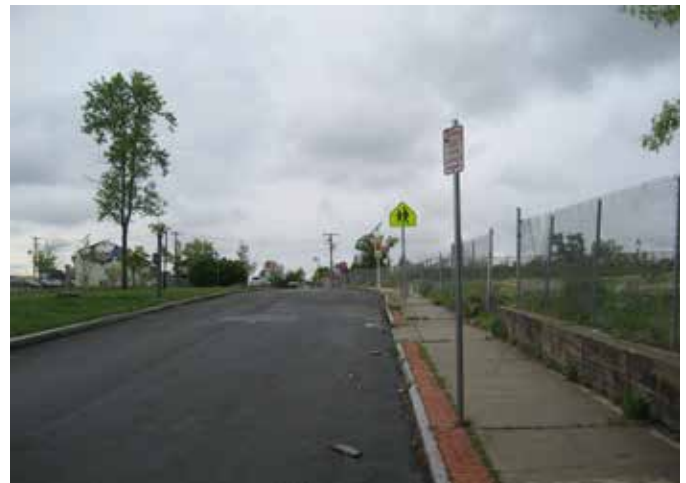
The Walnut Street extension is used and will continue to be used as a school drop-off zone with parking on both sides of the one-way street. The Pioneer Valley Planning Commission (PVPC) conducted an evaluation of the current student drop-off/pick-up process and found that after dropping off, some parents would make an illegal u-turn to reverse direction on Walnut Street. This practice needs to be discouraged, and as more parents use the Walnut Street extension for drop-off, specific procedures should be established and enforced to ensure safety for all users and walkers.

View looking north up the Walnut Street extension. Once the new school is built, this road section will officially be used as a drop off zone. Consult the appendix for additional recommendations for this area.

Other than the painted word SCHOOL on Walnut Street just north of the Hickory Street intersection, all other school zone markings, including a flashing school zone sign, are on the Walnut Street extension. Since traffic moves much faster up the hill on Walnut Street, we would encourage additional school zone signage on Walnut to bring more attention to the school's presence.

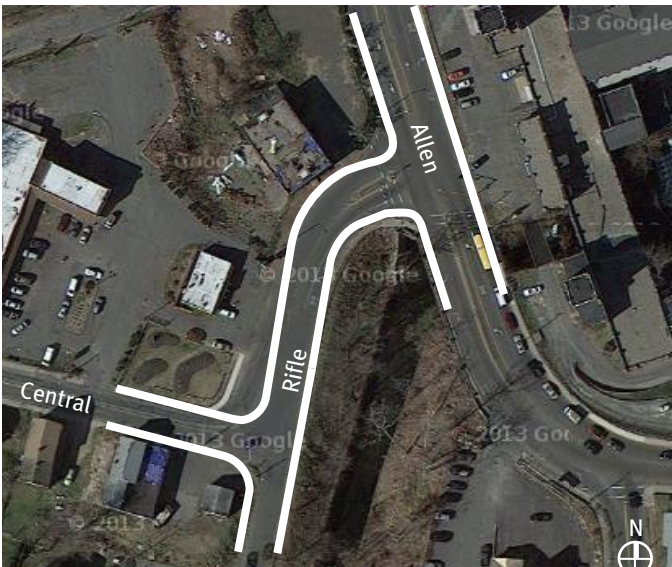
Figure 6. Diagram of suggested narrower lane widths and curb radii reductions.

Many students live in apartment complexes on Central Street and walk from Central to Rifle and then onto Allen Street. A shrub border on the west side of Allen Street impedes pedestrian circulation forcing walkers into the road when moving around a curve. The shrubs should either be maintained appropriately or removed. The Central/Rifle intersection and the Rifle/Allen intersection have excessively wide crossings with large curb radii. As the infrastructure is upgraded, we would recommend that the changes be made similar to those diagrammed below.

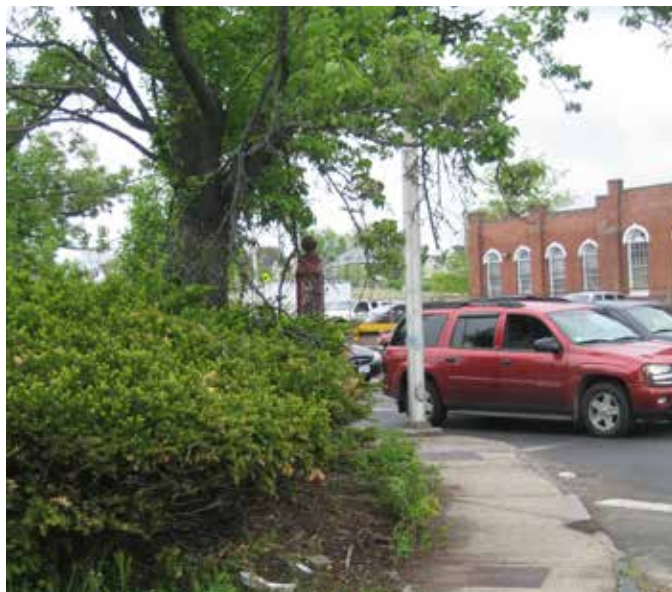
Shrubs along Allen Street obstruct the sidewalk forcing walkers into the street.

- Maintain vegetation along sidewalks
- Tighten curb radii

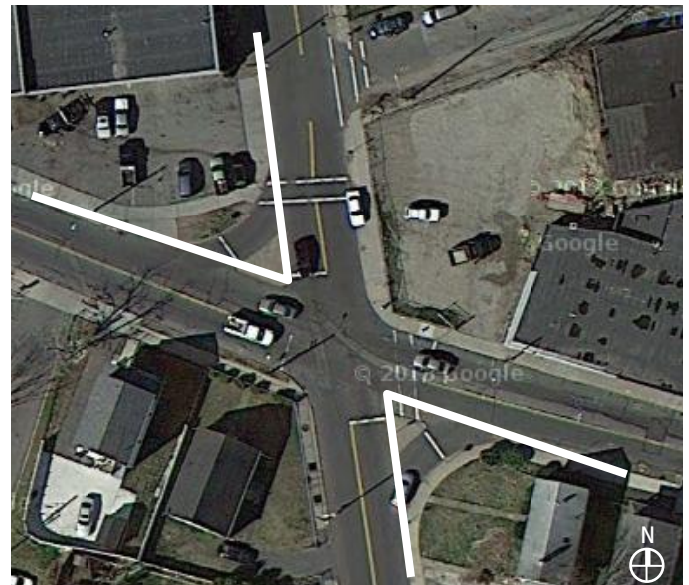
Figure 7. Diagram of the elimination of free right turns at the Hancock and Central intersection.

We understand that this intersection has been studied by the Springfield Department of Public Works and that improvements are planned. We would recommend that in addition to painting crosswalks, the city consider the elimination of the free right turn lanes. While this change may increase wait times at the traffic signals, it could significantly improve the pedestrian safety at the intersection.

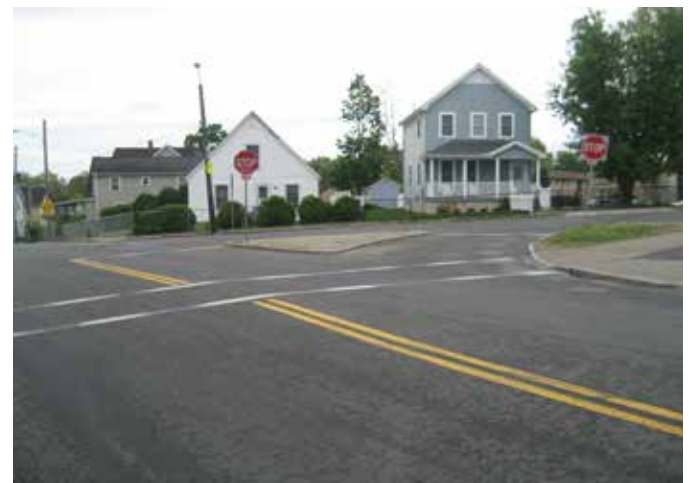
This intersection is particularly complicated for pedestrians to cross. The crosswalks are incomplete and exist on only a few roads of the intersection. South of Central Street, there is no crosswalk marked across Hancock. West of Hancock Street, there is no crosswalk marked across Central Street. Both Hancock Street and Central Street have free right turns that facilitate vehicular movement, but potentially jeopardize pedestrians as drivers move quickly through the intersection.

View of free right onto Central Street from Hancock Street

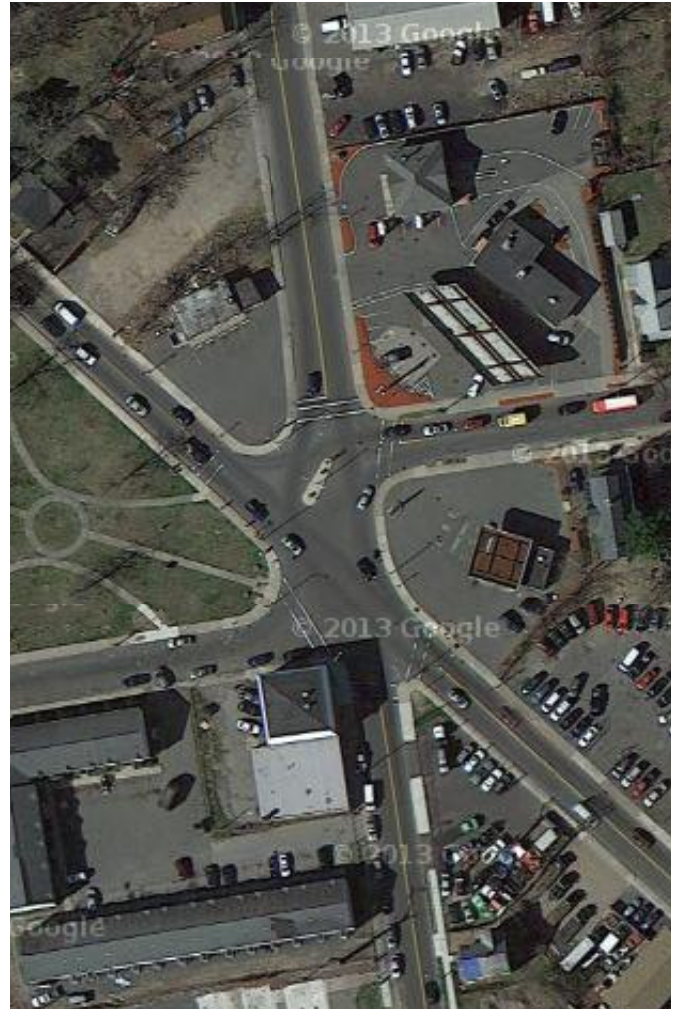
Well known in the city for its confusing layout, the six corners intersection includes five streets merging at irregular angles. Crosswalks lead across each street, but they are minimal with just two parallel white lines. There are no pedestrian traffic signals. A small traffic island sits in the center of the intersection, but it is unclear as to how vehicles are to circulate around it. As a pedestrian, it is difficult to anticipate where cars are coming from and when it is appropriate to cross the street.

Aerial view of the six corners intersection

- Curb radii be tightened to discourage wide, sweeping turns
- Pedestrian signals be added, and the
- Overall traffic pattern be regularized so there is a clear process for moving through the intersection for cars, bikes, and pedestrians.

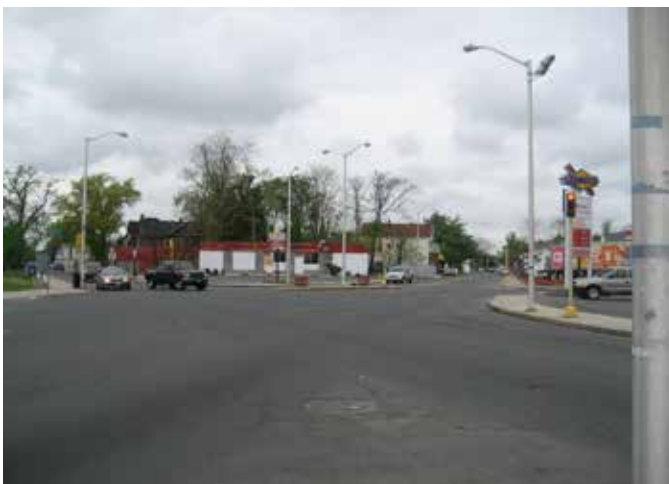
Vast stretches of asphalt characterize the pedestrian experience at the six corners intersection.

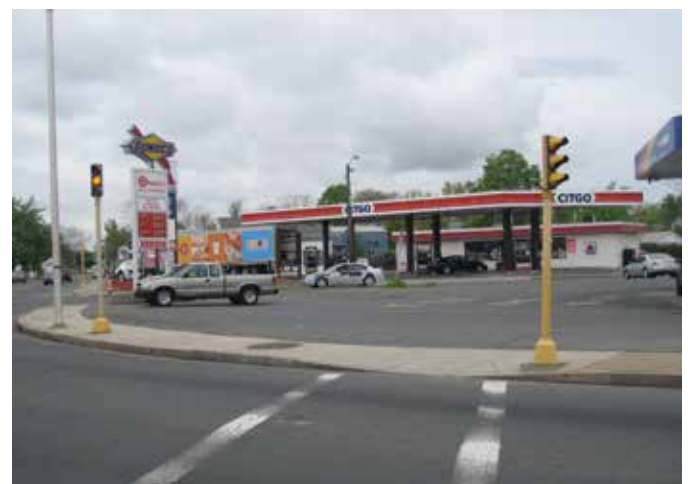
There is a substantial amount of undifferentiated pavement at the gas stations on the north and south sides of Alden Street, as well as around the vacant pizza establishment between Hancock and Walnut Streets. The school administration told us that children frequent the Dunkin Donuts and walk through the parking lots because it is the shortest route to school.

In addition to the asphalt in the roadway, large paved areas around two gas stations flank Alden Street.
