Top High Risk At-Grade Railroad Crossings in the Pioneer Valley

**Prepared under the direction of the Pioneer
Valley MPO by the:
PIONEER VALLEY PLANNING COMMISSION**

APRIL 2019

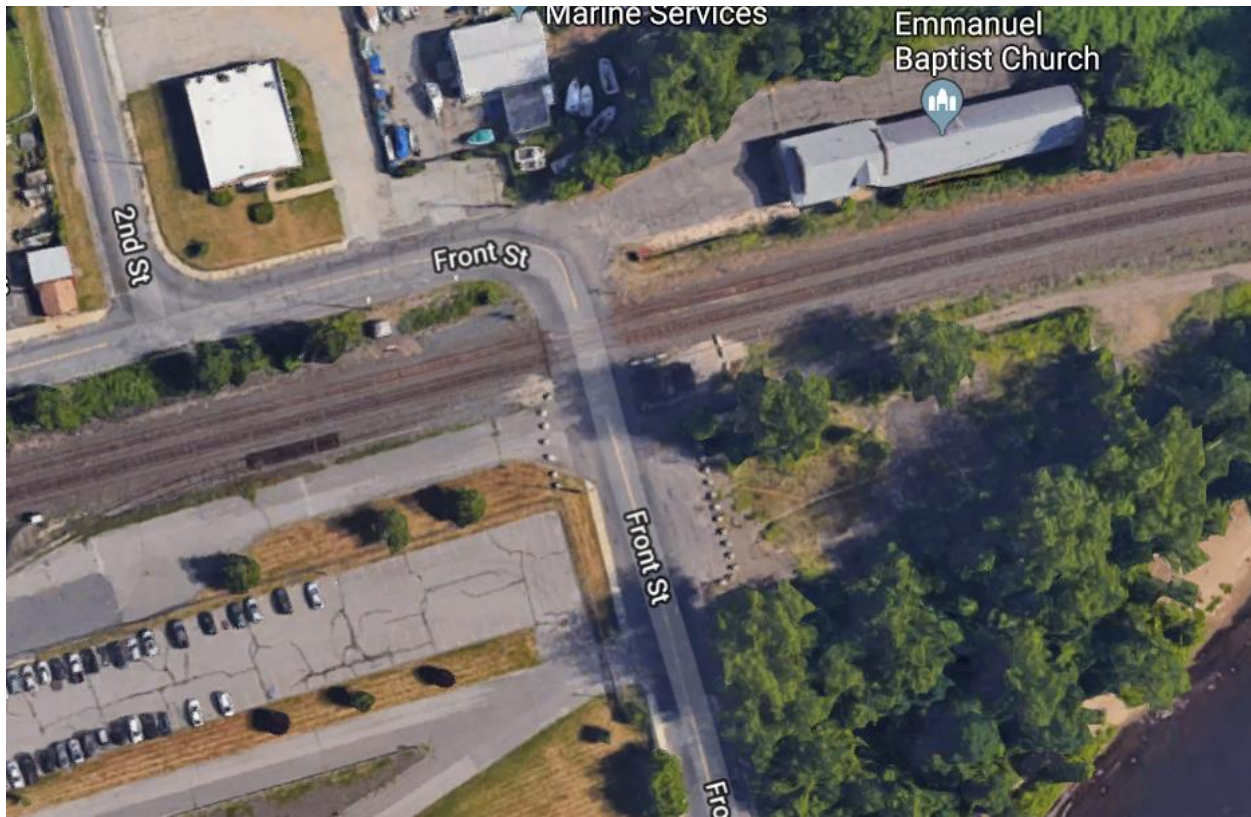
Figure 2: Aerial view of Front Street Crossing

Front Street is a local road serving small commercial development in the vicinity of the railroad crossing and it connects to Bridge Street in south providing access to residential neighborhoods in Agawam. Vehicles approaching the railroad crossing from north along Front Street have to make a sharp right turn in the close vicinity of the tracks. This geometry of the road sometimes makes it difficult for the faster moving vehicles to visualize the gates in advance.

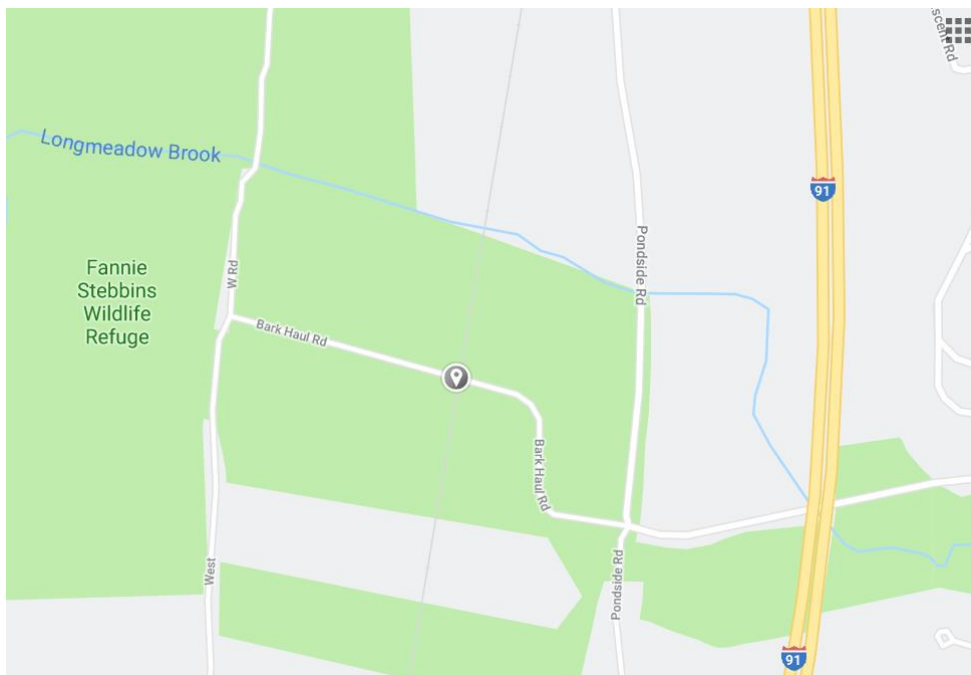
Figure 9: Bark Haul Road Crossing

It is listed as a Private Railroad crossing belonging to Amtrak. There are 2 tracks along the crossing. Bark Haul Road is a gravel path in the vicinity of the crossing along the train tracks within the Fennie Stebbins Wild life Refuge Area. The road is currently restricted to the motor vehicles beyond Pondside Road and is utilized as a trail by local residents and visitors for floodplain wildlife viewing and recreation. Motor vehicles were observed to utilize the vicinity of the intersection of Bark Haul Road and Pondside Road for parking.

The WBAPS report states there are cross bucks present at the location however at the time of field visit only Stop signs were observed along both approaches of Bark Haul Road supplemented by a private railroad crossing sign and an information sign for reporting incidents and emergencies. The sign post for westbound approach of Bark Haul Road was damaged and the signs were laying along the road. Overgrown vegetation was covering the signs along both directions.

In the meantime short term improvement measures like repairing the damaged signs and proper maintenance of the gate restricting the access of motor vehicles should be considered to ensure the safety of the users of this road.
