Traffic and Transportation Study
at the Intersection of
Page Boulevard (Route 20) and Bircham Street
in the City of Springfield, MA

June 2022

Safety Study and Signal Warrant Analysis at the Intersection of Page Boulevard (Route 20) and Bircham Street in the City of Springfield, MA

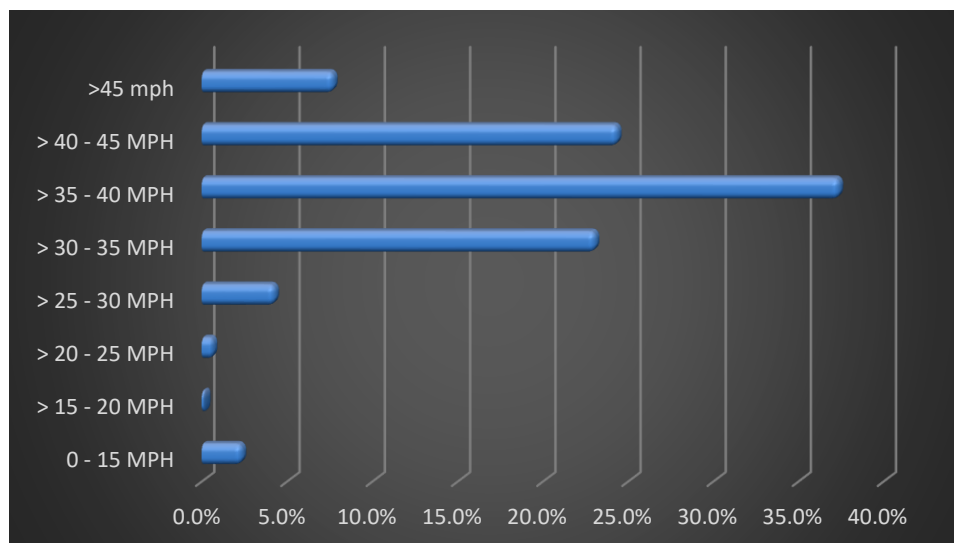
Figure 4: Travel Speed in Percentage of Vehicles Along Westbound Approach of Page Boulevard

Speeds for the study area were further classified into 5 mph ranges to identify the percentage of traffic in each range. This information is presented in Figures 4 and 5. It is observed that more than 80% of vehicles along the eastbound approach are travelling above the posted speed limit. This percentage is reduced slightly to almost 70% in the westbound direction. Nearly 20% of vehicles are travelling over 45 mph in the eastbound direction as they approach the intersection.

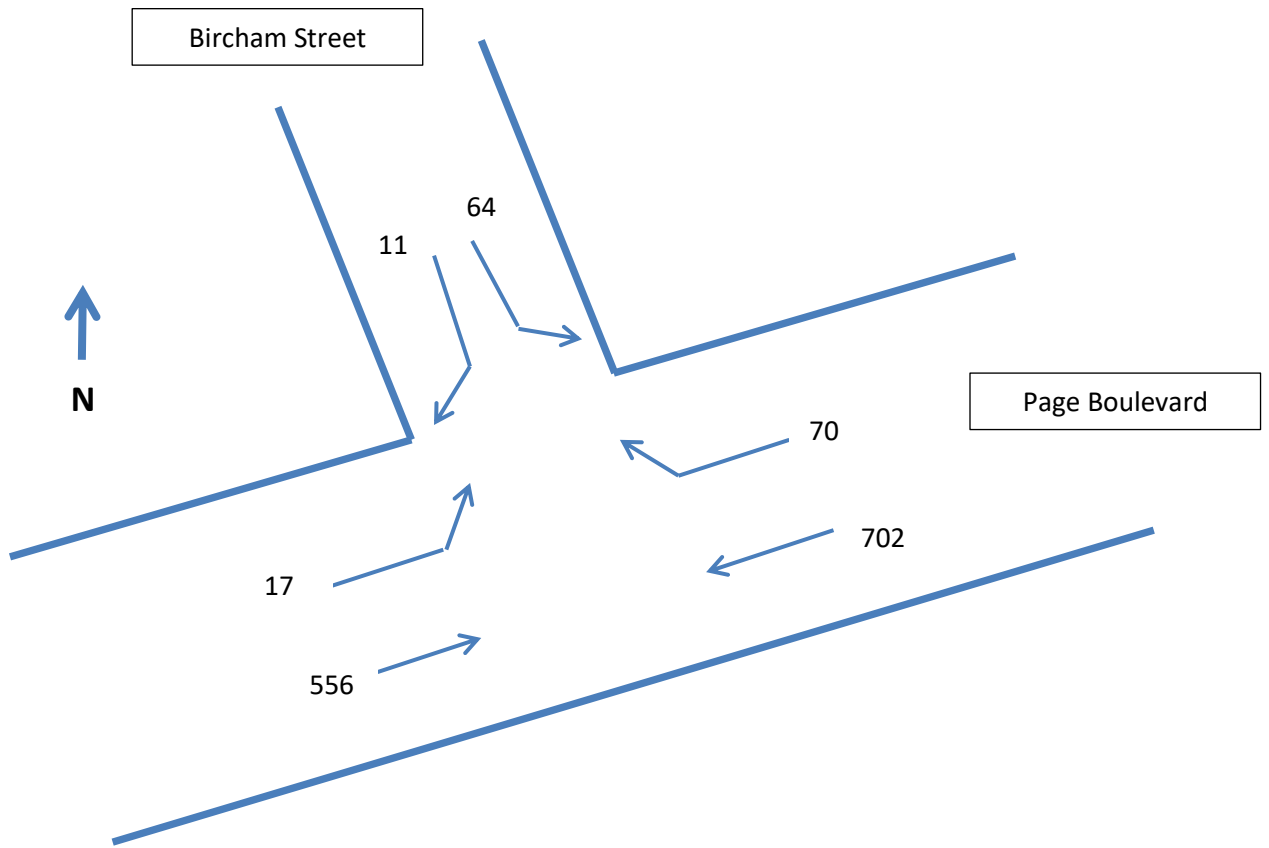
Morning Peak Hour Turning Movement Counts (7:15 am to 8:15 am)

A vast majority of vehicles exiting Bircham Street turn left onto Page Boulevard during both the morning and afternoon peak hours. It was observed during data collection and multiple field visits that at certain intervals there were queues of more than six vehicles waiting to exit Bircham Street. Bircham Street is likely utilized as a cut through route to travel between Worcester Street and Page Boulevard.

The volume of vehicles currently turning left from Page Boulevard onto Bircham Street is low during both the morning and afternoon peak hours. This is a movement of concern because of the higher potential for conflict with the high volume of through traffic in the opposite direction. Left turning traffic from Page Boulevard onto Bircham Street was not observed to create queues during data collection.

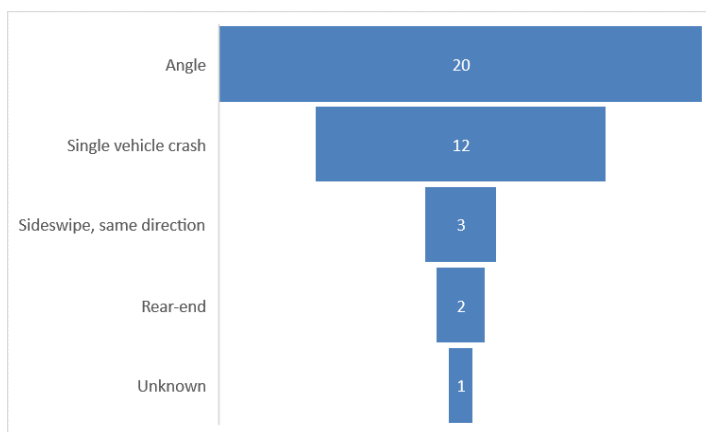
Figure 7: Crash Type

Crash data was obtained from MassDOT’s IMPACT crash portal utilizing the spatial query for the five-year period between calendar years 2017 to 2021. A total of 38 crashes were reported in the study area at the intersection within this time period. Table 3 represents the classification of these crashes and circumstances and conditions under which these crashes were reported to have occurred. A vast majority of crashes occurred during daylight hours, under clear weather and dry road conditions. Figure 7 depicts the manner of collisions or crash type. A majority of crashes were angle type collisions, followed by single vehicle crashes.
