Brightwood Neighborhood Walk Assessment Springfield, MA

November 18, 2015

MAKING MASSACHUSETTS MORE WALKABLE

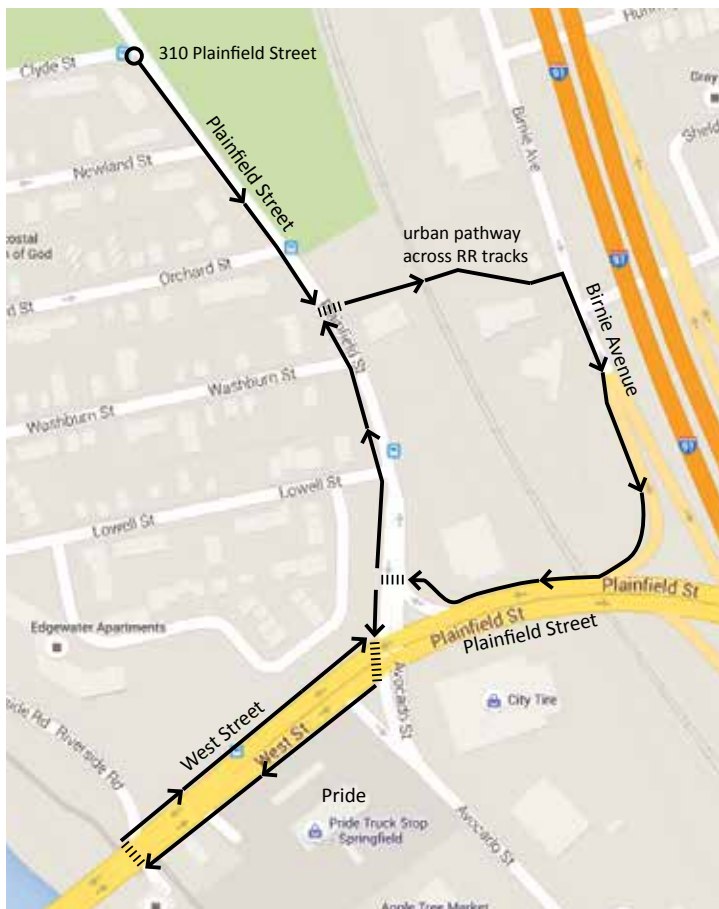
Walk audit route along Plainfield Street to the railroad crossing and to West Street and Pride Market.

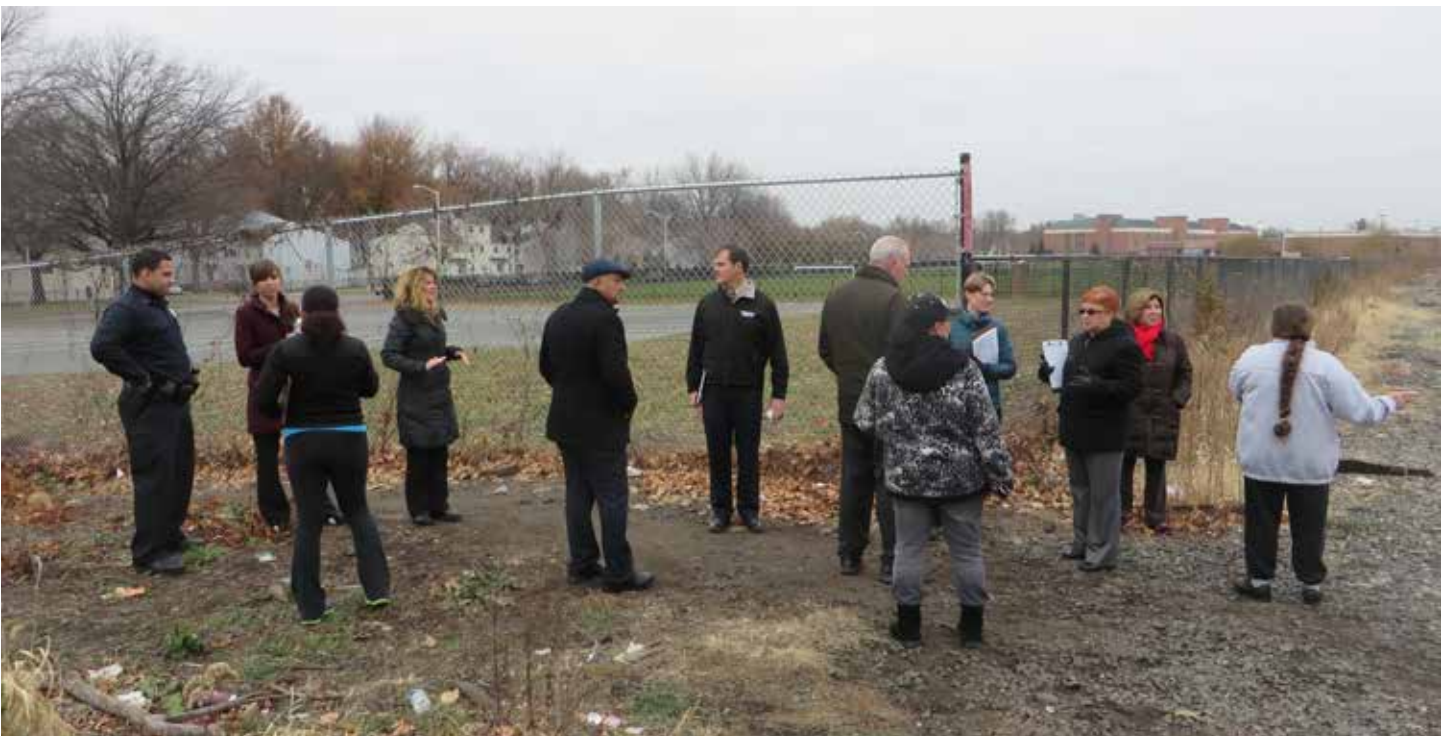
Walk audit participants assess the conditions of the railroad crossing between Plainfield Street and Birnie Avenue.

A narrow, unmarked dirt path across railroad tracks and through overgrown and trash-strewn lots with a high prevalence of drug activity is one of the only ways for pedestrians to enter and leave the Brightwood neighborhood and access Birnie Avenue and Main Street. Many students and their families currently use this unsafe crossing to get to and from Chestnut Middle School. The City of Springfield currently provides police presence and periodic clearing of overgrowth and trash along the railroad crossing path, but a long-term infrastructure solution is necessary to ensure safe passage for pedestrians. Expecting pedestrians to walk along Plainfield Street all the way to Route 20 to get to Main Street is not a viable solution, given the long distance involved to access desired destinations and the significant pedestrian safety challenges at the convergence of Plainfield Street and Route 20, which are documented elsewhere in this report.

WalkBoston recommends that the City continue to work with MassDOT to advocate for the proposed underground Amtrak railroad crossing. The City should also work to ensure that both ends of the underground passageway have safe, aesthetically pleasing and easily navigable connections to Birnie Avenue, Plainfield Street and the broader Brightwood community. The passageway must also be well lit at all hours.

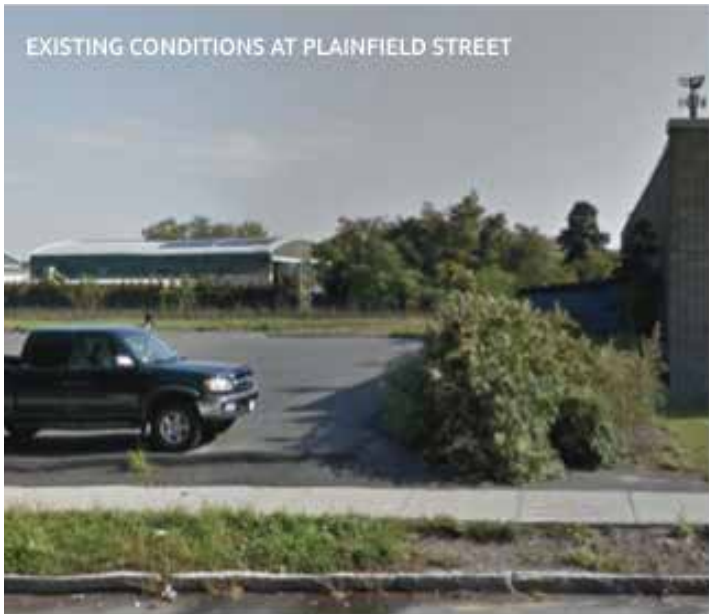
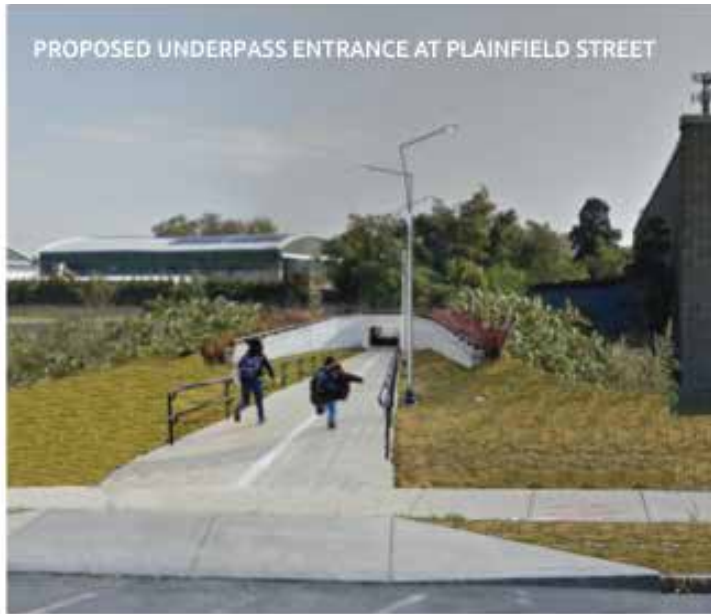
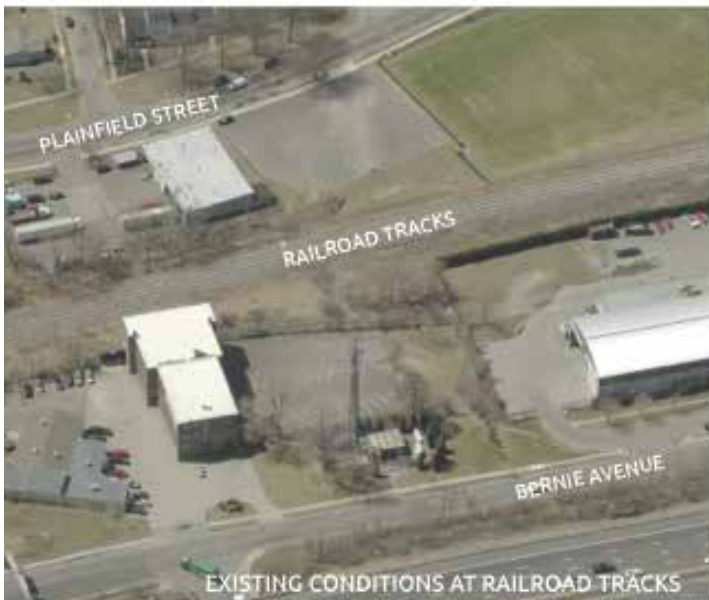
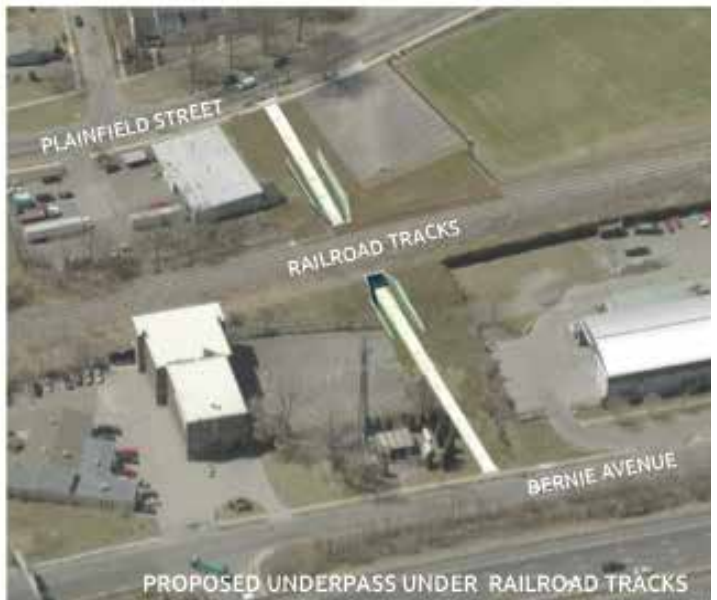
MassDOT's proposed plans for a railroad underpass between Plainfield Street and Birnie Avenue will significantly improve walking conditions and connectivity for Brightwood residents. The project is slated to be built in 2017-2018. (Source: MassDOT)
