SAFETY STUDY OF

Amostown Road, Pease Avenue and Morgan Road

Safety Study of Amostown Road, Pease Avenue and Morgan Road

Final Report

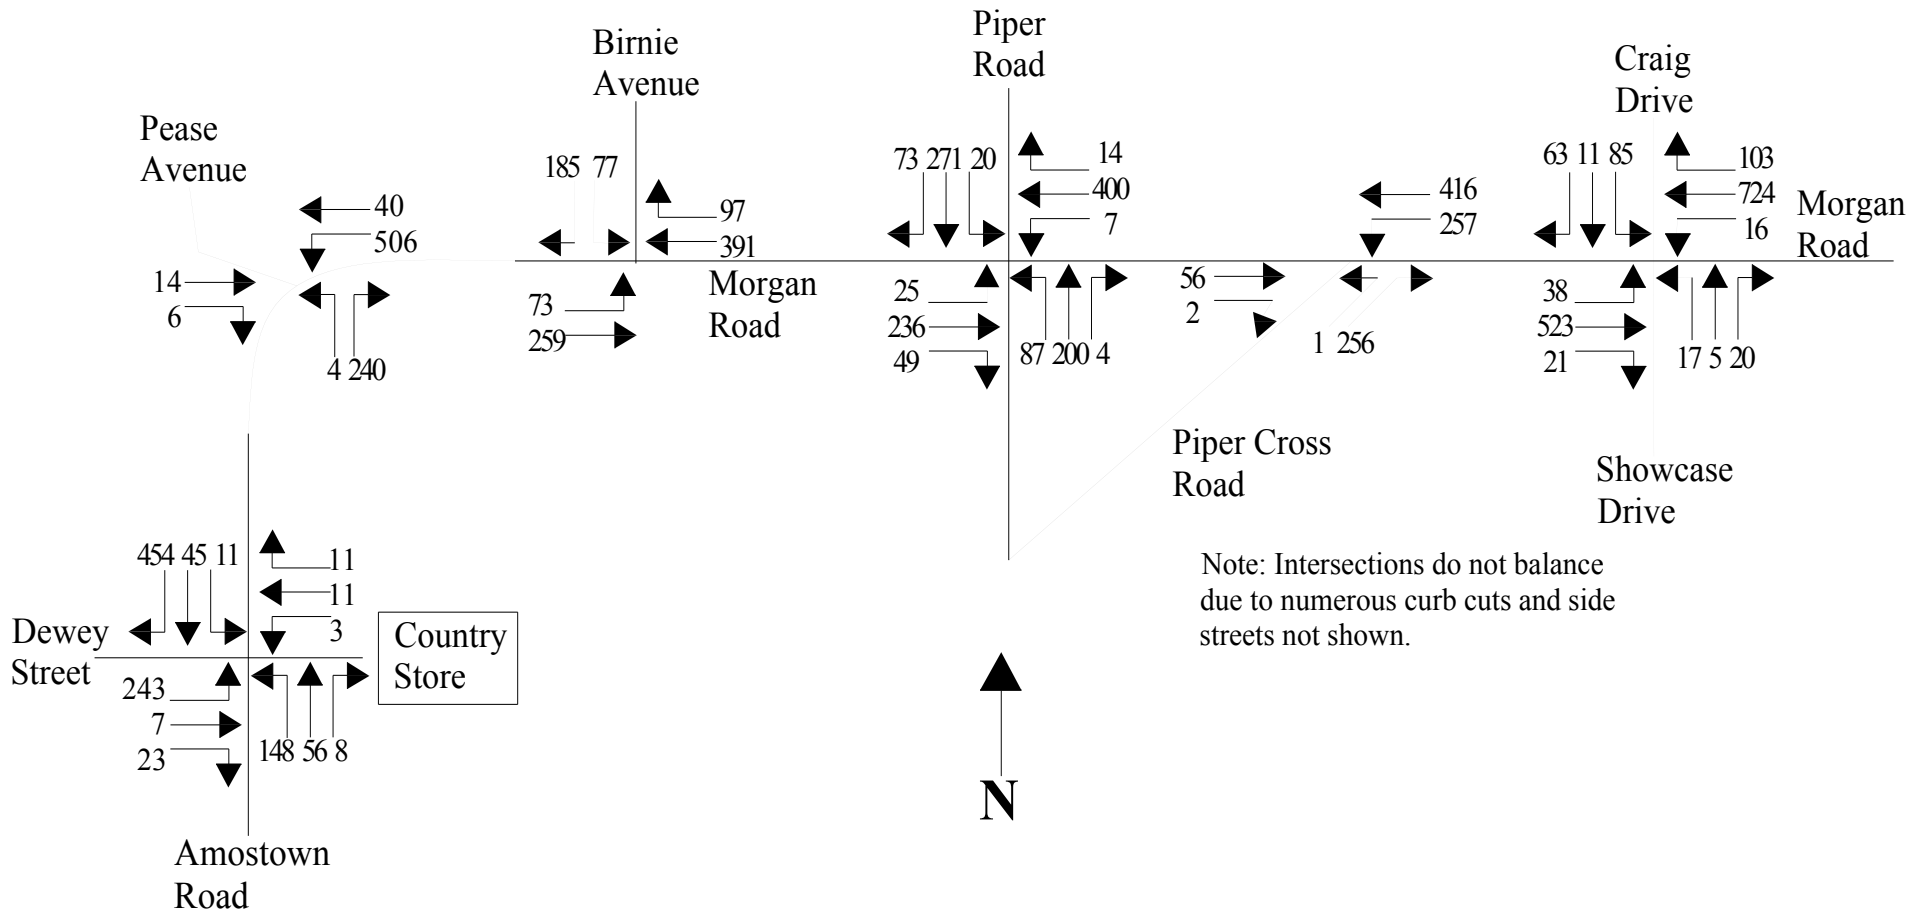
Figure II-2 - Afternoon Peak Hour Turning Movement Counts

Based on the MassHighway data, traffic volumes during the month of March are estimated to be slightly lower than the annual average. Therefore, the traffic count data was adjusted to reflect average month conditions. Turning movement count data for the morning and afternoon peak hours are summarized on Figures II-2 and II-3.
