Ware

Downtown Signal Coordination and Safety Study

January 2011

**PREPARED UNDER THE DIRECTION OF PIONEER VALLEY MPO BY:
PIONEER VALLEY PLANNING COMMISSION
60 CONGRESS STREET
SPRINGFIELD, MA 01104**

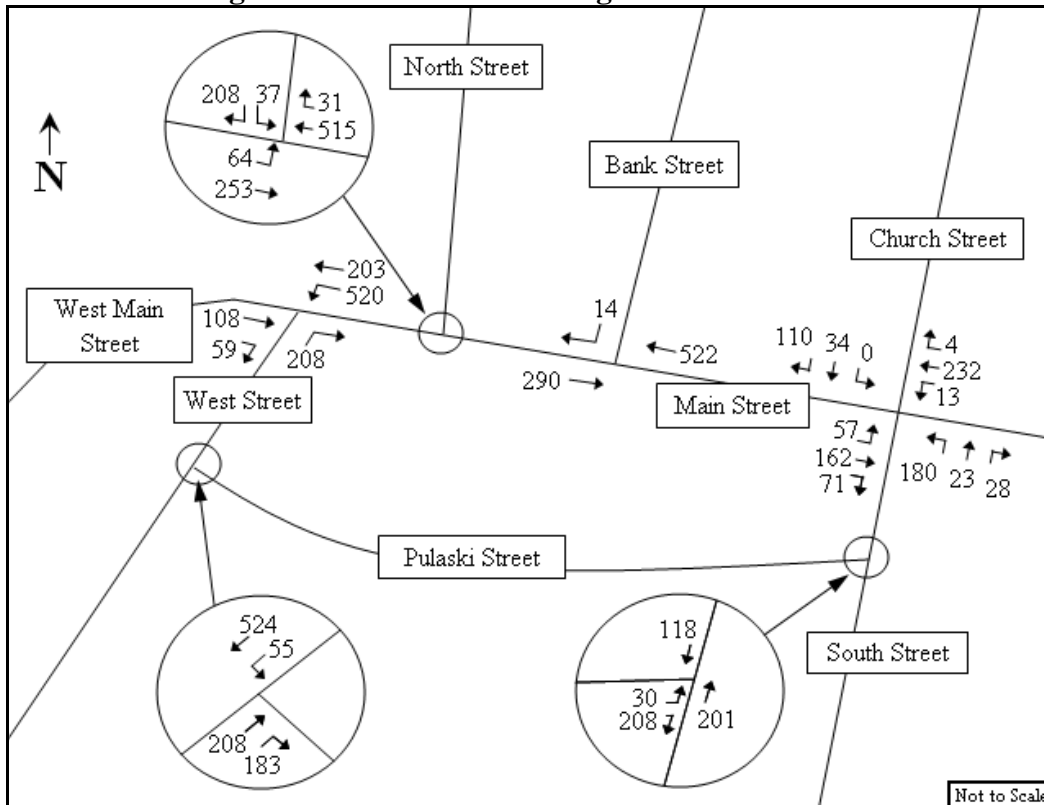
Figure II-1-AM Peak Turning Movement Count

As traffic volumes tend to fluctuate over the course of the year the Massachusetts Department of Transportation (MassDOT) develops yearly traffic volume adjustment factors to reflect monthly variations. These factors were examined to determine how traffic conditions in the study area compare to average month conditions in accordance with the month that each intersection was studied. Based on the data and location of the TMC's, traffic counts were adjusted accordingly. TMC data for the morning and afternoon peak hours are summarized in Figures II-1 and II-2 respectively

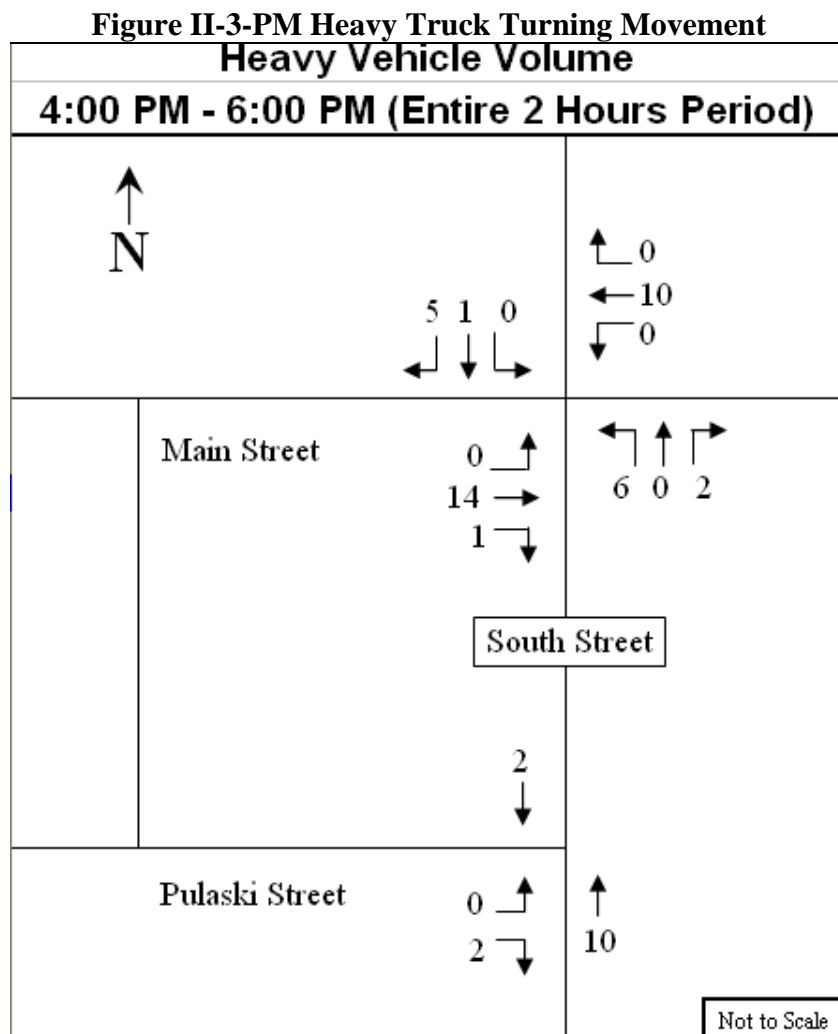
Based on information provided by Lenard Engineering Incorporated, the existing turning radius for right turns on the eastbound approach of Main Street at its intersection with South Street and Church Street does not comply with the American Association of State Highway and Transportation Officials (AASHTO) standards for larger trucks. As a result, trucks are required to complete this maneuver from the through movement lane on Main Street. Inexperienced drivers and drivers unfamiliar with this area have a history of driving over the existing curbing and sidewalk that surrounds Nenameseck Square. There is also a history of collisions with the cast iron fencing that surrounds Nenameseck Square. The PVPC conducted a turning movement count of heavy vehicle traffic at this location and the intersection of South Street with Pulaski Street. The results of this count from 4:00 PM until 6:00 PM are summarized in Figure II-3. As can be seen in the figure, heavy vehicle traffic is relatively light during the afternoon peak hour. These movements are complicated, however, by the non-standard geometry of the intersection and high volumes of traffic.

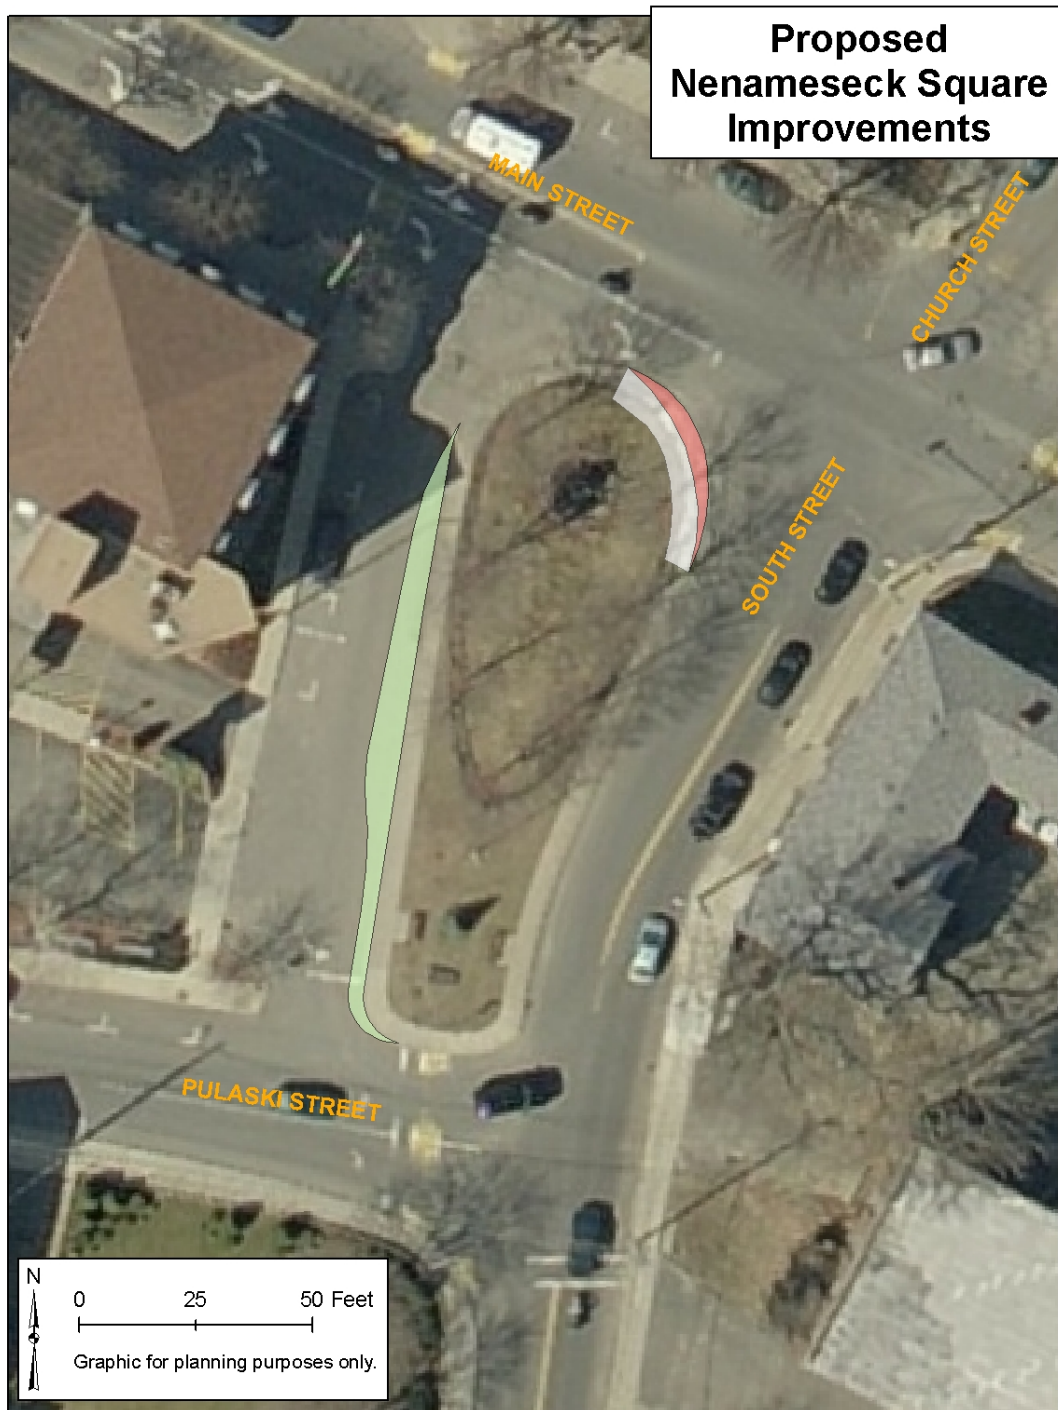
Figure IV-1-Proposed Nenameseck Square Improvements

Nenameseck Square requires an improved radius to allow for right turns by heavy vehicles onto South Street. Trucks making right turns onto South Street from Main Street do not have adequate space to make this movement and utilize part of the sidewalk. Pedestrians are not allowed to use this sidewalk due to the dangers these trucks present when making these turns. To improve the movement of trucks PVPC has developed a conceptual drawing of the Nenameseck square to allow for truck movement without using the sidewalk (Figure IV-1). This plan reduces the sidewalk width in order to increase the turning radius directly abutting the intersection of South Street and Main Street. Additional green space is proposed on the Bank Access Road side of the square to make up for any loss.

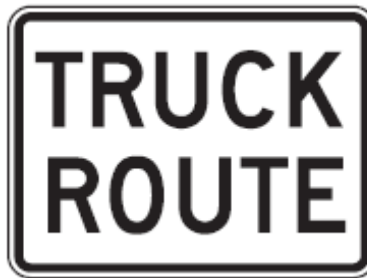
Figure IV-2-Suggested Truck Route Sign

With heavy movement of trucks through the downtown of Ware, the town could enact a suggested truck route in the short term. Using a standardized sign seen in Figure IV-2 a non-enforceable suggested truck route could be established. While use of a designated truck route is not mandatory, these advisory signs encourage trucks drivers to stick to the labeled truck route. Ultimately, these signs aid truck drivers by avoiding hazardous obstacles that they would encounter using roads such as Pulaski Street.
